57 Vehicle does not start using the key reader and/or the key is not recognized during immobilizer servicing.

57 23 05 2070128/1 April 27, 2023.

Model(s)	Year	VIN Range	Vehicle-Specific Equipment
Q5 and SQ5	2018 – 2024		
Q5 e quattro	2020 – 2024		
Q5 Sportback, and SQ5 Sportback	2021 – 2024	All	Not Applicable
A3, S3, RS 3, e- tron GT, and RS e-tron GT	2022 – 2024

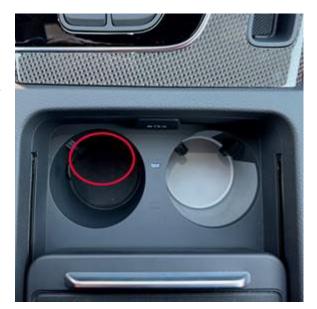
Figure 2: Reader coil location in the Q5.

In the Q5 the pictogram for the reader coil must be in the front left cup holder in the forward position as seen in the direction of travel (figure 2).

Please move the lining mat in the cup holder to the correct position.

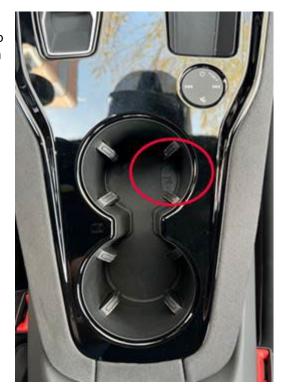
Figure 3: Reader coil location in the e-tron GT.

In the e-tron GT, the pictogram for the reader coil must be in the forward front cup holder as seen in the direction of travel, on the right side (figure 3).

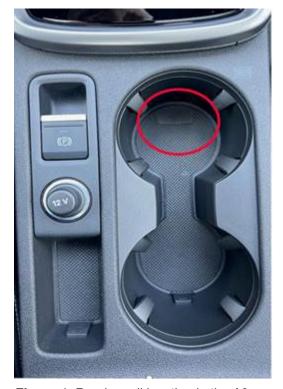
Figure 4: Reader coil location in the A3.

In the A3, the pictogram for the reader coil must be in the forward front cup holder as seen in the direction of travel (figure 4).
