Technical Service Bulletin

GROUP	NUMBER
DRIVESHAFT AND AXLE	23-DS-001G-1
DATE	MODEL(S)
APRIL, 2023	GV70 (JK1) GV80 (JX1)

SUBJECT: E-LSD AND TRANSFER CASE ACTUATOR DIAGNOSIS

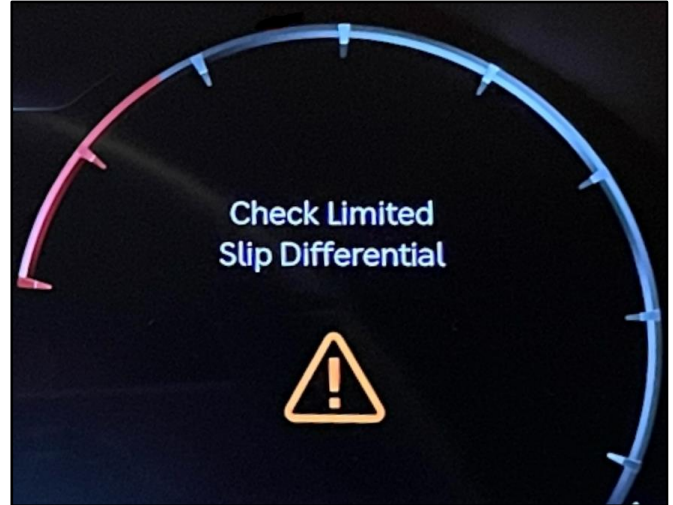
1. Confirm E-LSD warning message, "Check Limited Slip Differential" is displayed in the cluster.

If any of the following DTCs are present, P188213, P188900, or P189600, continue with E-LSD actuator replacement.

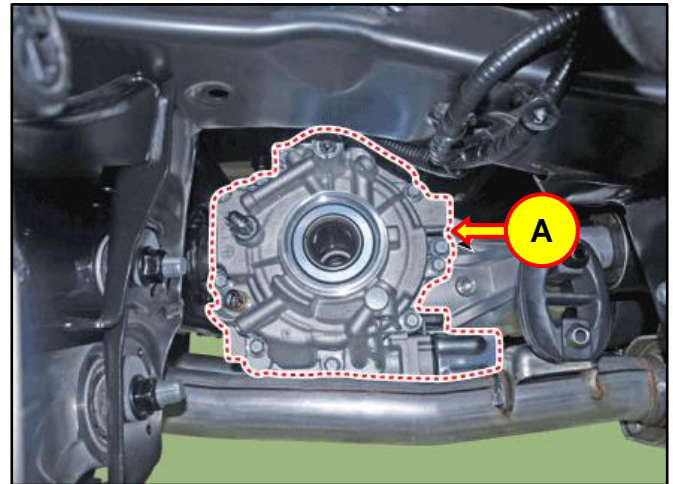
2. Lift the vehicle to remove the Electronic Limited Slip Differential (E-LSD) (A).

Refer to the applicable shop manual.

Electronic Limited Slip Differential System →
 Electronic Limited Slip Differential Assembly →
 Electronic Limited Slip Differential (E-LSD) →
 Removal and Installation

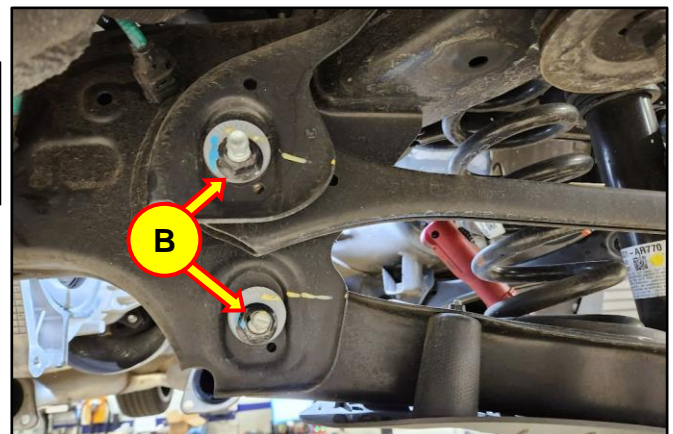
Do not touch the alignment settings (B) for the rear suspension during E-LSD removal.

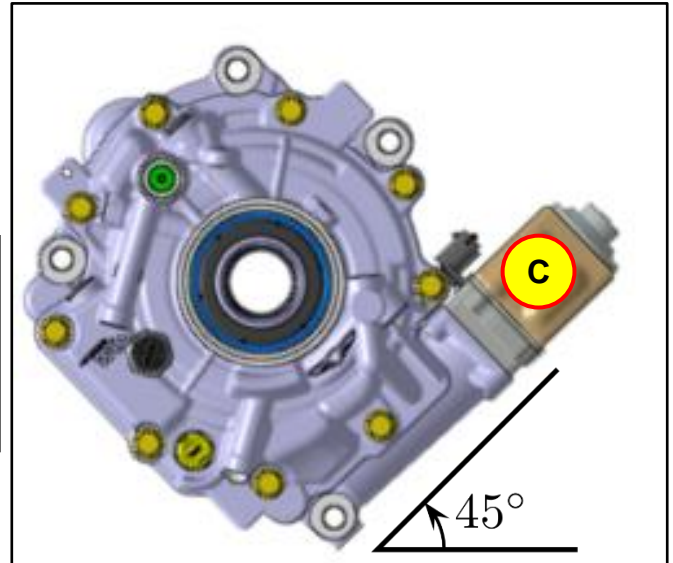
3. Place the E-LSD onto a work bench.

Rotate the E-LSD to point the actuator (C) at a 45-degree angle.

During removal and installation of the actuator, maintain the E-LSD at a 45-degree angle to not spill fluid. Low fluid levels may damage the E-LSD.

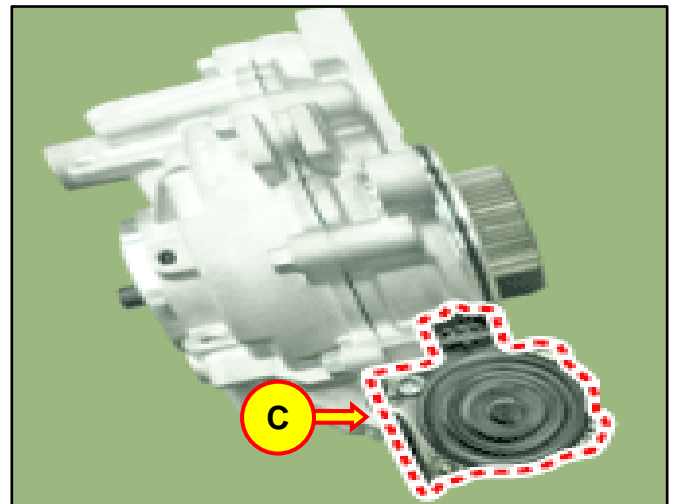
4. Leave the E-LSD in this position for at least 10 seconds to allow the fluid to drain from the actuator into the E-LSD.
5. Loosen the bolts and remove the actuator (C).

E-LSD Actuator Tightening Torque

lb-ft	• 8.24-8.39
-------	-------------

kgf.m	• 1.14-1.16
-------	-------------

N.m	• 11.17-11.37
-----	---------------

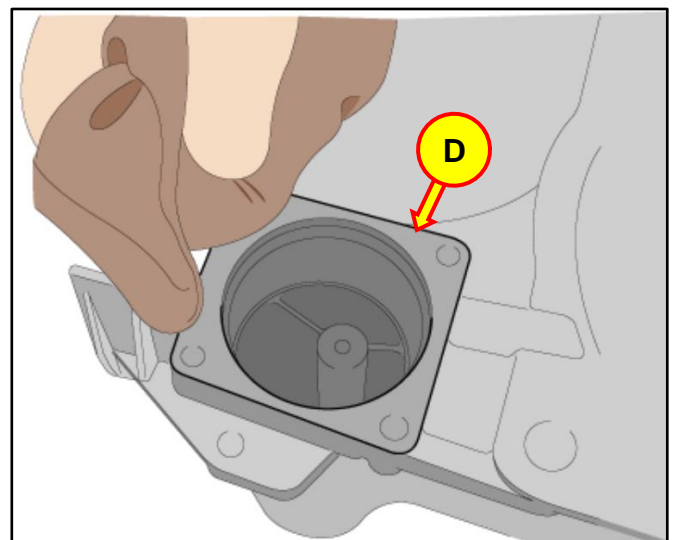
6. Wipe the actuator seating surface (D) with a clean cloth.

Do not allow foreign substances to enter the E-LSD.

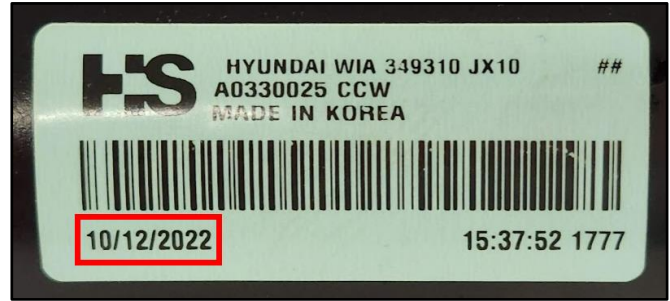
- Confirm date on new actuator label is 07/14/2022 or after.

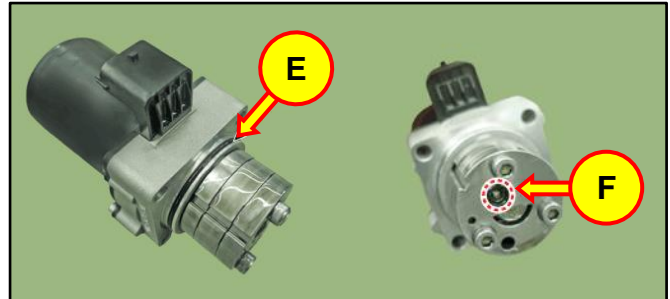
- Ensure the both O-rings (E) and (F) are properly seated on the new actuator.

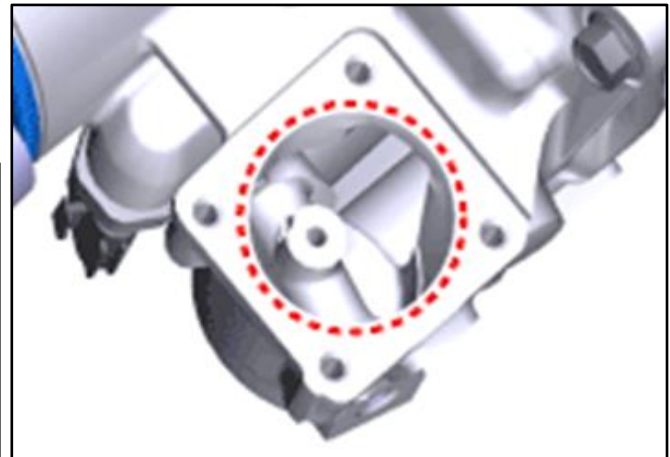
- If fluid is lost, add fluid for the amount lost into the actuator opening.

Using the wrong fluid specification or low fluid levels may damage the E-LSD.

Fluid Specification: TF 0870C, E-LSD
 Synthetic Transfer Case Fluid, Part Number:
 00232-19096

E-LSD Fluid Capacity: 395mL - 425mL

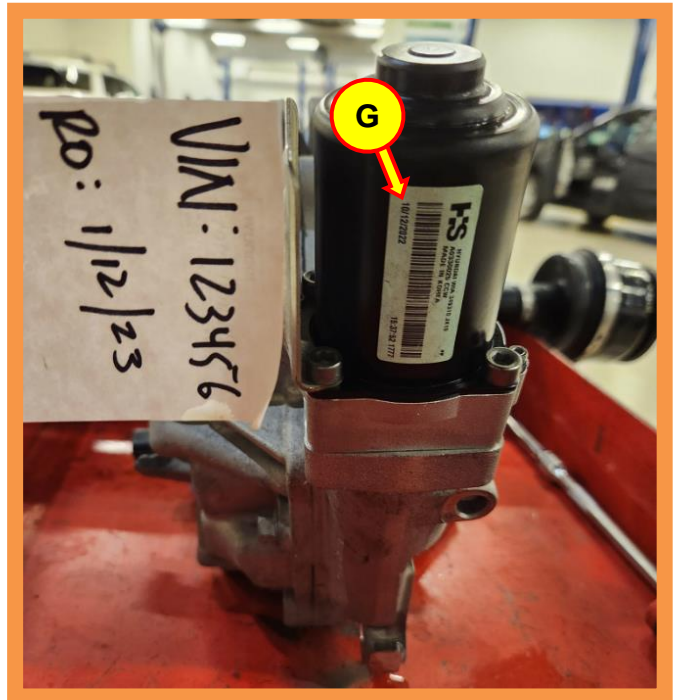
Using STUI, take a clear photo of the installed actuator with the last 6 digits of the VIN and the date of repair on a piece of paper. The manufacture date of the actuator (G) must be clearly visible. See example shown to the right.

11. Before reinstalling the differential assembly take a STUI photo.

Upload the photo to STUI.

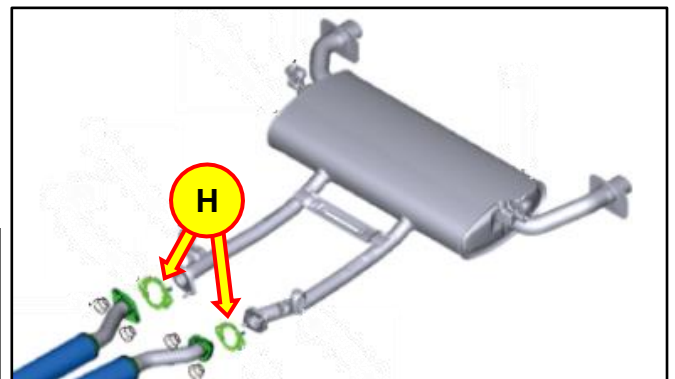
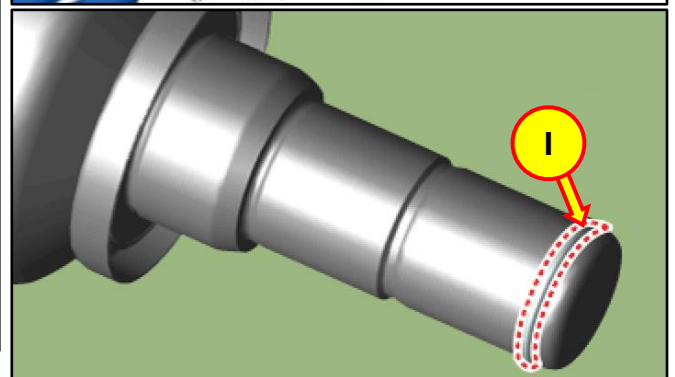
The following new parts must be used during reassembly:

Part Name	Part Number	Qty
Rear exhaust gasket (H) (to muffler)	28751-2S000	2
Axle Clip (I)	49557-T6000	1
Axle Castle Nut	49551-4T000	1

Reusing parts will cause the exhaust to leak and the axle to become unseated.

12. Install parts in the reverse order of removal.

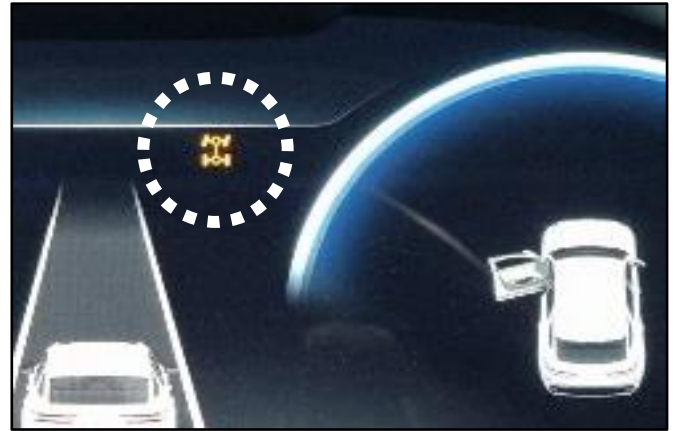
1. Confirm transfer case warning lamp is displayed in the cluster.

If any of the following DTCs are present, P196000, P195800, or P195513, continue with transfer case actuator replacement.

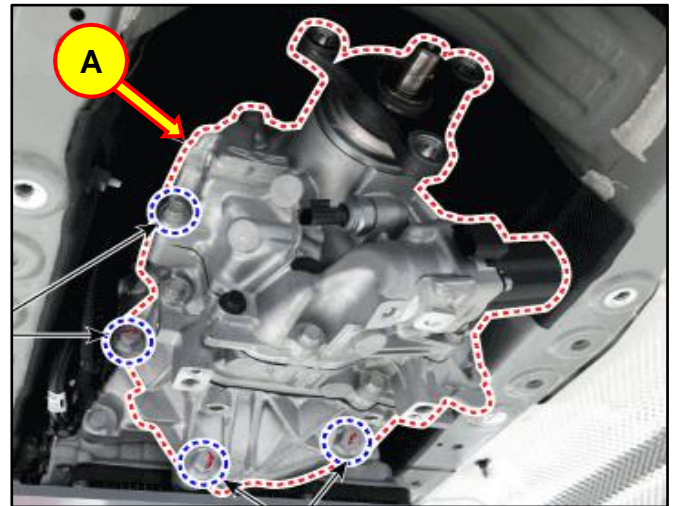
2. Lift the vehicle to remove the transfer case (A).

Refer to the applicable shop manual.

4 Wheel Drive (AWD) System → Transfer Assembly → Transfer Case Assembly → Removal

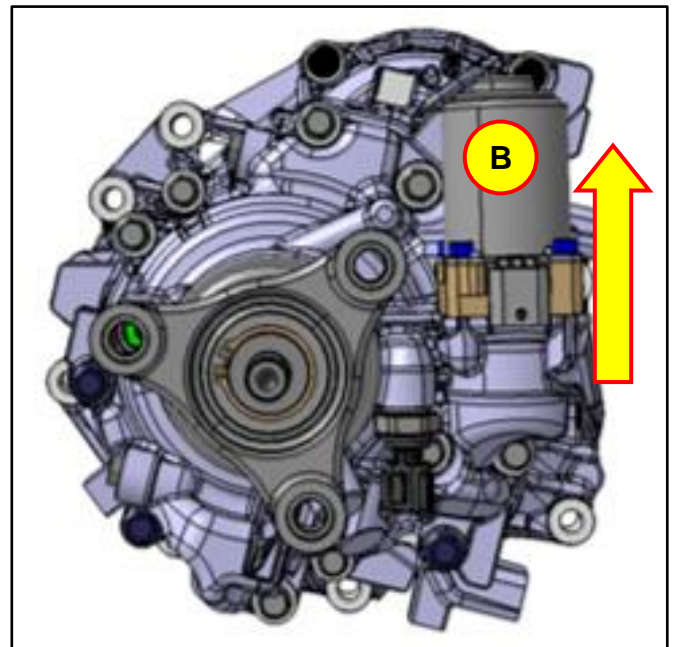
3. Place the transfer case onto a work bench.

Rotate the transfer case to point the actuator (B) up in a vertical position.

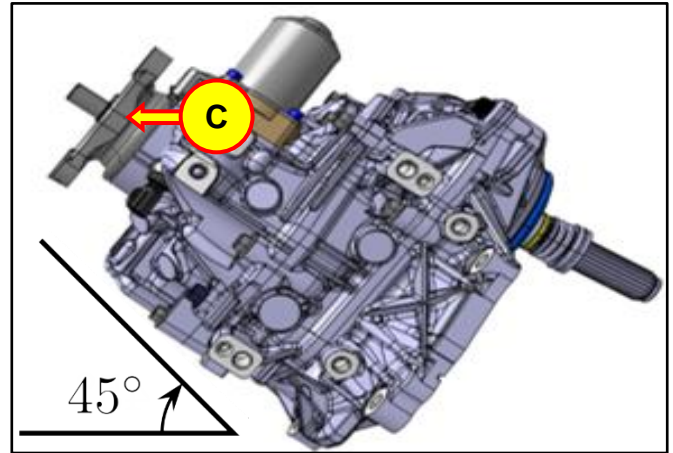
Lift the flange (C) end of the case at a 45-degree angle.

During removal and installation of the actuator, maintain the transfer case at a 45-degree angle to not spill fluid. Low fluid levels may damage the transfer case assembly.

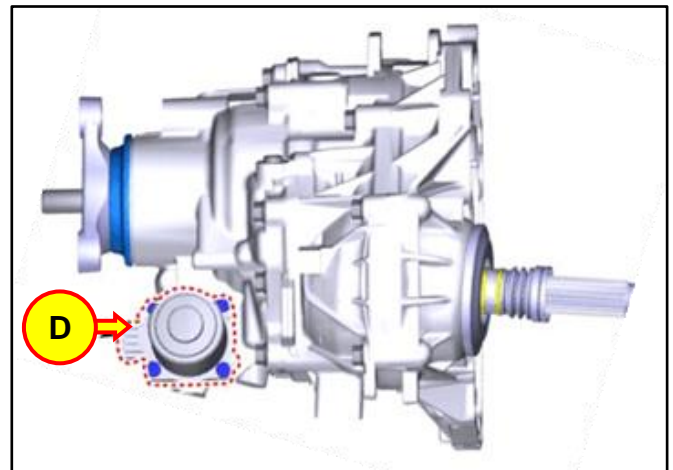
4. Leave the case in this position for at least 10 seconds to allow the fluid to drain from the actuator into the case.
5. Loosen the bolts and remove the actuator (D).

Transfer Case Actuator Tightening Torque

lb-ft	• 8.24-8.39
-------	-------------

kgf.m	• 1.14-1.16
-------	-------------

N.m	• 11.17-11.37
-----	---------------

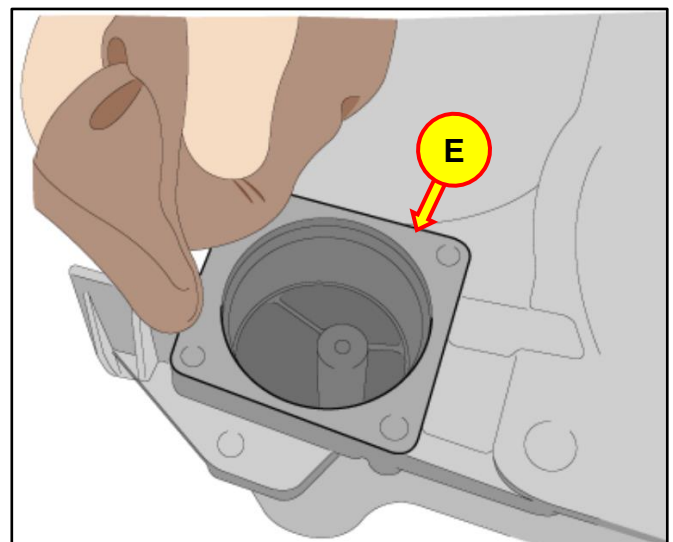
6. Wipe the actuator seating surface (E) with a clean cloth.

Do not allow foreign substances to enter the case.

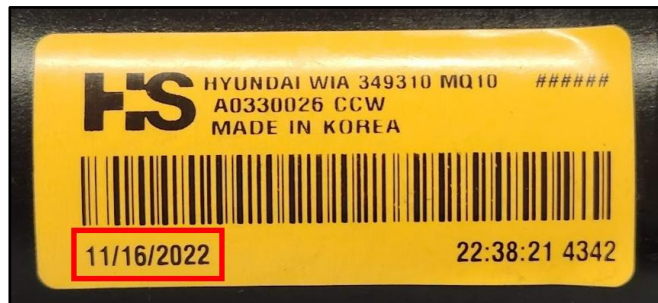
- Confirm date on new actuator label is 07/11/2022 or after.

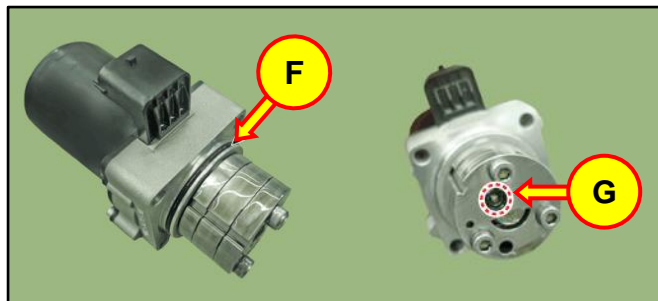
- Ensure the both O-rings (F) and (G) are properly seated on the new actuator.

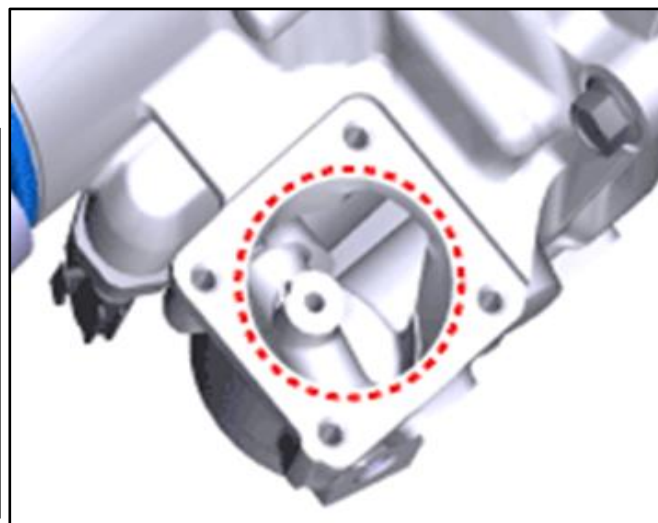
- If fluid is lost, add fluid for the amount lost into the actuator opening.

Using the wrong fluid specification or low fluid levels may damage the E-LSD.

Fluid Specification: TF 0870C, E-LSD Synthetic Transfer Case Fluid, Part Number: 00232-19096

E-LSD Fluid Capacity: 395mL - 425mL

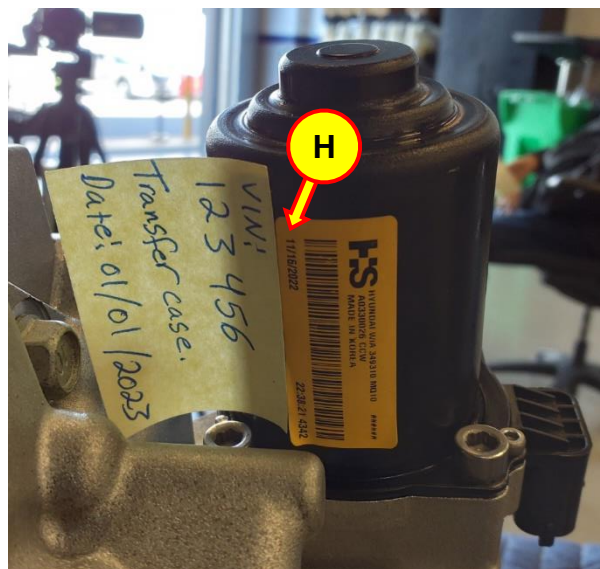
Using STUI, take a clear photo of the installed actuator with the last 6 digits of the VIN and the date of repair on a piece of paper. The manufacture date of the actuator (H) must be clearly visible. See example shown to the right.

- Install the new actuator.
- Before reinstalling the transfer case assembly, take a STUI photo.

Upload the photos to STUI.

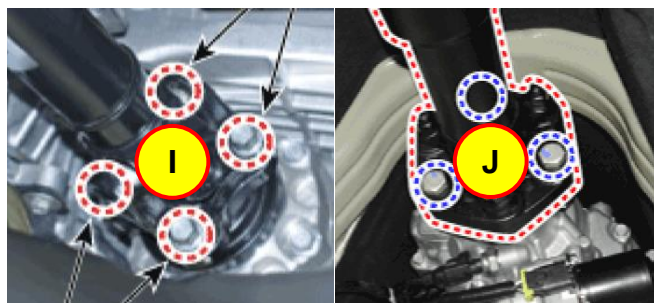
Front propeller shaft to front differential

The following new parts must be used during reassembly:

Part Name	Part Number	Qty
Front Propeller Shaft Bolts (I) (to front differential)	49129-B1100	4
Rear Propeller Shaft Bolts (J) (to transfer case)	49319-T6100	3
Rear Exhaust Gasket (K) (to exhaust muffler)	28751-2S000	2
Front Exhaust Gasket (L) (to catalyst)	28751-3J000	2

Reusing parts will not provide the correct clamping force and can cause the exhaust to leak.

12. Install parts in the reverse order of removal.
