**HYUNDAI**
Technical Service Bulletin

GROUP CAMPAIGN	NUMBER 23-01-037H
DATE APRIL 2023	MODEL(S) HYUNDAI GENESIS (DH)

SUBJECT: GENESIS (DH) AUXILIARY CANISTER INSTALLATION
(SERVICE CAMPAIGN 965)

Description: Certain 2015-2016MY Hyundai Genesis (DH) vehicles may exceed evaporative emissions standards due to Onboard Refueling Vapor Recovery (ORVR) system. To correct this symptom, install an auxiliary canister assembly between the canister and Canister Close Valve (CCV).

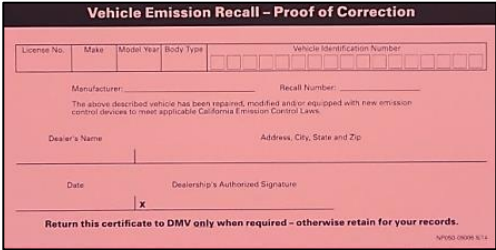
Apply to all vehicles regardless of State
NP050-09006	Vehicle Emission Recall-Proof of Correction Card

The Vehicle Emission Recall - Proof of Correction card must be completed by the Dealership's Service Manager using a permanent ink pen. A fine point pen is recommended. When filling in the information, copy the information directly from the vehicle, not from the repair order. ALL INFORMATION MUST BE PRINTED AND NEAT.

- 1. Enter Vehicle's License No.
- 2. Enter "Hyundai" (Manufacturer)
- 3. Enter Model Year
- 4. Enter "Genesis" (Body Type)
- 5. Enter the vehicle's VIN Number
- 6. Enter "965" (Recall Number)
- 7. Enter Dealership Name
- 8. Enter Dealership's Address. NOTE: Enter the physical address, not the mailing address (not a P.O. Box)
- 9. Enter Date of Repair
- 10. Service Manager Sign Here

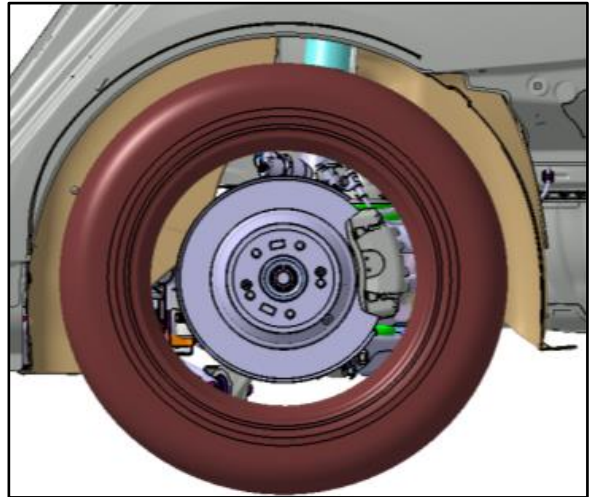
1. Lift the vehicle.

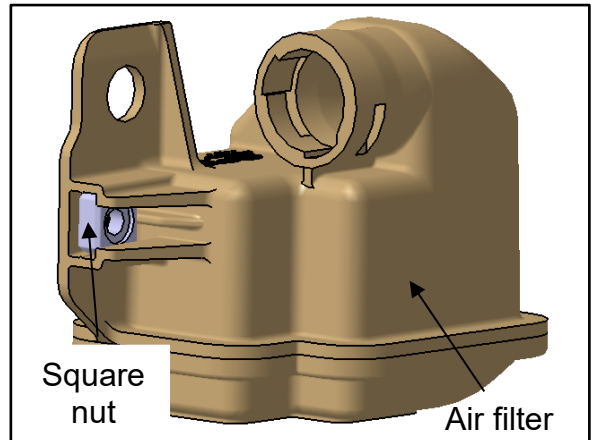
- Attach the square nut to the new supplied air filter.

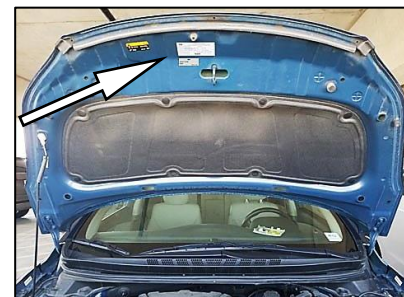
16. Using a permanent marker or pen, fill in the information on the 00305-SC965 Campaign Sticker and apply onto the hood in the area next to the Emission Label as shown.

Be sure to clean the mounting surface to ensure proper label adhesion.
