Technical product information

Topic	Incorrect graphics shown within the MMI after replacement of the Electronic information systems control unit 1 (J794)
Market area	Bentley: worldwide (2WBE)
Brand	Bentley
Transaction No.	2070031/1
Level	EH
Status	Approval
Release date

Incorrect graphics shown within the MMI after replacement of the Electronic information systems control unit 1 (J794)

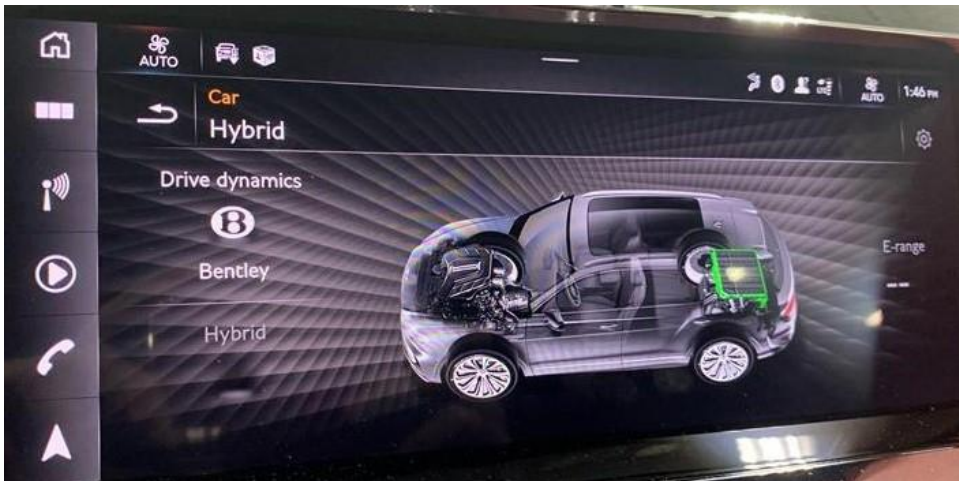
Figure 1

After replacement of the Electronic information systems control unit 1 (J794) has been conducted the following graphic is evident within the MMI screen (Figure 1)

The graphic shown is for Hybrid vehicles only therefore it is incorrect for V8 and W12 engine derivative vehicles

1) Perform a factory reset of the infotainment system through the MMI screen menu as follows:

- Settings > System maintenance > Restore factory settings

- Accept to restore factory settings

If the above does not resolve the concern, please raise a Technical DISS query and await feedback before conducting any further work
