**SERVICE BULLETIN**

**APPLICABILITY:** 2012 (AFTER VIN C\*411693)- 14 MY  
Forester Models with 2.5L FB Engines

**NUMBER:** 02-144-13R

**SUBJECT:** Surface Treatment Change To Oil Control  
Piston Rings

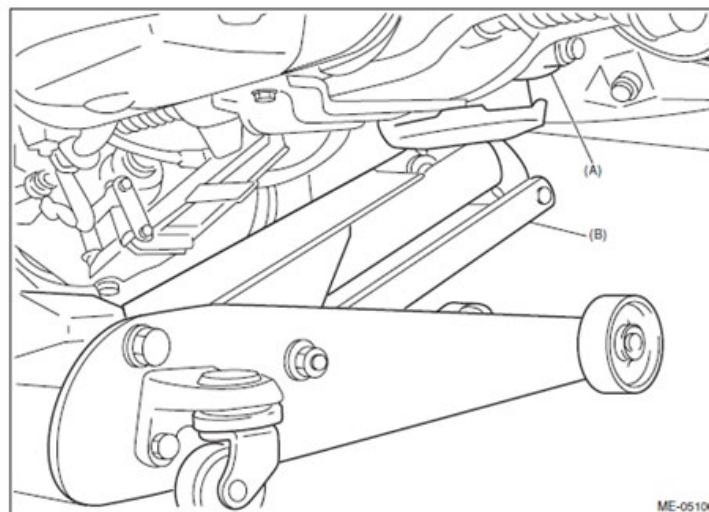
- When draining the engine oil, do not remove the engine oil filter. Leave the existing oil filter in place through engine disassembly, reassembly, installation and initial startup after engine reassembly.
- When removing the engine, there is no need to remove the transmission case cover (CVT only) or to disconnect / disturb any of the transmission harness connectors. While raising the transmission with the service jack placed under the front differential as shown in the illustration below, **only raise it enough to access and remove the engine mounting hardware**. Raising it too high can push the transmission up into the bulkhead / transmission tunnel and possibly cause damage.

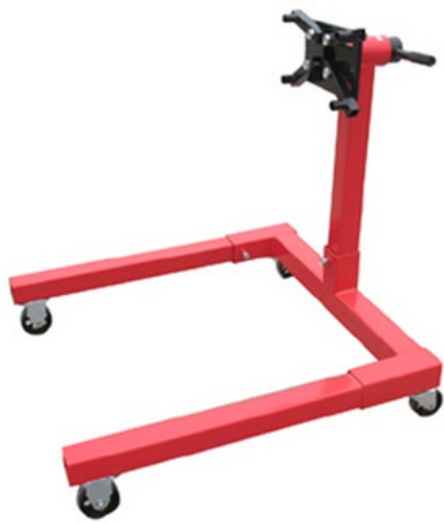
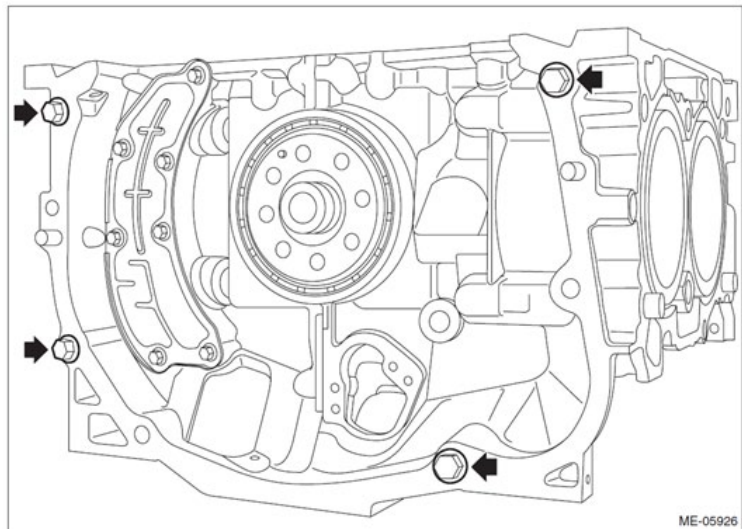
- Once the engine is removed, if you are using a generic engine stand (preferable since engine rotation is necessary), use the four mounting holes on the engine block shown below to mount it. Do not use the studs in the upper oil pan as the upper oil pan has to be removed to access the connecting rod bolts. **NOTE:** The connecting rod bolts are one-time-use and must be replaced.

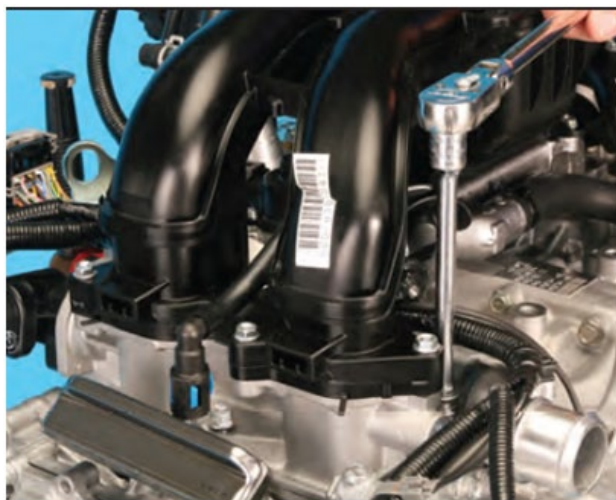
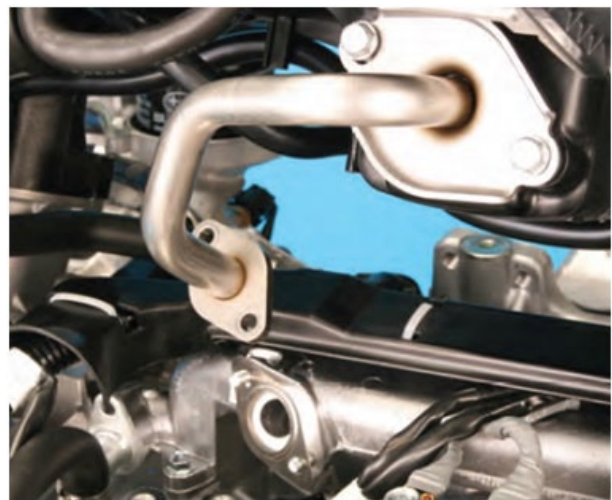
- When removing the intake manifold, as shown in the photos below, leave the TGV assemblies attached to the upper intake, remove the 2 nuts holding the EGR tube to the water pipe then remove the complete assembly from the cylinder heads as a unit.

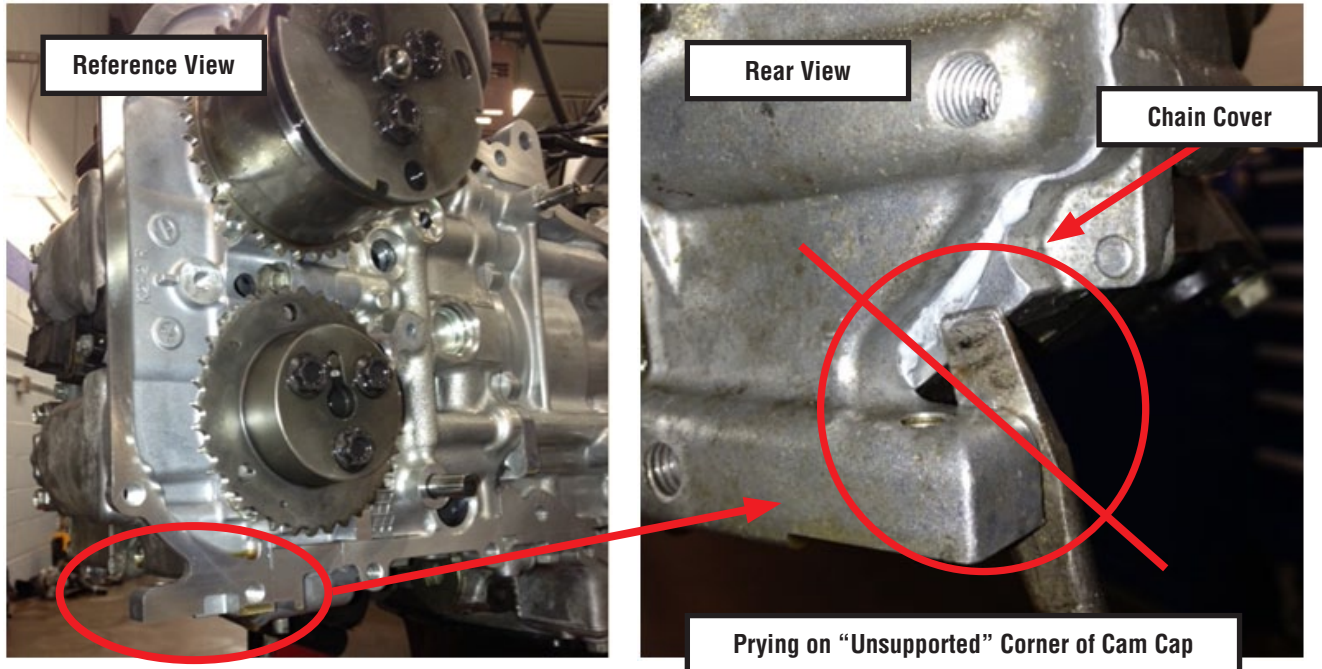
- **IMPORTANT:** After all 32 bolts securing the chain cover are removed, be **VERY** careful where you pry and what you pry on to break the silicone sealant bond. The photos below show an example of where NOT to pry. In this case, the cam cap became cracked requiring a complete cam carrier replacement. Patience is the key!

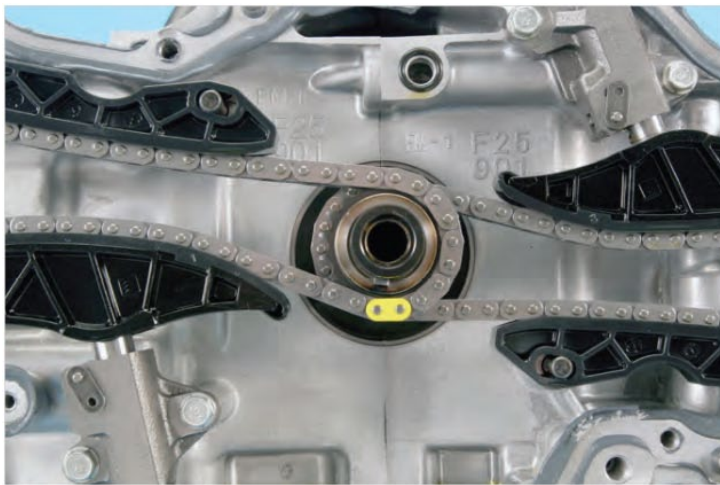
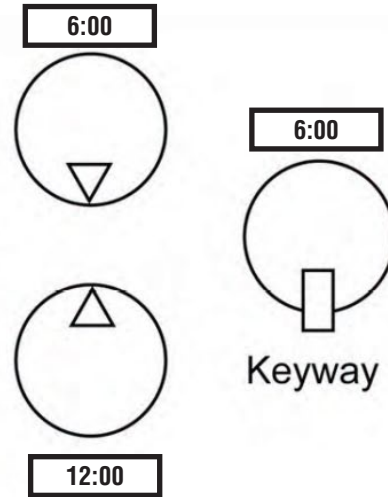
- Begin timing chain removal by positioning the crankshaft keyway at the 6:00 position. The RIGHT bank intake camshaft timing mark ( $\Delta$ ) must be at 6:00 with right bank exhaust timing mark at 12:00 (camshafts will be unloaded).

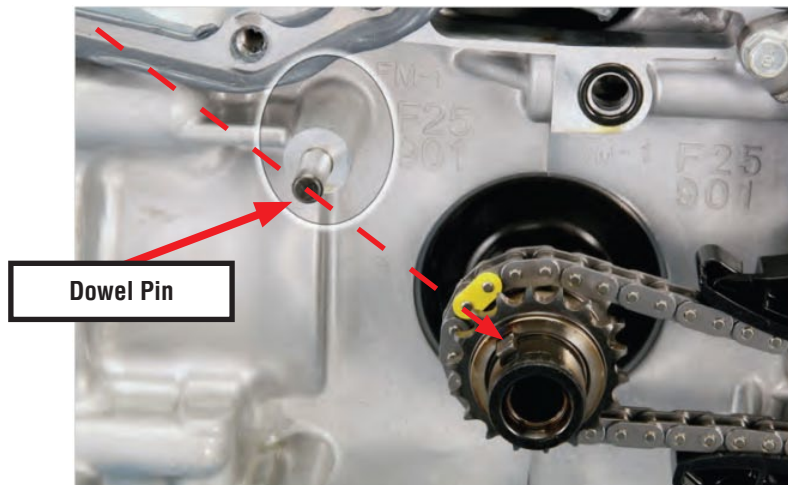
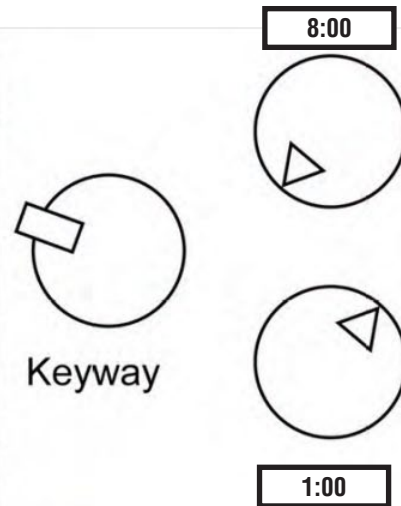
- Compress the chain tensioner by hand, insert a pin through the lever into the access hole to lock the plunger in place then remove the 2 bolts, tensioner, guides and right side timing chain.
- After turning the crankshaft **CLOCKWISE**, repeat the procedure for the LEFT side with the timing marks ( $\Delta$ ) positioned as shown below. Align the crankshaft sprocket keyway with RH chain dowel pin (shown in red below).

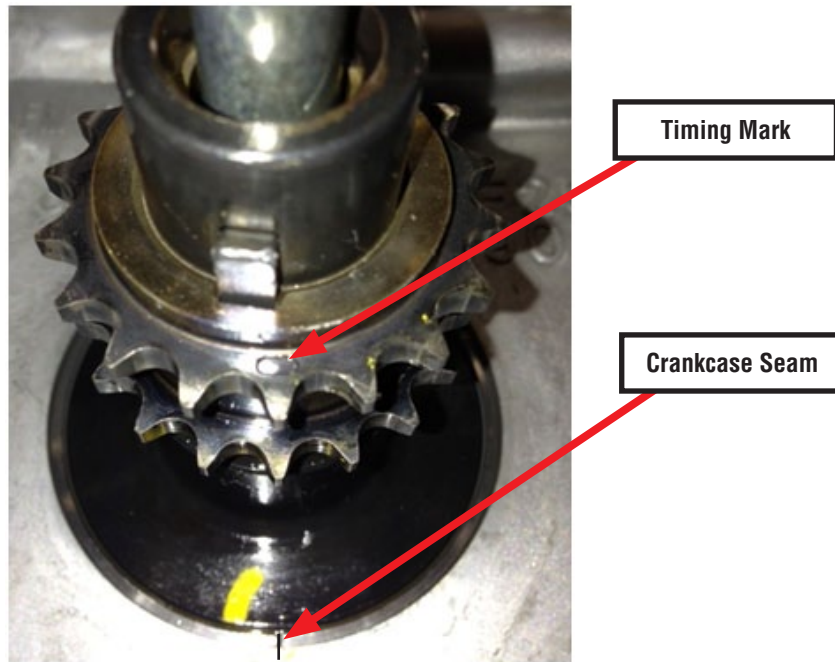
- Compress the chain tensioner by hand, insert a pin through the lever into the access hole to lock the plunger in place then remove the 2 bolts, tensioner, guides and the left side timing chain.
- After the left chain is removed, turn the crankshaft in a **COUNTER CLOCKWISE** direction until the timing mark on the crankshaft sprocket (**NOT** the keyway) is back to the 6:00 position as shown below. This positions all the pistons away from TDC and prevents accidental contact between the pistons and valves.

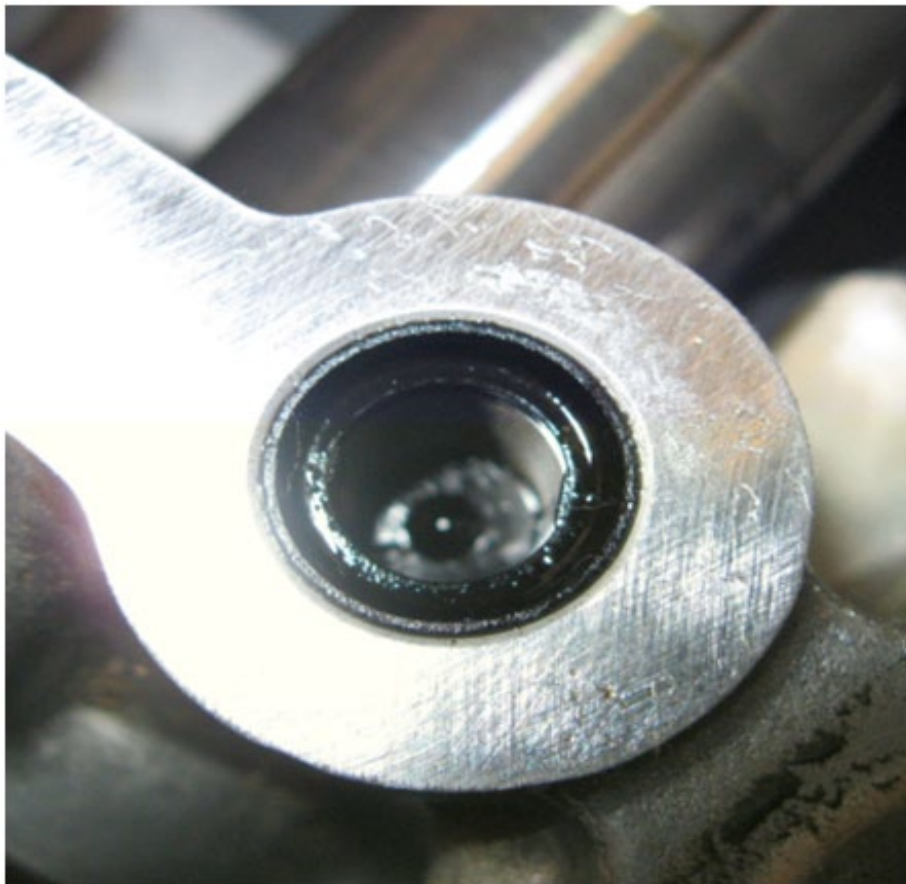
- ALWAYS install new connecting rod bolts as they are one-time use items.
- It is very important to take the time necessary to thoroughly clean the old silicone sealer from all the removed components before reassembly. It is a good idea to clean the surrounding areas then use tape to block off any oil passages in the front cover and cam carrier so any small bits of removed silicone debris are kept from entering the oil passages and possibly causing problems after reassembly. Once all the old sealer has been removed, remove any block-off tape, rinse out any oil passages thoroughly with brake cleaner and shop air.
- Don't forget to clean (**without removing**) the filter screens in the cam carriers (one filter in each) as shown in the photo below.

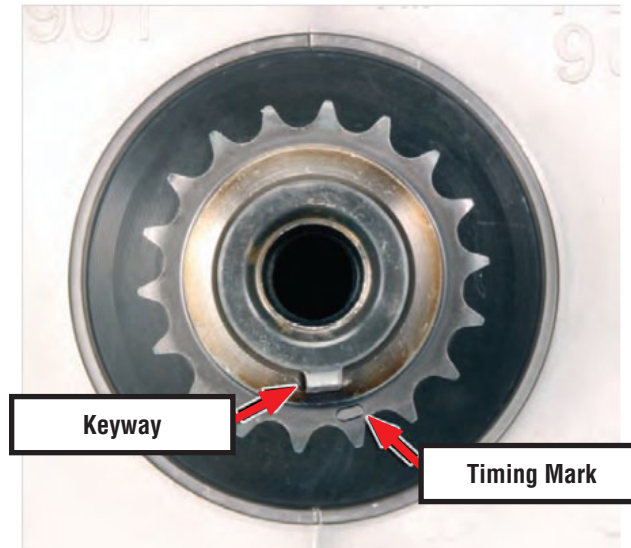
- To begin timing chain re-installation, turn the crankshaft **COUNTER-CLOCKWISE** until the crankshaft sprocket keyway is back to the 6:00 position. NOTE: The keyway is **NOT** a timing mark.

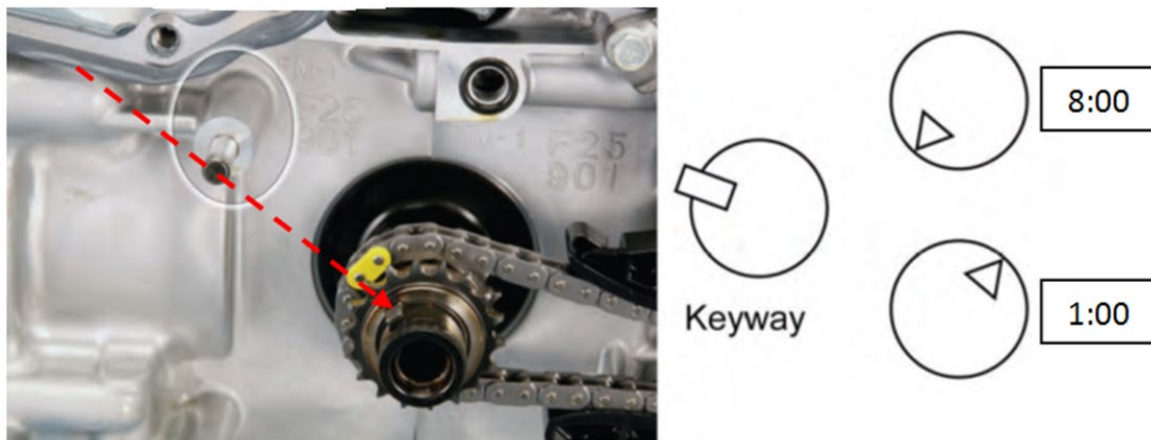
- Arrange the timing marks as shown below, turning the crankshaft **CLOCKWISE** into position. Align the indicator link with the timing mark on the crankshaft sprocket, keyway with the dowel pin.

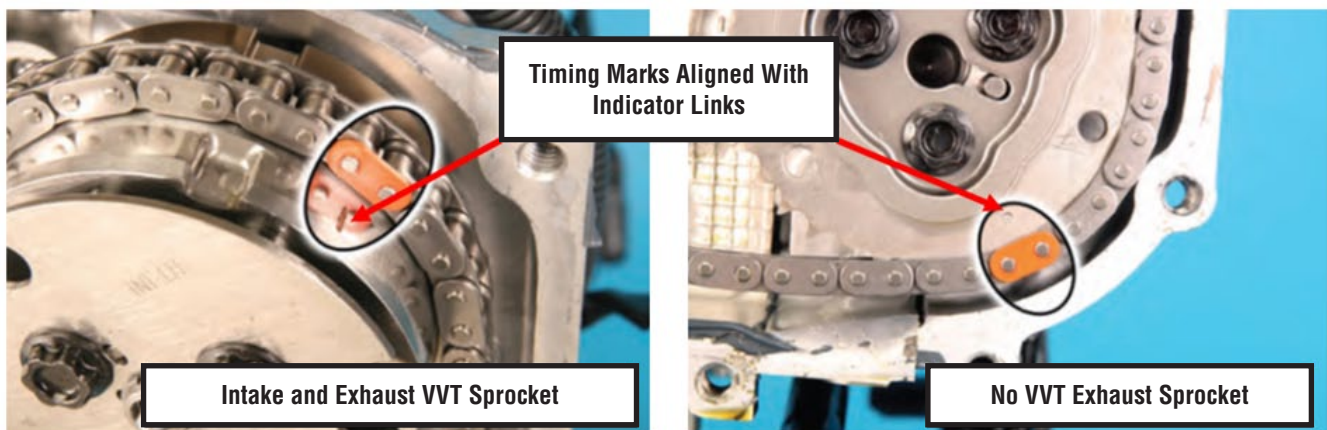
- Align the indicator links to the timing marks found on the outside of the sprocket assemblies as shown in the photos below (Exhaust sprocket face images will vary with / without exhaust VVT).

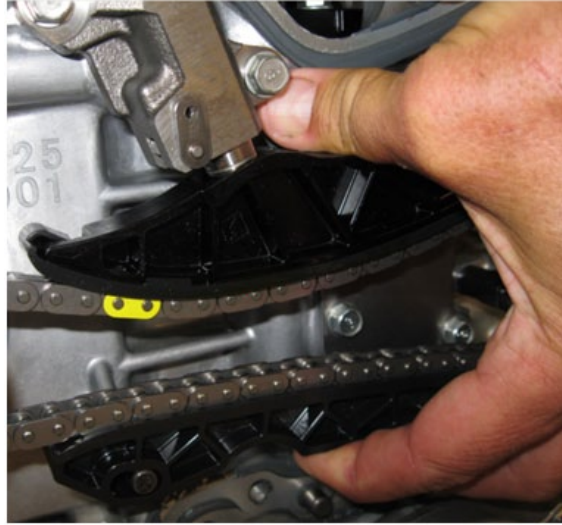
- Install the chain guides and tensioner. Once proper positioning has been confirmed, pull the pin to release the tensioner. With your hand, grab and squeeze the upper and lower chain / guides together as shown in the reference photo below to allow the plunger in the tensioner to fully extend and “click” into its furthest notch.

- Same as the left side, align the indicator links to the timing marks found on the cam sprocket assemblies. Install the chain guides and tensioner. Once proper positioning has been confirmed, pull the pin to release the tensioner. With your hand, grab and squeeze the upper and lower left side chain / guides together to allow the plunger in the tensioner to fully extend and click into its furthest notch as shown in the previous (right side) photo.

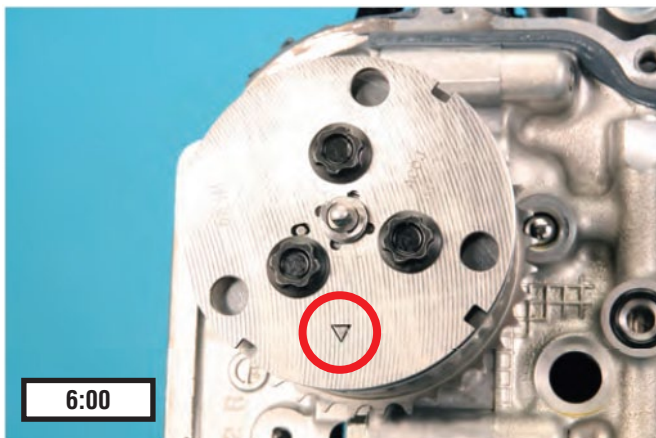
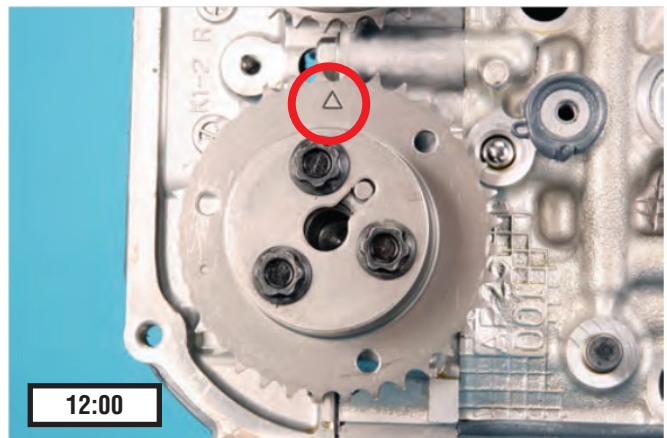
- Rotate the crankshaft COUNTER-CLOCKWISE until the crankshaft sprocket timing mark is at the 6:00 position. Position the cam sprocket timing marks as shown below; intake 6:00, exhaust 12:00.

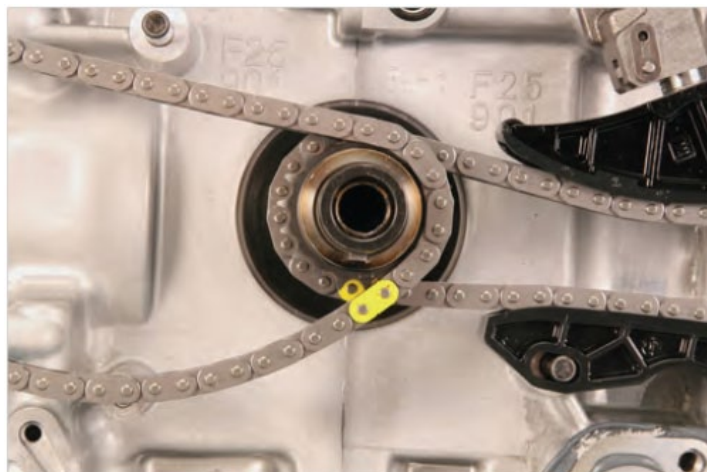
- Align the indicator link with the timing mark on the crankshaft sprocket as shown below.
