Technical product information

Topic	Air spring fault finding guidelines
Market area	Bentley: worldwide (2WBE)
Brand	Bentley
Transaction No.	2053492/10
Level	EH
Status	Approval
Release date

The front and/or rear suspension appears to have dropped

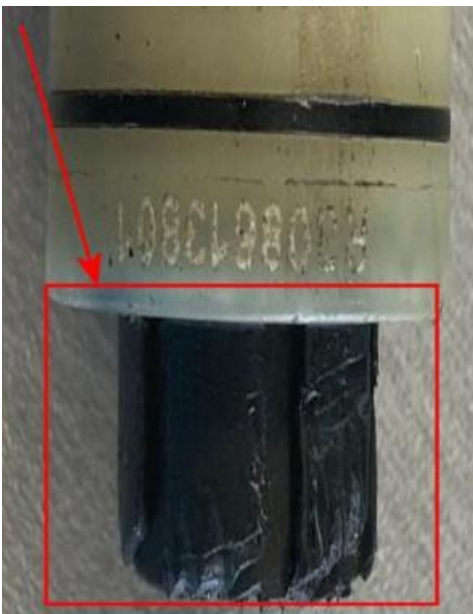
Figure 3 - Shows an example of a Bentayga front air spring damper minimum pressure valve, the valve was damaged during disconnection of the air supply line from the front air spring damper

Please note: In this scenario the front air spring was replaced, as damage was caused to the minimum pressure valve during the disconnection of the air supply line, please be aware that warranty payments will be cancelled should any damage be caused to the air spring assemblies due to the applicable procedures within the applicable Rep.Gr not being followed

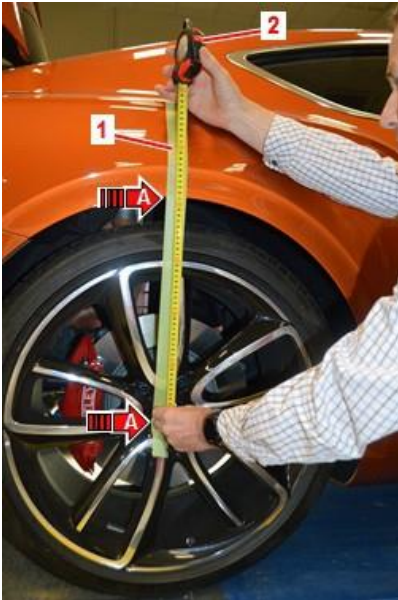
Figure 5

Apply strips of masking tape (1) from the centre of each wheel to the highest part of the wheel arch as shown, making sure the masking tape is applied 'taut'

Using a tape measure (2), measure and take note of the ride heights (A-A) at all four corners of the vehicle. See Figure 5.

Leave the vehicle overnight and again measure the ride heights (**A-A**) at all four corners of the vehicle. Compare these values with those taken previously.

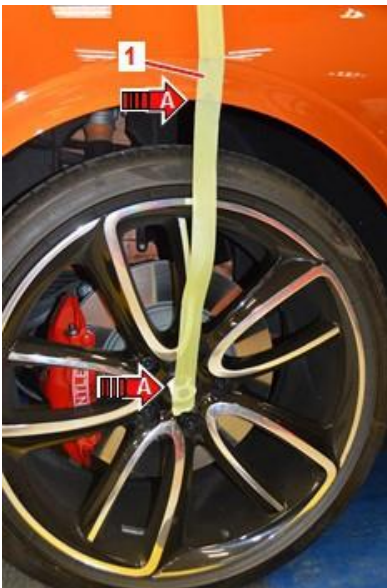
Figure 6

If there **IS** a difference in ride heights, and the strips of masking tape (**1**) have 'sagged' (shown in Figure 6), then refer to the following leak finding procedures below.

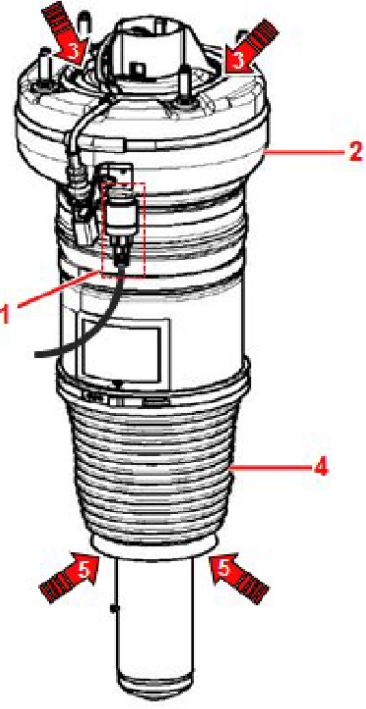
Front air spring check points – Mulsanne

Check	Yes	No	Comments
Air connection to air spring (1) Upper air spring (2) Top of air spring (3) Air spring gaiter condition (4) Bottom of the air spring (5)

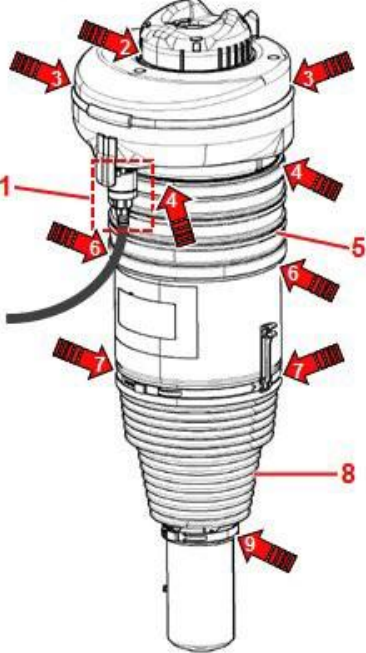
Front air spring check points – Bentayga

Check	Yes	No	Comments
<p>Air connection to air spring (1)</p> <p>Top of air spring (2 & 3)</p> <p>Upper areas of air spring gaiter (4 & 6)</p> <p>Air spring upper gaiter condition (5)</p> <p>Lower areas of air spring gaiter (7 & 9)</p> <p>Air spring upper gaiter condition (8)</p>

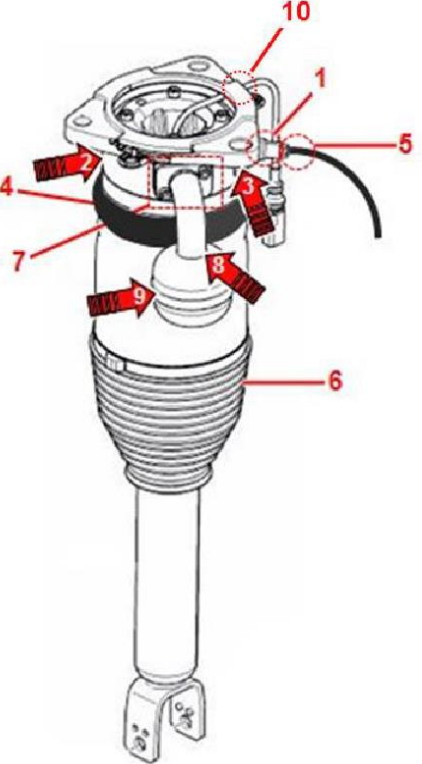
Rear air spring check points - Continental series (pre 2018) and Flying Spur

Check	Yes	No	Comments
Brass fitting to air spring (1) Top of air spring (2 & 3) Air spring bellows (4) Air feed pipe connection (5) Air spring gaiter condition (6) Air canister and canister to air spring (7, 8 & 9) Electrical cable route for air escaping (10)

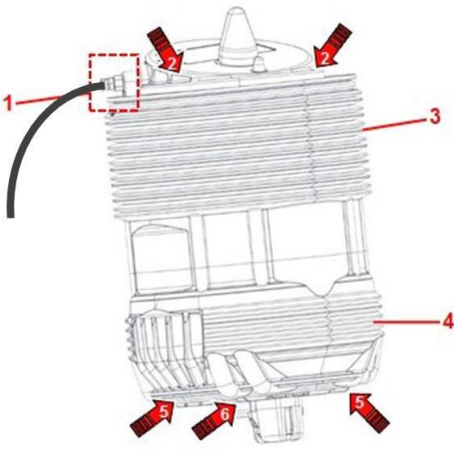
Rear air spring check points – Mulsanne

Check	Yes	No	Comments
Air feed pipe connection (1) Top of air spring (2 & 3) Upper air spring bellows (4 & 5) Lower air spring bellows (6 & 7) Air spring gaiter condition (8 & 9)

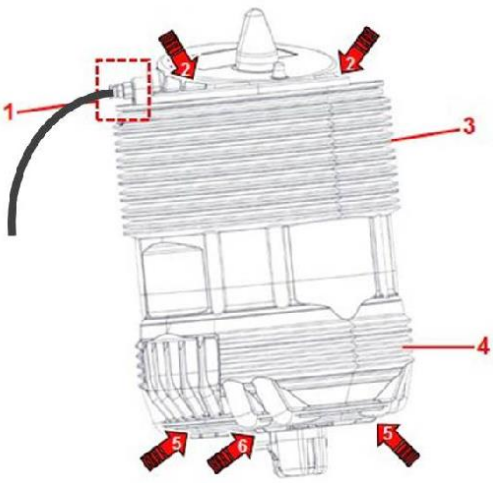
Rear air spring check points – Bentayga

Check	Yes	No	Comments
Air feed pipe connection (1) Top of air spring (2) Air spring gaiter condition (3 & 4) Lower areas of air spring (5 & 6)

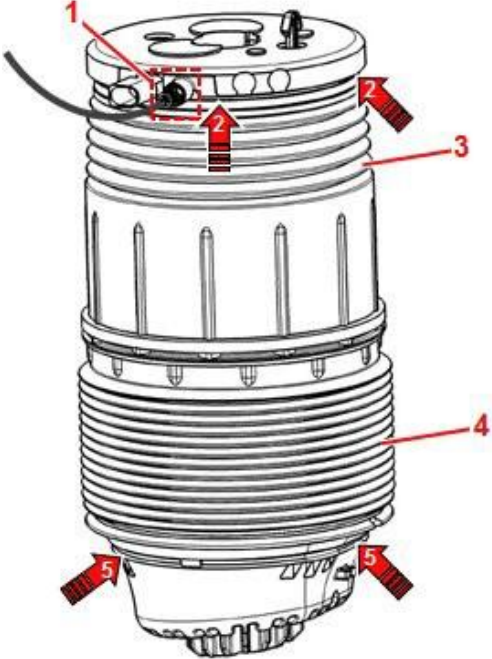
Rear air spring check points – New Continental GT/C and New Flying Spur

Check	Yes	No	Comments
Air feed pipe connection (1) Top of air spring (2) Air spring gaiter condition (3 & 4) Lower area of air spring (5)

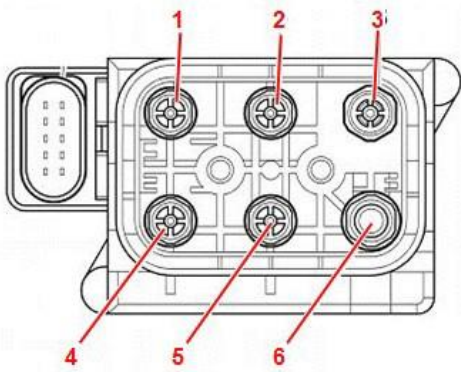
Air supply check points - Mulsanne

Check	Yes	No	Comments
<p>Air pipe connections (1 to 6)</p>

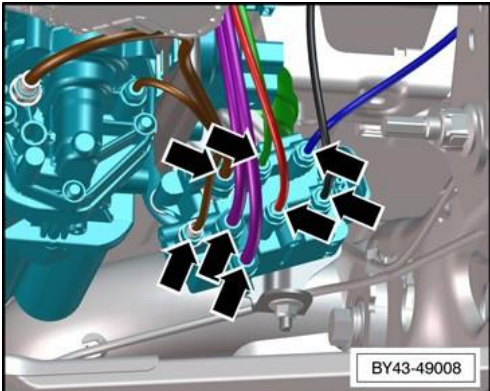
Air supply check points - Bentayga

Check	Yes	No	Comments
<p>Air pipe connections (arrows)</p>

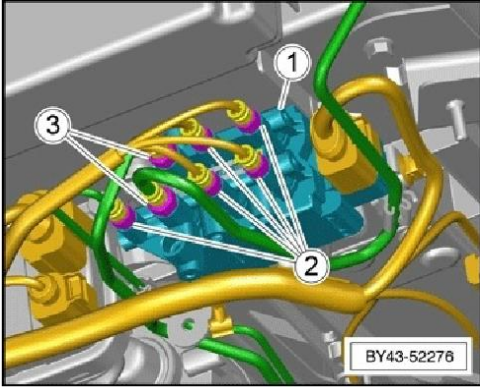
Air supply check points – New Continental GT/C and New Flying Spur

Check	Yes	No	Comments
Air pipe connections (2 & 3)

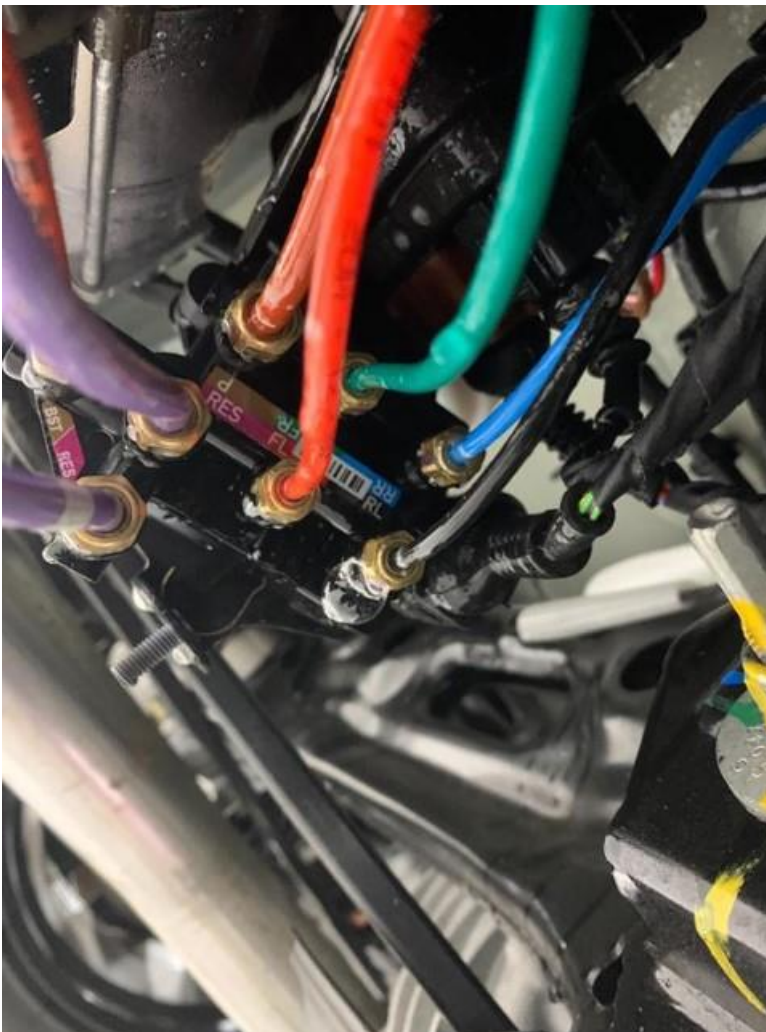
Figure 9

VERY IMPORTANT: In the event a leak is found at the air supply unit (Figure 9) a video and photographs of the leak is required to be attached to a new or existing DISS query

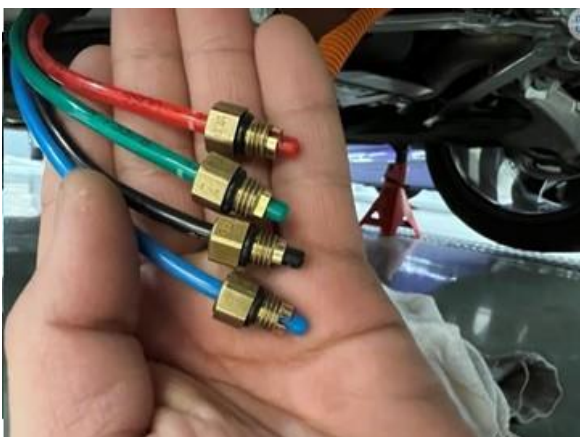
Figure 12

- Referring to Figures 12,13 and 14 attach clear photographs of the components shown

In the event an air leak or any other issues were found at any of the afore mentioned locations the operative should attach clear photos or video (if requested) to a new or existing DISS query

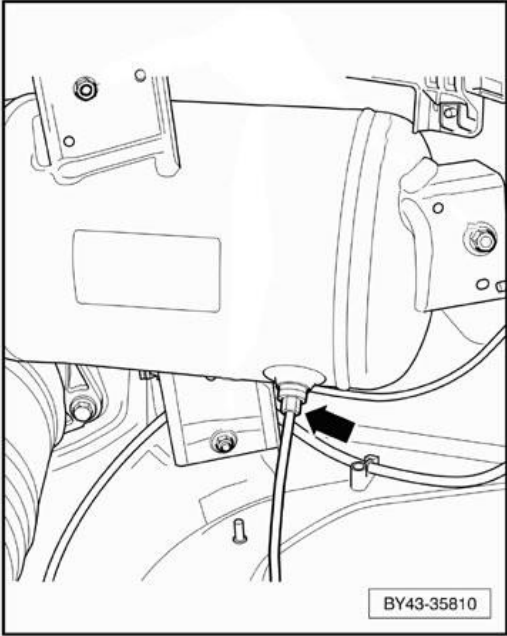
Air supply check points - Continental series (pre 2018) and Flying Spur

Check	Yes	No	Comments
<p>Air pipe connection (arrow)</p> <p>Location - GT & Flying Spur: LH rear wheel arch</p> <p>Location – GTC: Behind backboard trim panel</p>

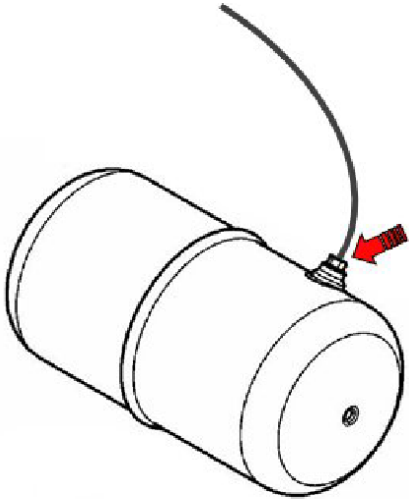
Air supply check points - Mulsanne

Check	Yes	No	Comments
<p>Air pipe connection (arrow)</p> <p>Location – Boot floor</p>

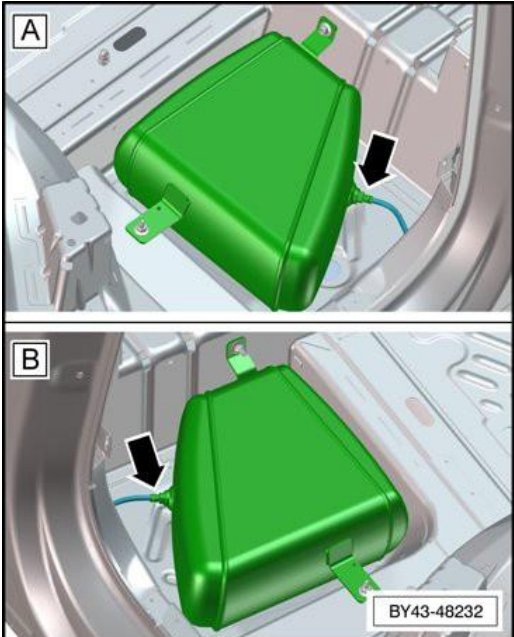
Air supply check points - Bentayga

Check	Yes	No	Comments
<p>Air pipe connections on the twin tanks (arrows)</p> <p>Location – Rear footwells beneath carpets</p>

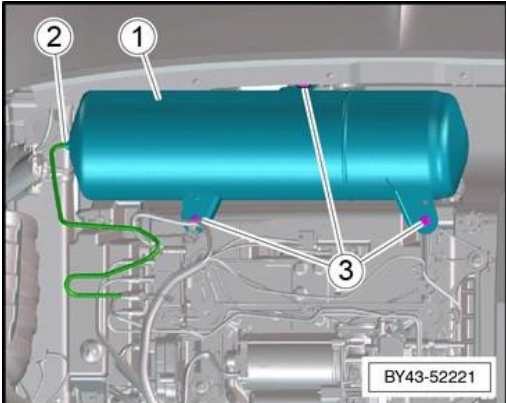
Air supply check points – New Continental GT/C and New Flying Spur

Check	Yes	No	Comments
<p>Air pipe connection (2)</p> <p>Location – Refer to the repair manual depending on model</p>
