## Technical product information

<b>Topic</b>	Flying B mascot clear wings replacement procedure
<b>Market area</b>	Bentley: worldwide (2WBE)
<b>Brand</b>	Bentley
<b>Transaction No.</b>	2069611/1
<b>Level</b>	EH
<b>Status</b>	Approval
<b>Release date</b>

### New Flying Spur

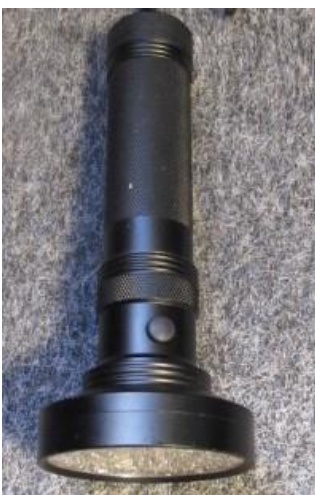
Figure 2

**UV light (Figure 2) the specification must be as follows:**

- Minimum power output must be 5W

**The UV Wavelength must be as follows:**

- Minimum wavelength of 395nm (nanometres)
- Grey or dark brown UV safety glasses must be worn when conducting the adhesive bonding procedure
- Standard safety glasses must be worn whilst conducting all other steps other than the UV adhesive bonding procedure

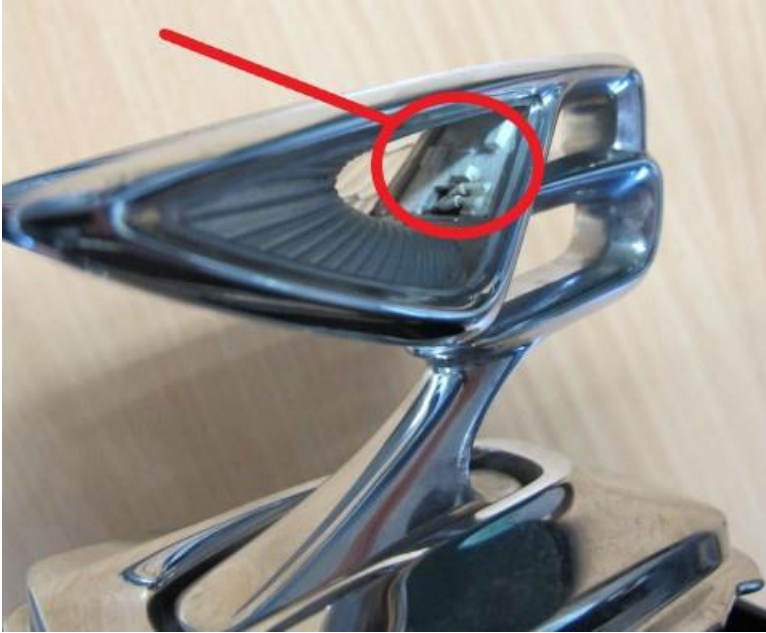
Figure 5

1) Due to the location of the LED light (Figure 5) damage can be caused to the Flying B mascot therefore it is imperative the wings are drilled at the exact location shown within Figure 6

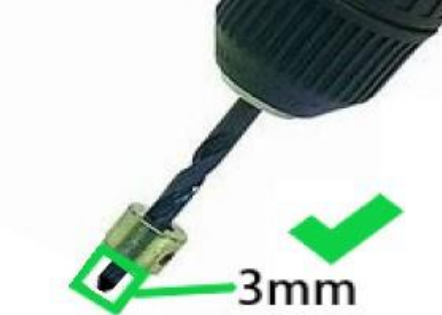
Figure 9

Hint: A standard 3mm drill bit can be used however the drill must be used in conjunction with a drill stop tool to ensure a depth of 3mm is not exceeded (Figure 9)

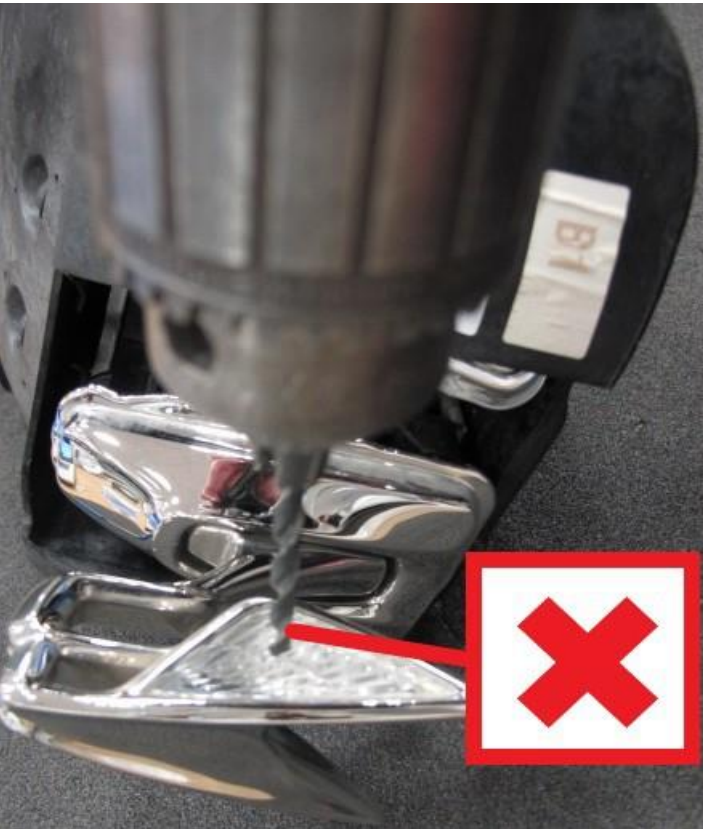
Figure 10

- Do not use a standard drill without using a drill stop as damage can easily be caused to the mascot or LED (Figure 10)

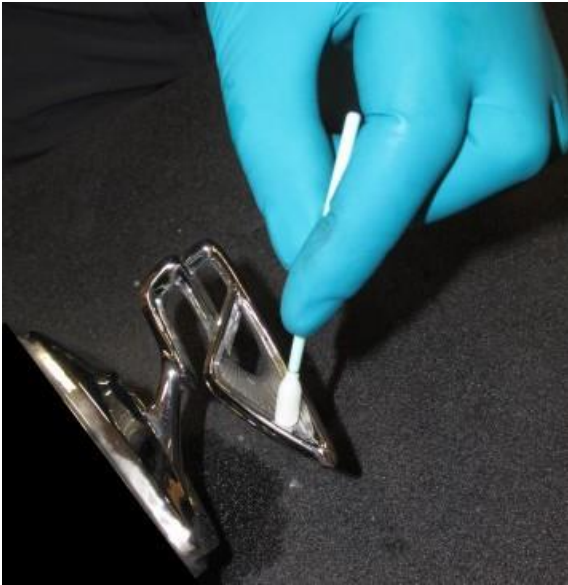
2) Referring to Figure 11 - Using foam cleaning tips in conjunction with 3M surface cleaner thoroughly clean the Flying B aperture

Once the adhesive has been removed using the 3M cleaner the operative should wait 60 seconds to allow the liquid to evaporate

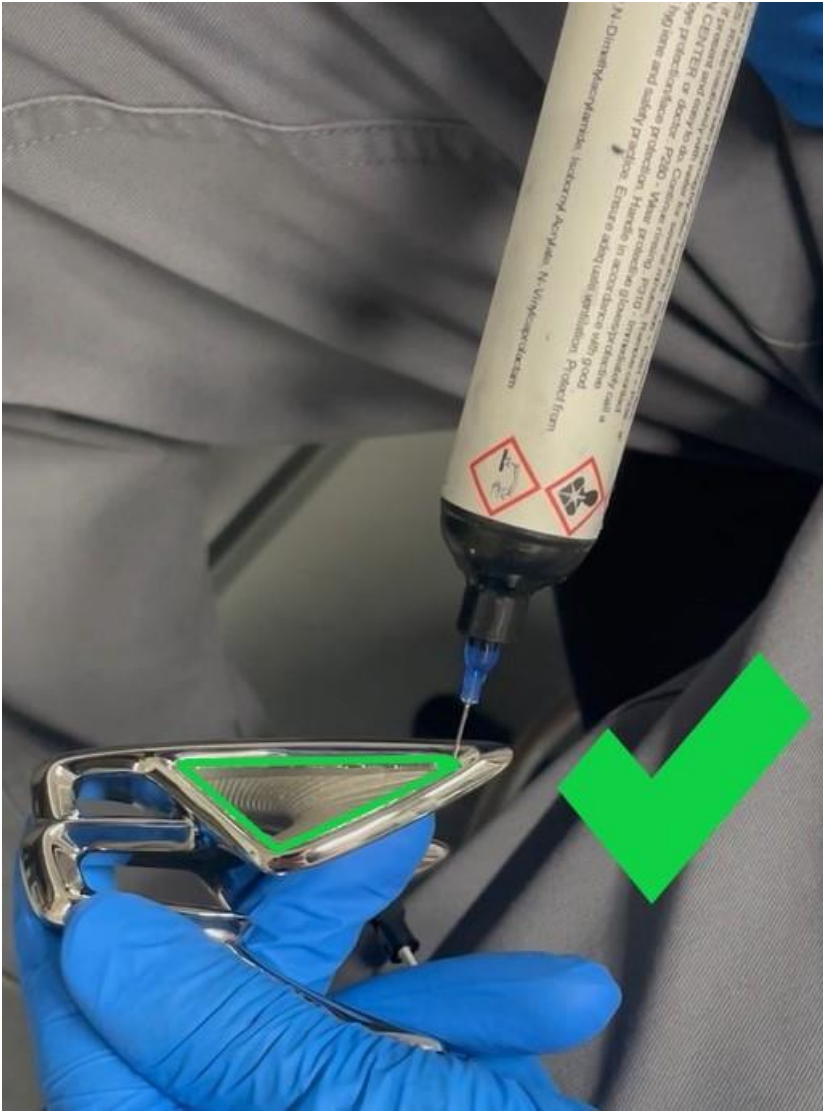
4) Referring to Figure 12 - Apply the adhesive as shown ensuring the adhesive is applied in a consistent manner noting the following:

- Poor Cleaning of the Flying B mascot can lead to debris inside the mascot
- Should too much adhesive be applied the excess will be visible and would be seen through the clear wings

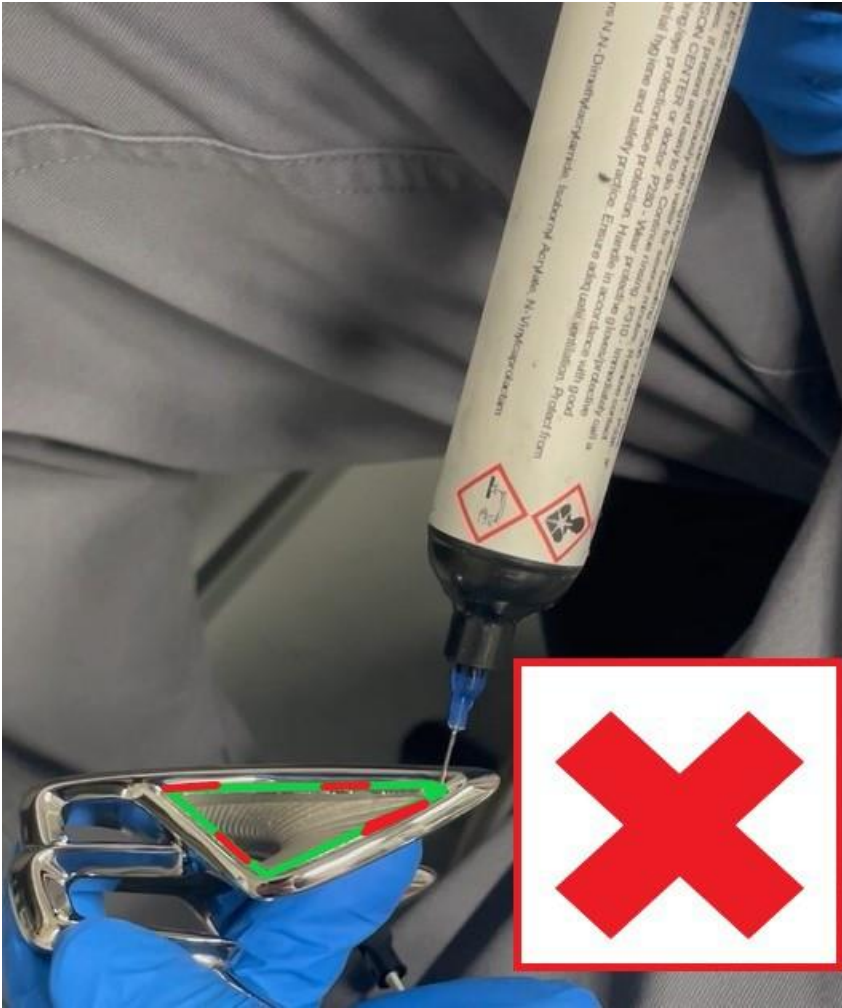
Figure 13

Should the adhesive dosage be sporadic/not consistent (Figure 13) there is a risk of insufficient sealing and water ingress

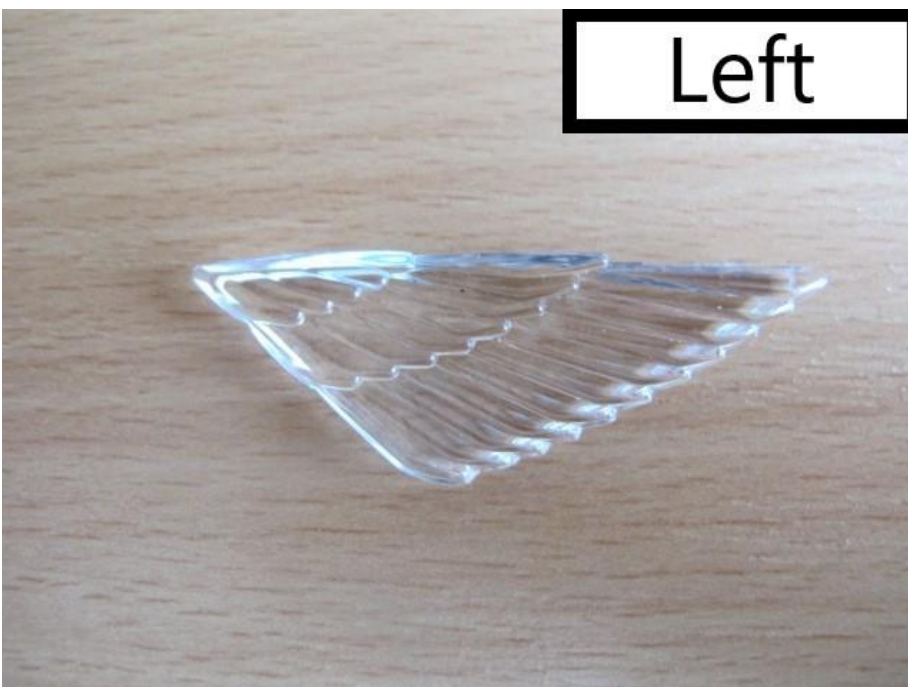
CAUTION before fitting the clear wings the operative MUST ensure the wings are fitted in the correct location ensuring the serrations are on the outer sides as shown in Figures 14 and 15

- Figure 14 - Left hand side

CAUTION before fitting the clear wings the operative MUST ensure the wings are fitted in the correct location ensuring the serrations are on the outer sides as shown back in Figures 14 and 15

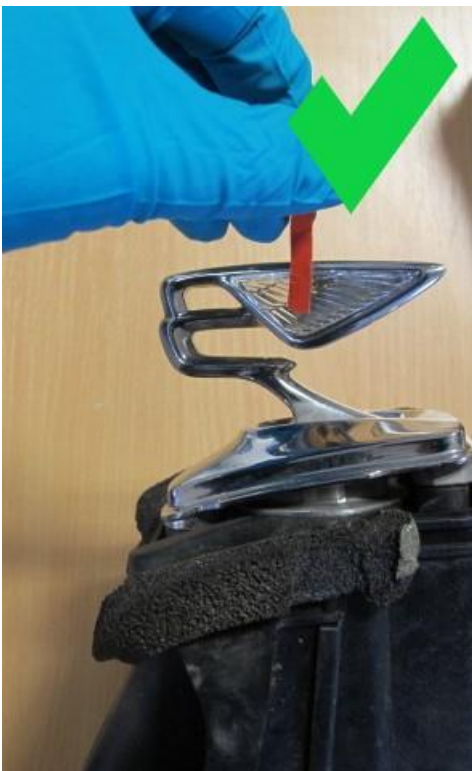
5) Referring to Figure 16 - Ensuring suitable gloves are worn – Use suitable double sided tape to hold the wing at the location shown, fit the replacement wing ensuring the adhesive is not disturbed, once fitted wipe away any excess adhesive from the outside of the clear wing and mascot using a clean cloth and 3M surface cleaner

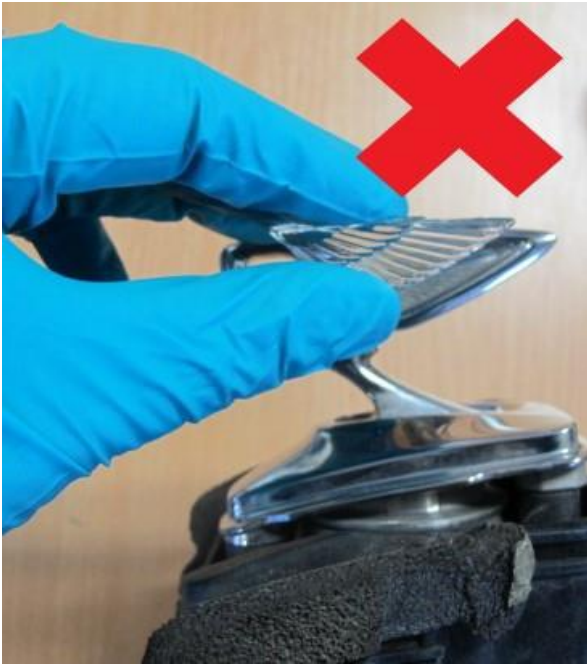
Do Not hold the wing as shown in Figure 17 as the adhesive can easily be disturbed when using this method

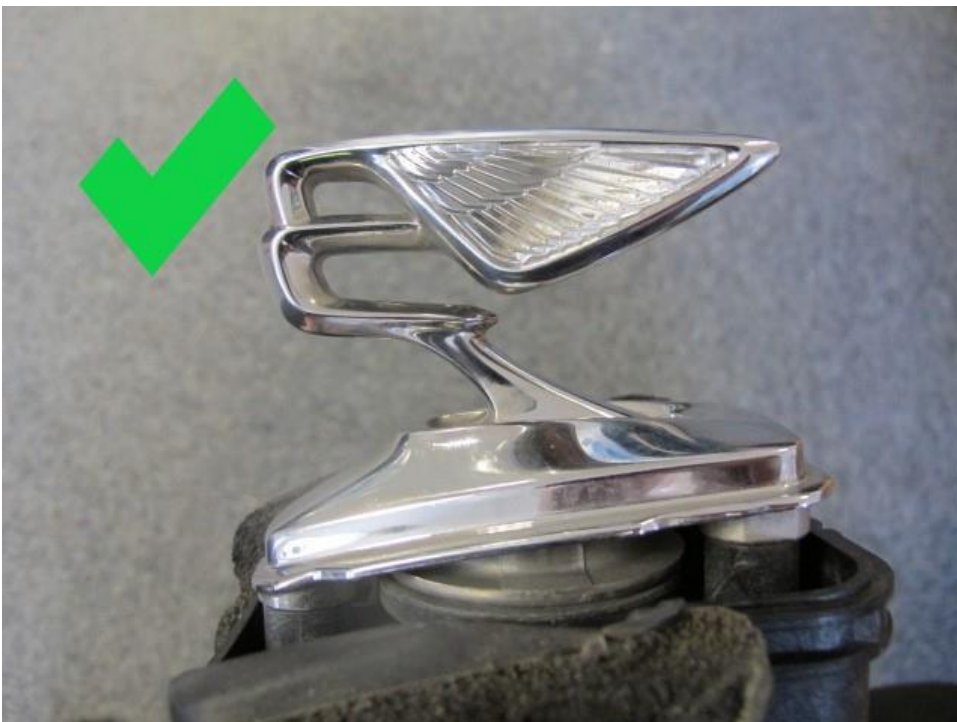
6) Once fitted the wing should be as shown in Figure 18

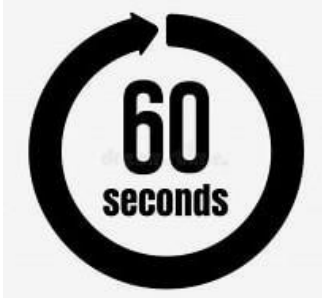
7) Referring to Figure 19 - With the Flying B assembly placed on a suitable clean surface – Ensure suitable UV safety glasses are worn - Switch on the UV lamp

The operative should be aware that the distance quoted of 100mm and the time of 60 seconds to cure the adhesive may vary depending on the type of light which has been sourced, the operative should refer to the manufacturer's instructions of the lamp

Ensure the beam is projecting equally onto the newly fitted clear wing for a duration 60 seconds as shown in Figure 19
