TECHNICAL SERVICE BULLETIN

Parking Brake Switch Broken – Built On Or Before 18-Sep-2022

23-2162

Ford 2021-2022 Bronco	Built on or before 18-Sept-2022
---------------------------------	---------------------------------

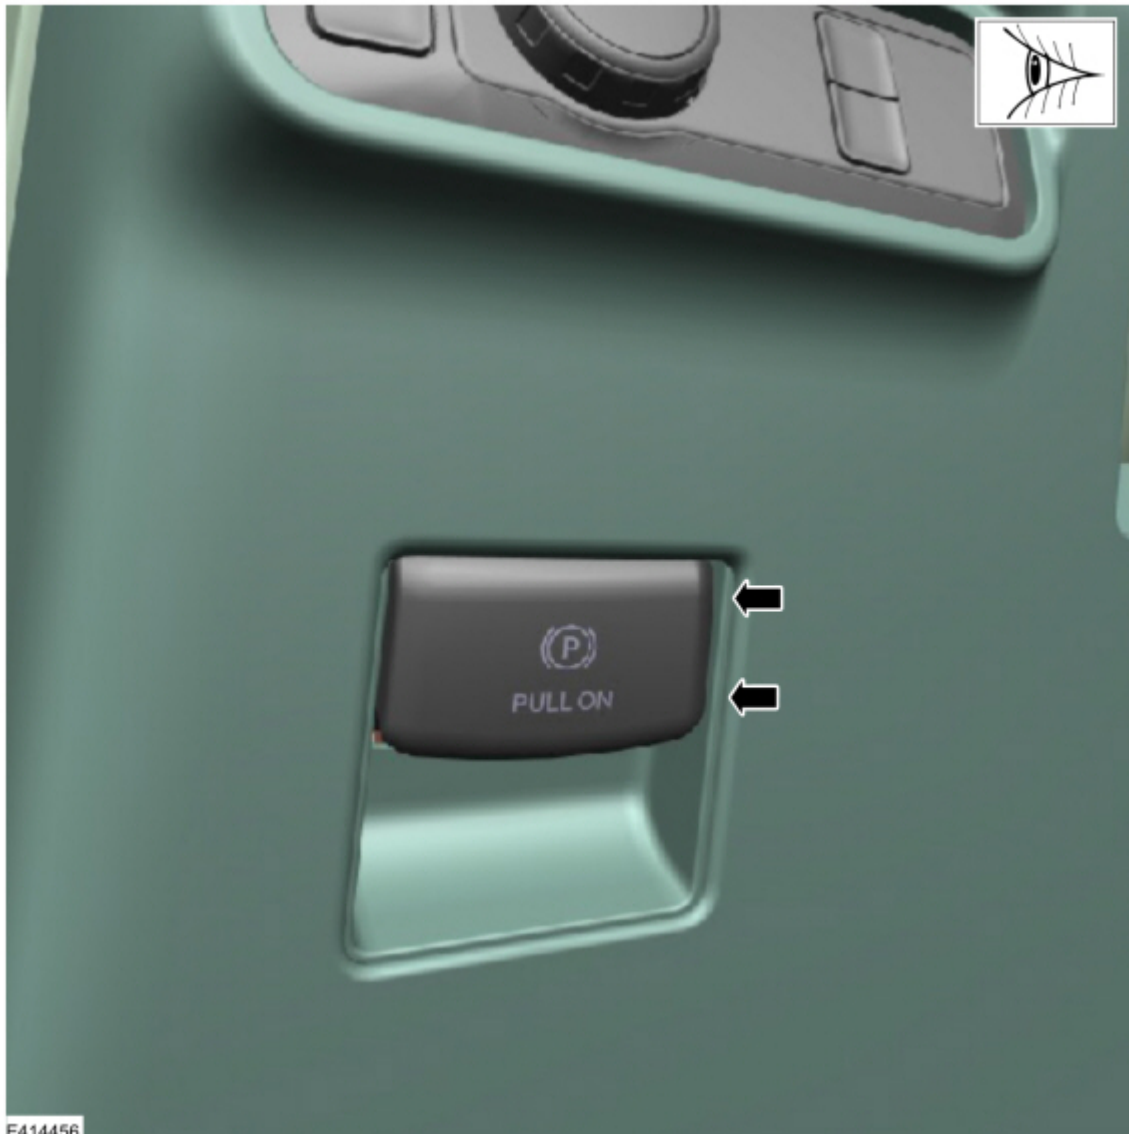
Figure 1 - Pull-up Style Parking Brake Switch

1. Is the vehicle currently equipped with the pull-up style parking brake switch? Refer to Figures 1-2.

- (1). Yes – vehicle has the pull-up style parking brake switch. Proceed to Step 2.
 - (2). No – vehicle has the pull-down parking brake switch. Proceed to Step 3.
2. Replace the steering column opening cover. Refer to Workshop Manual (WSM), Section 206-05 > Removal and Installation > Parking Brake Switch. The steering column trim panel comes with a new pull-down style parking brake switch. The new switch will not install into the older style steering column opening cover. Repair is complete.
 3. Replace the parking brake switch. Refer to the WSM, Section 206-05 > Removal and Installation > Parking Brake Switch.

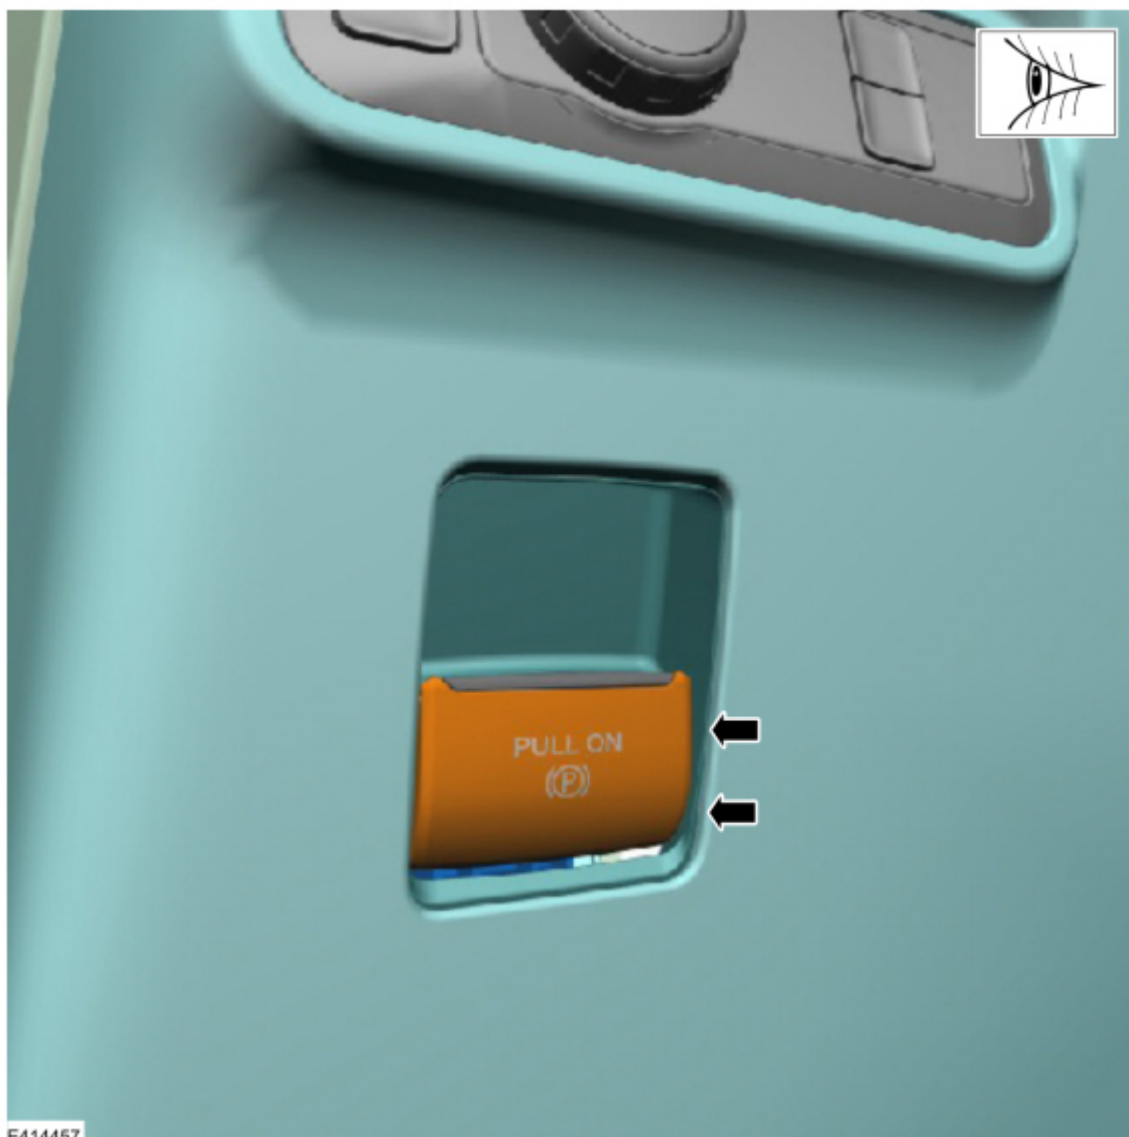
Figure 2 - Pull-down Style Parking Brake Switch
