Technical Bulletin

Model(s)	Year	Eng. Code	Trans. Code	VIN Range From	VIN Range To
Passat Sedan	2001-2010	All	All	All	All
Passat Wagon	2001-2010	All	All	All	All

50 14 02 December 10, 2014 **2038981** Supersedes V501401 dated November 24, 2014 to update the attachments.

Front Fender - Corrosion on Wheel Arch

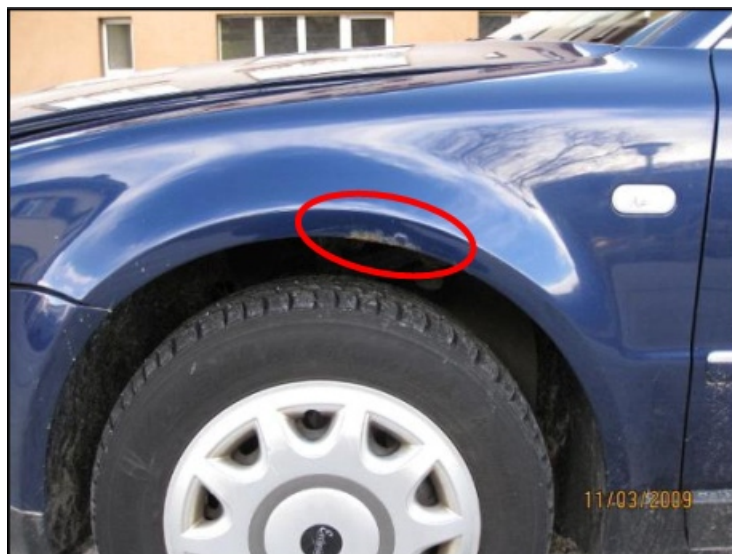
Figure 1 (corrosion on left wheel arch)

Corrosion on the wheel arch area of the front fender (Figure 1).

The wheel liner touches the arch area of the fender and rubs off the paint in the contact area.

The corrosion is caused by dirt accumulations and movements of the wheel liner.

1. Repair the fender: If the edge area is only slightly corroded (no through-corrosion/perforation), proceed as follows:

- Remove the front bumper according to the repair manual. See Repair Manual Group 63 in Elsa.
- Remove the side indicator (in fender, if equipped) according to the repair manual. See Repair Manual Group 94 in Elsa.
- Remove the front wheel liner according to the repair manual. See Repair Manual Group 66 in Elsa.
- Remove the corrosion with the pneumatic brush grinder VAS 6446.
- Apply a VOC compliant epoxy primer as an anti-corrosion treatment and primer (locally sourced).
- On the inner fender apply (in the complete contact/edge area) adhesive/sealer (part number: D 511 500 A2) as further edge protection (Figure 2, green line).
