Tech Tips

TT 55-13-01

2001-2006 Jetta Wagon, 2004-2008 Touareg (without Rear View Camera) – Rear Lid Does Not Open After Handle Replacement

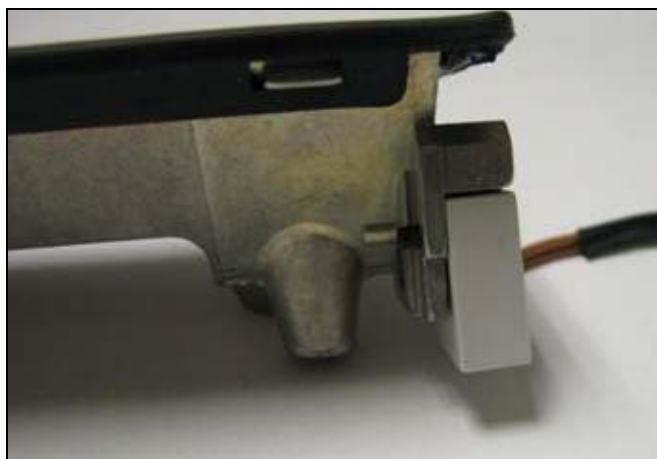
To remove micro switch, gently pry it away from handle.

If the rear lid handle is replaced with part number 1J0 827 566L, the microswitch from the original handle must be transferred to the new handle. If original microswitch is not available, microswitch part number 1J5 962 104 B should be ordered and installed.

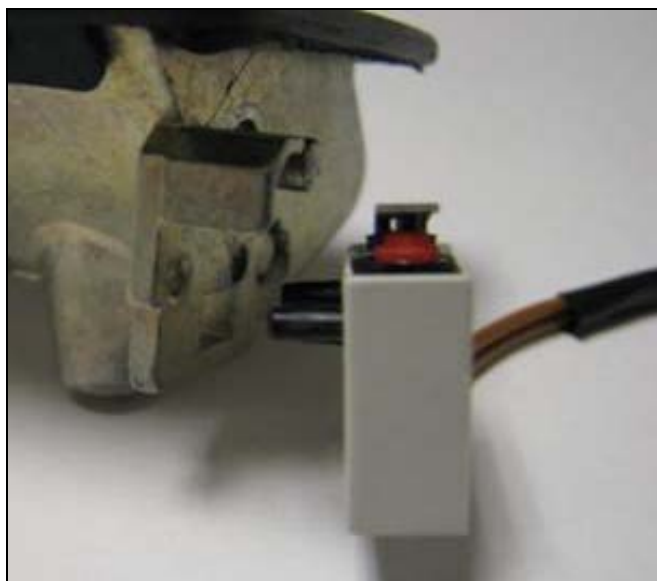
To install micro switch, align mounting tabs with handle alignment holes.
