## 2019-20 MDX A/C Compressor Shaft Seal Leak

Supersedes 23-024, dated June 30, 2023, to revise the information highlighted in yellow.

Oil/Refrigerant leak from the A/C compressor shaft seal.

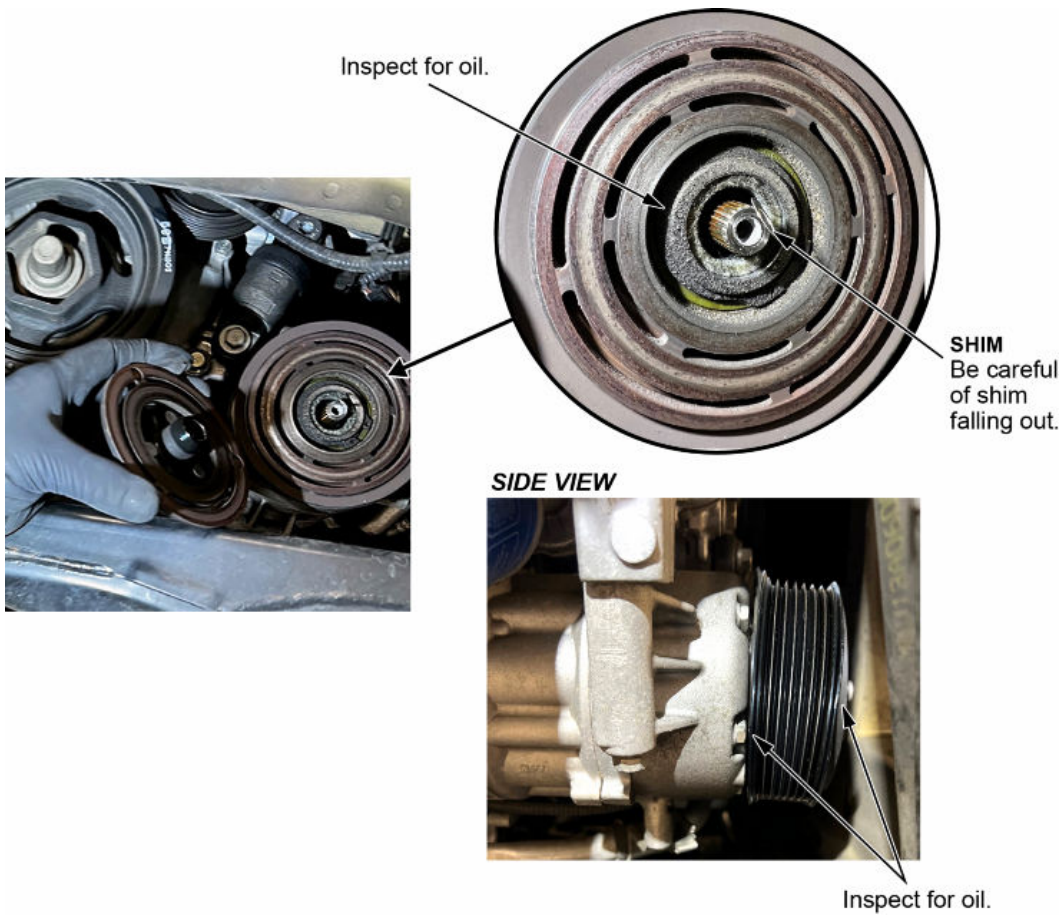
5. If no oil is noticed, leave the compressor on the vehicle. Remove the center hub bolt while holding the armature plate with the A/C clutch holder and remove the hub/armature plate from the compressor. Then, inspect both for oil.

- If oil is present on the hub/armature plate, then proceed to the repair procedure.
- If no oil is present, then proceed to step 7.

Examples of dry and oily clutch assemblies.

Rotor	Hub	Rotor	Hub
Dry	Dry	Oily	Oily

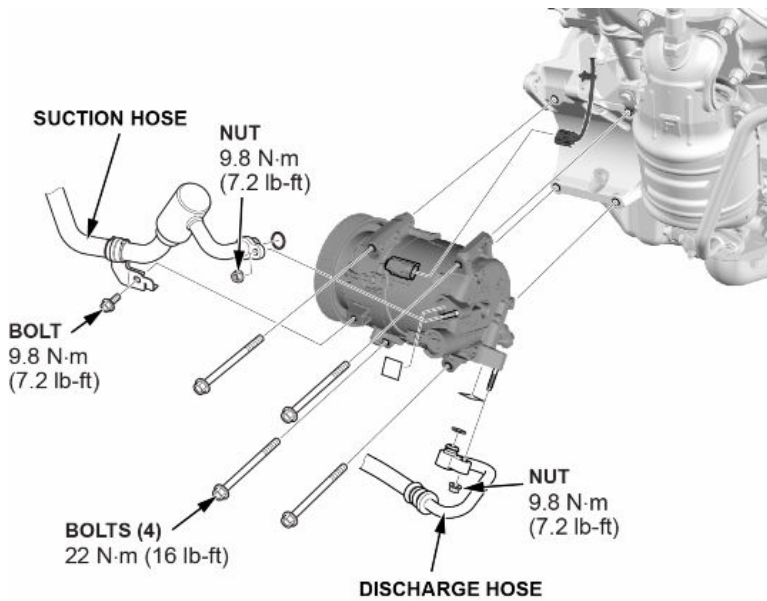
8. Disconnect the discharge and suction hose.

NOTE: Use the port plugs in the seal assembly kit to immediately seal the ports after disconnection. This prevents moisture and dust contamination from entering the A/C compressor. Installing an A/C compressor into a contaminated system can result in premature A/C compressor failure.

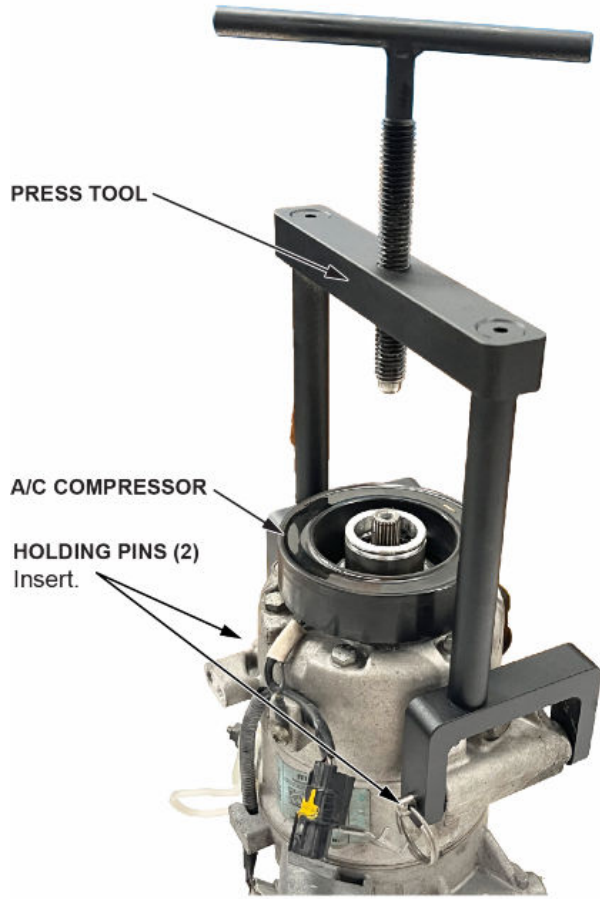
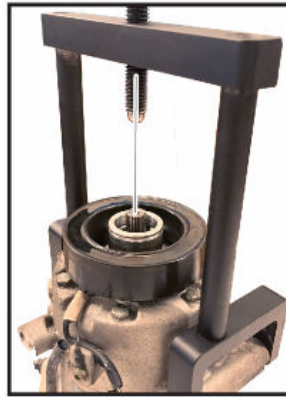
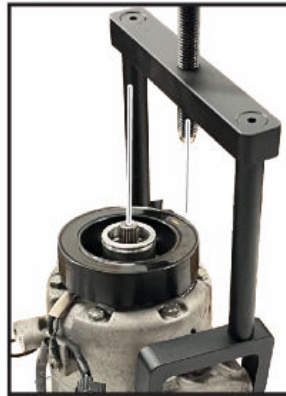
18. Place the press tool onto the A/C compressor and insert the holding pins (2). Make sure the press tool installs where the press shaft should align with compressor shaft. The press tool will only align correctly in one orientation. The pins must go all the way through.

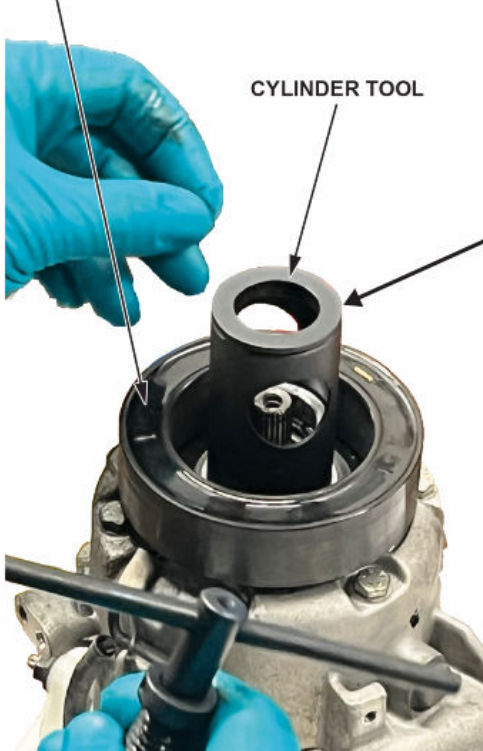
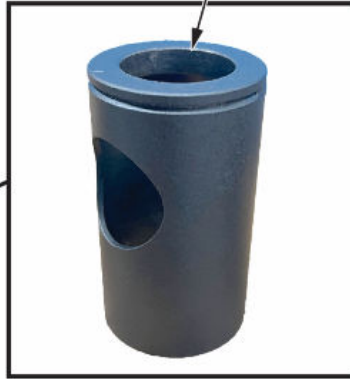
23. Insert the cylinder tool onto the A/C compressor.

A/C COMPRESSOR

CYLINDER TOOL

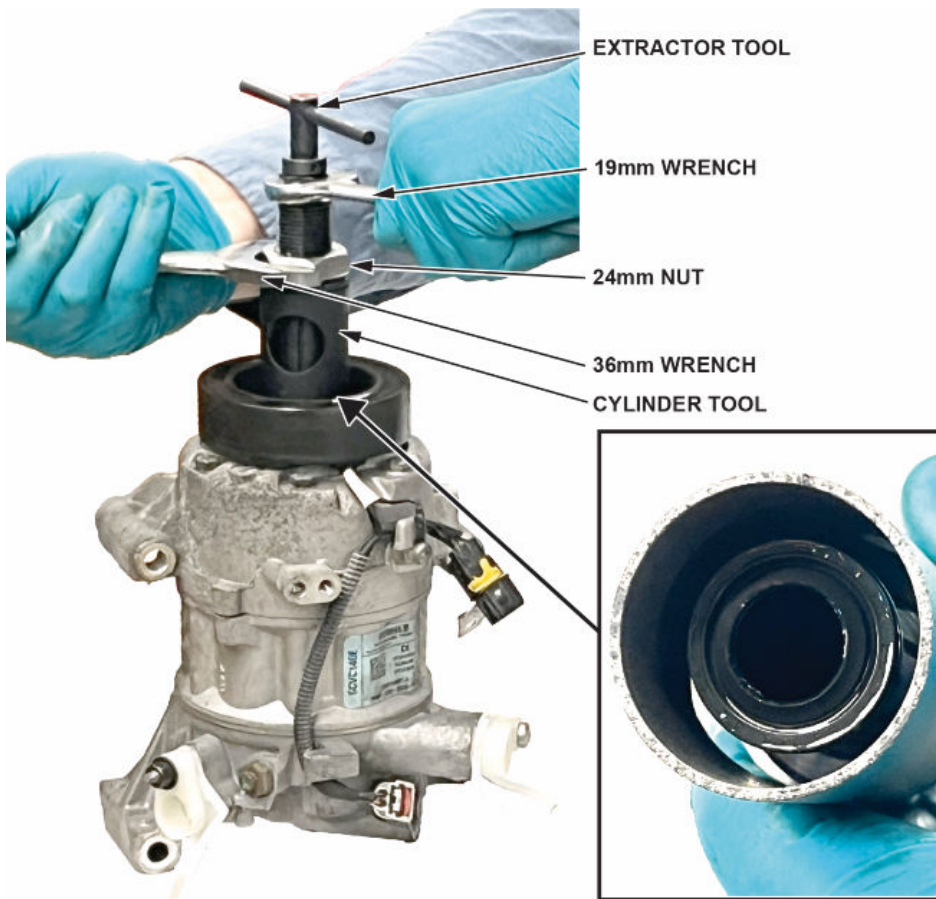
27. With the **19 mm** wrench in place, lower the **24 mm** nut down until it reaches the cylinder. Slowly and carefully adjust until the extractor tool comes out freely with the seal.

- Resistance will be felt while lowering **24 mm** nut and will cease once the seal is extracted.
- If the seal does not come out on the first step, repeat the process starting at step 13.

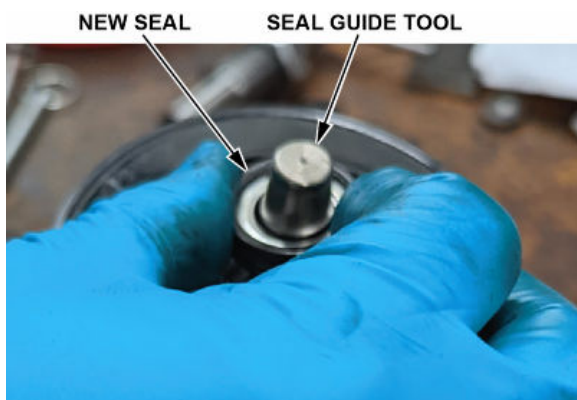
32. Insert the new seal onto the seal guide tool.

NOTE: The seal is directional and must be placed with the metal side upward.

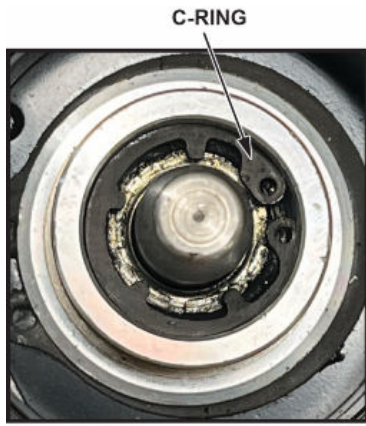
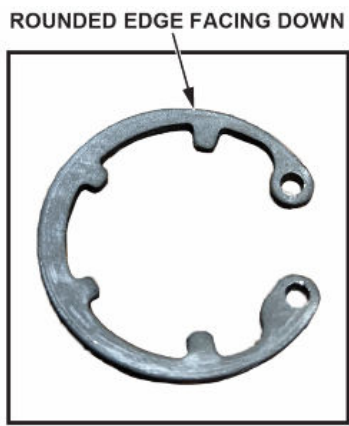
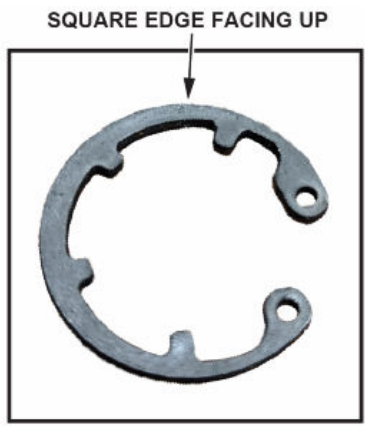
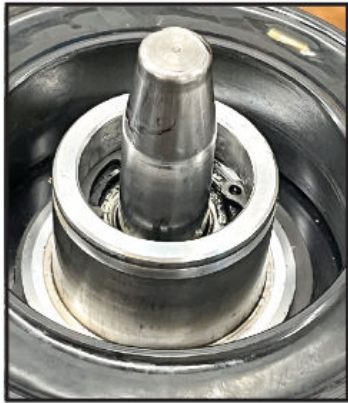
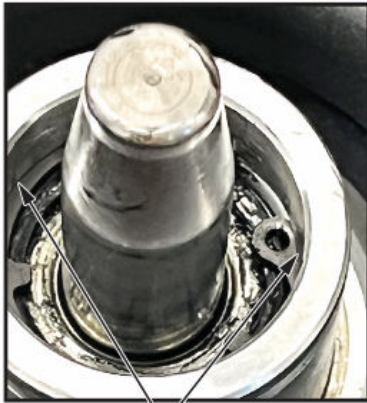
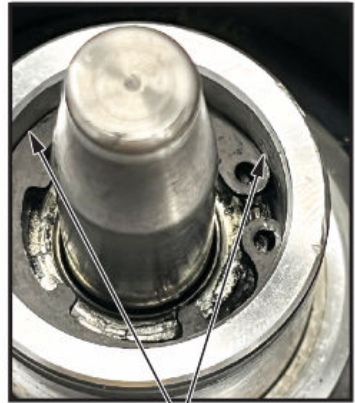
35. Insert the seal C-ring with the teeth's rounded side pointing down into the bore.

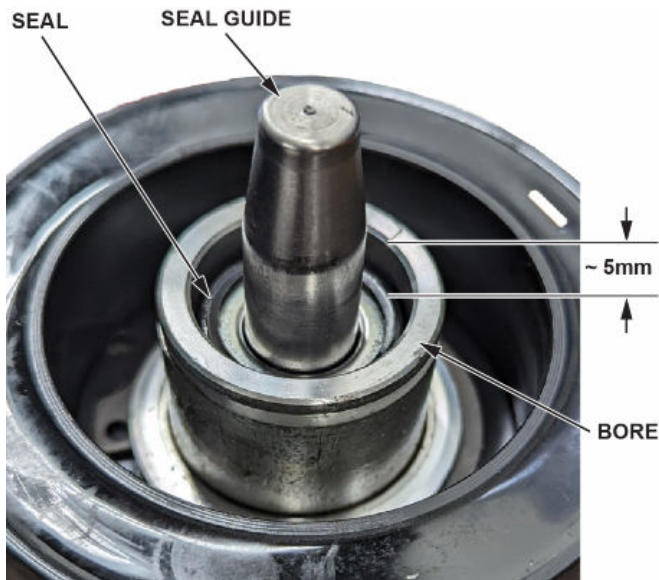
37. Tighten the press by rotating the handle clockwise until it reaches the adapter tool. Slowly and carefully continue to rotate the handle clockwise until the seal is pressed down roughly **10 mm** below the bore.

NOTE: Tighten the press until the C-Clip is installed into the clip groove. There will be a sound or vibration felt when the C-clip is fully set.
