Technical Bulletin

87 13 01 October 29, 2013 **2005566** Supersedes Technical Bulletin V871204 dated April 26, 2012 to update Passat vendor code in the warranty table.

HVAC, Unpleasant Odor

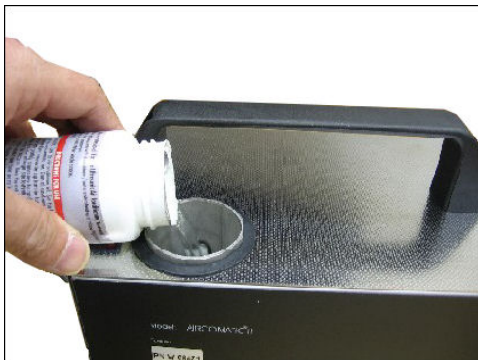
6. Remove the neck (long black pipe) of air conditioning cleaner VAS 6189A / VAS 6189B and fill with a bottle of cleaning fluid part number 30208 (observe instructions on bottle).

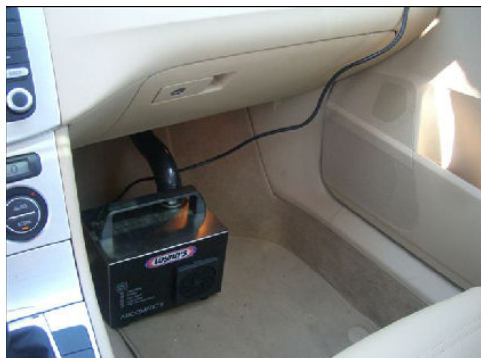
7. Place the air conditioning cleaner on the floor underneath the passenger glove box and point the neck towards the front of vehicle (see illustration).

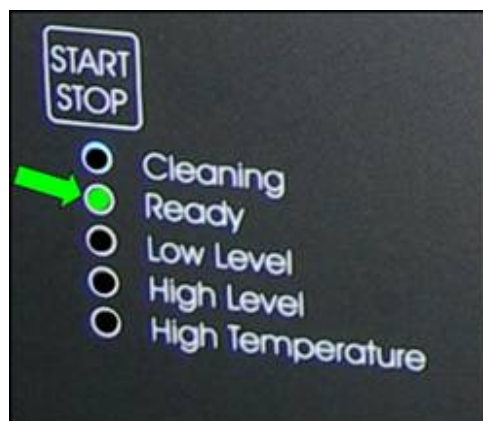
8. Route the cable of cleaner through the side window to the outside. Close the side window and connect the power cable. A self-test starts; when a green arrow lights up the unit is operational.

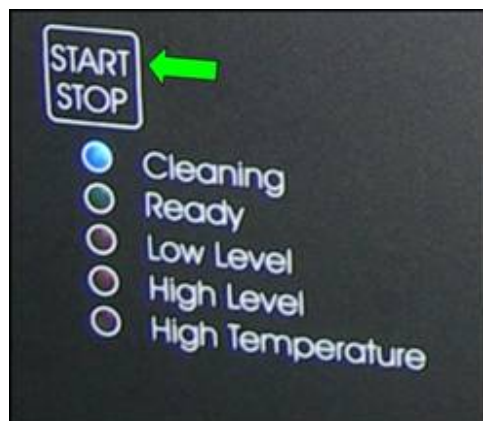
9. Start the cleaner (VAS 6189B / VAS 6189B), the warning light "Cleaning" comes on. Close all doors and windows.
