Release Date	07/25/2023	Technical Service Bulletin		
<b>97GX UPDATE</b>

<b>Electronics Box Wiring Harness– (NVLW)</b>

This Update has been proactively released to prevent the following condition(s) from occurring in the vehicle:	
Criteria	Technical Background
01	An unsealed splice may have been routed in the lower part of the under hood electronics box where it can be exposed to moisture resulting in corrosion. This corrosion may cause a warning message <i>“Electrical system not working correctly. Please go to workshop”</i> to appear.

Criteria	Remedy
01	Replace the unsealed splice with a wiring repair kit.

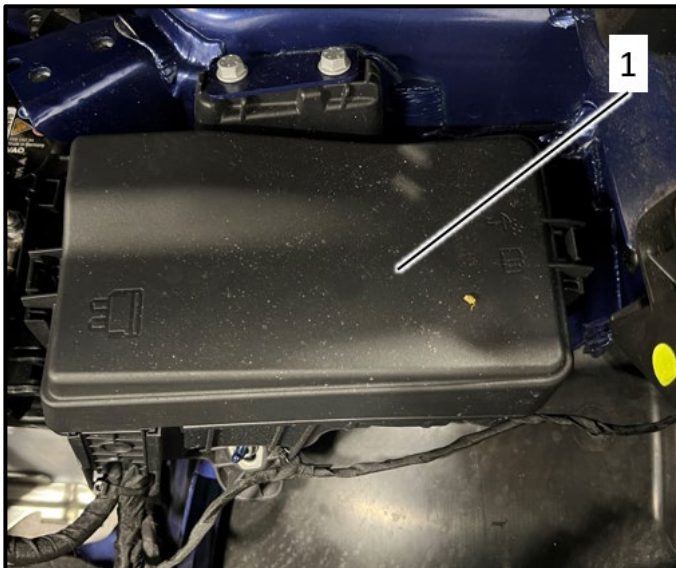
- Remove the cover <1> from the SB fuse panel under the hood.
