Squeak noise when opening or closing windows

REF NO: TJ 36700.1.1	ISSUING DEPARTMENT: Technical Service	CAR MARKET: United States and Canada	
PARTNER: 3 US 7515 Polestar		ISSUE DATE: 2023-07-19	STATUS DATE: 2023-07-25
FUNC GROUP: 8440	FUNC DESC: Glass for side doors and window	Page 1 of 3

Technical Journal 36700.1.1

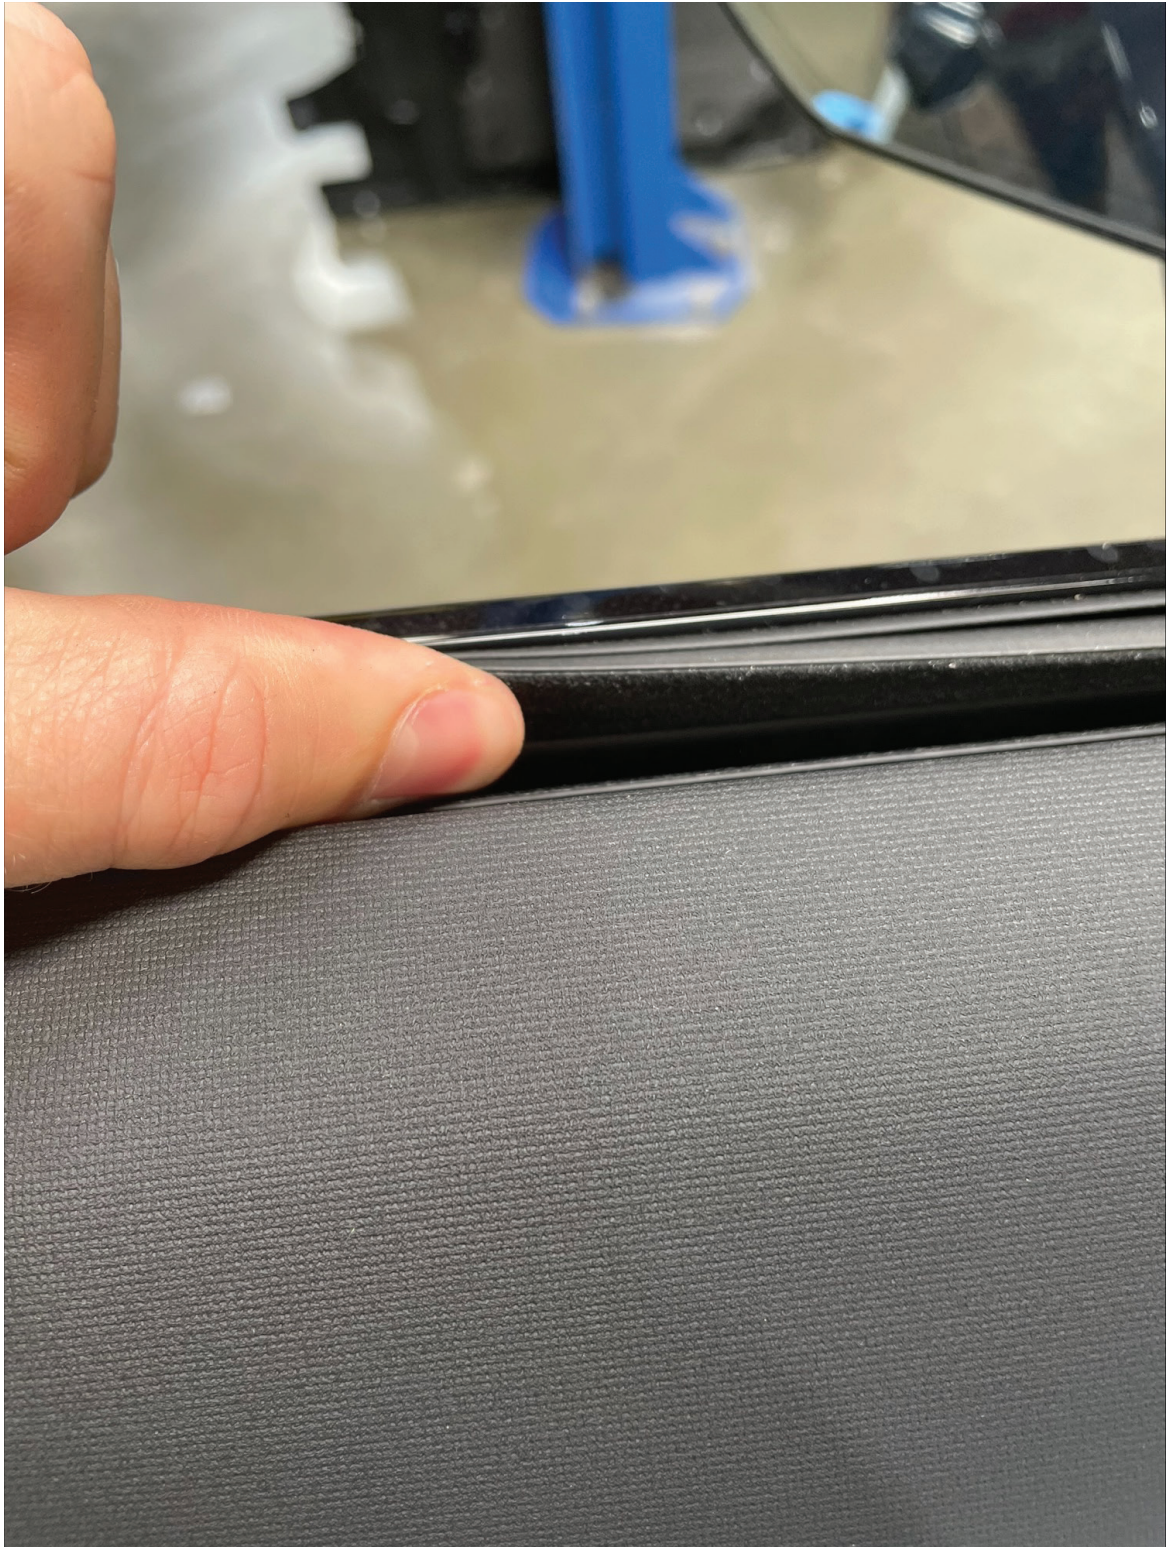
File Name	File Size
Image (003).jpeg	0.7880 MB

If customer complains of windows squeaking when opening or closing please follow advice under "Service".

If customer complains of a squeak noise when opening or closing the windows please apply PTFE spray 30749880 to the scraper molding (please see attached picture for reference)

Note: Do this on all doors.
