## NFI Bunk Wiring Inspection

**VOLVO**

Years	Models
2021-2022	VN

### Introduction

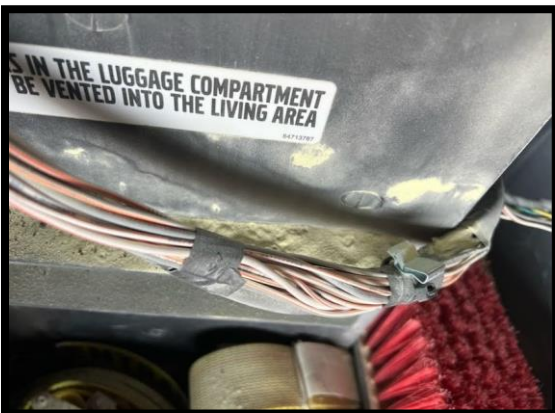
Certain NFI Volvo trucks could experience an issue with the APU wiring under the bunk. The wiring under the bunk could break loose from its mounting clips causing it to rub. Follow the instructions below to inspect and ensure all wiring under the bunk area is properly secured with clips or fasteners.

7. Inspect the bunk harness to ensure the harness is routed correctly and secured with clip. The harness should not be loose and hanging down or rubbing. (Examples of loose or bad routing)

- a) If damage is found to the harness during the inspection **Stop** and notify Alexander Leclear [alexander.leclear@volvo.com](mailto:alexander.leclear@volvo.com) before proceeding.
  - b) If the harness is not damaged, follow the instructions below to ensure the harness is routed and secured correctly.
8. Ensure the harness is routed according to the drawing below.

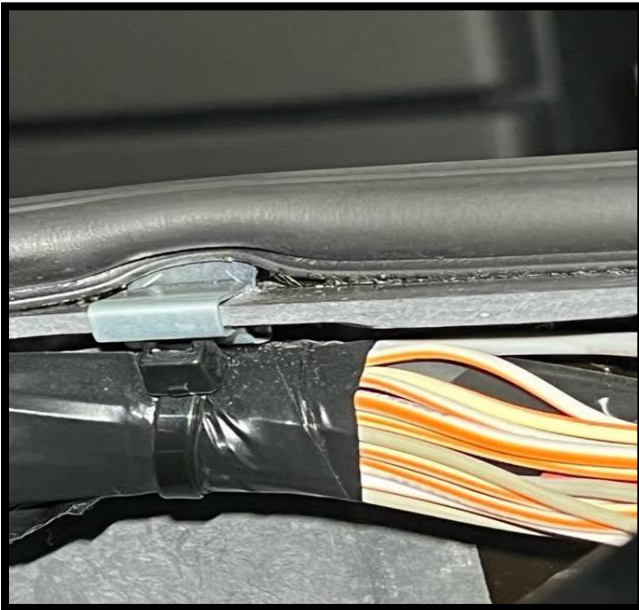
9. The harness should be attached to the bunk rail with clips and cable ties.

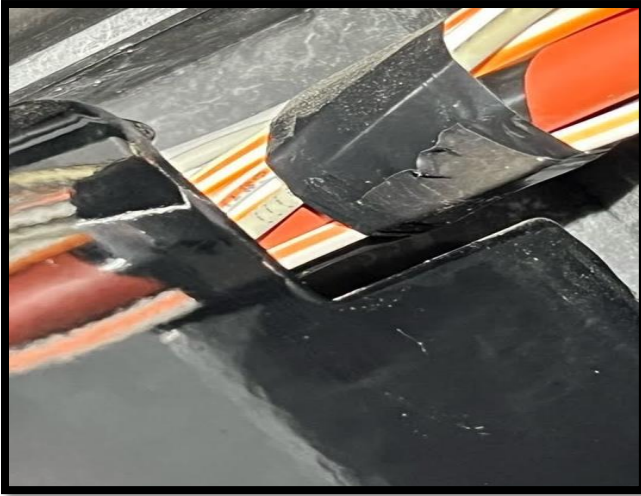
10. Make sure that the harness is not rubbing on any metal when passing through holes.
