## Technical product information

<b>Topic</b>	HVAC refrigerant leakage suspected Or reports of a damp/musty smell within the cabin - Diagnosis guidelines
<b>Market area</b>	Australia E04 Bentley rest Asia and Australia (6E04),China 796 VW Import Comp. Ltd (Vico), Beijing (6796),Germany E02 Bentley rest Europe (6E02),Japan E03 Bentley Japan (6E03),Korea, (South) E08 Bentley South Korea (6E08),United Arab Emirates E06 Bentley Middle East and Africa (6E06),United Kingdom E01 Bentley UK (6E01),United States E05 Bentley USA and rest America (6E05)
<b>Brand</b>	Bentley
<b>Transaction No.</b>	2069806/2
<b>Level</b>	EH
<b>Status</b>	Approval
<b>Release date</b>

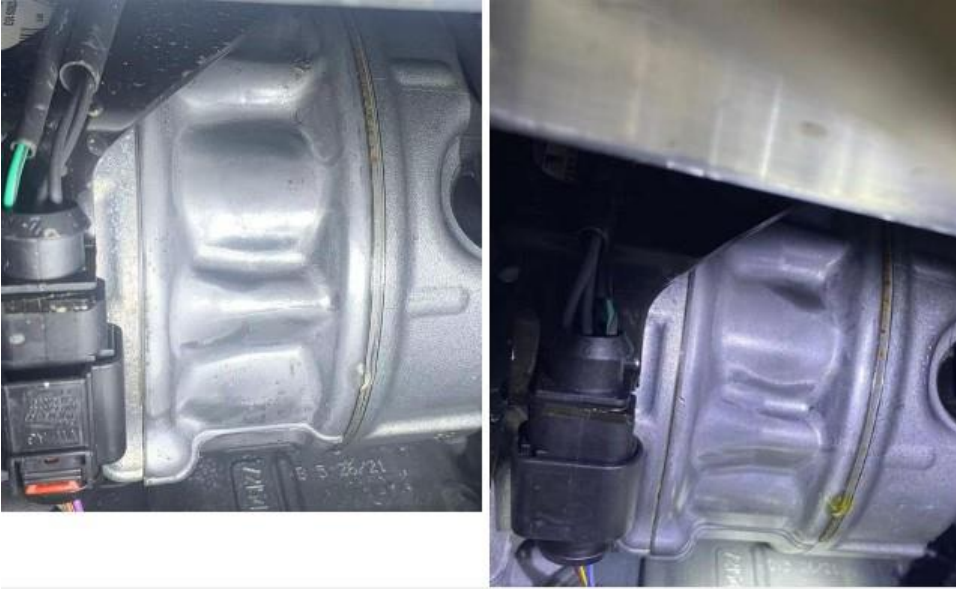
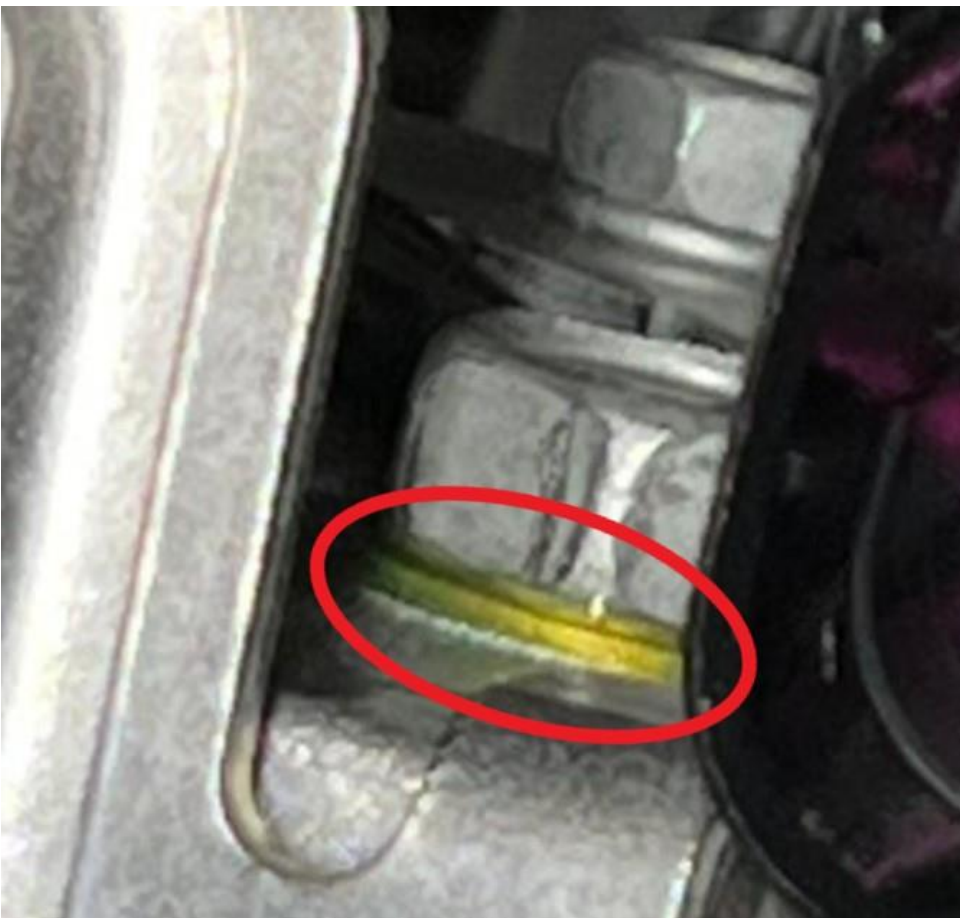
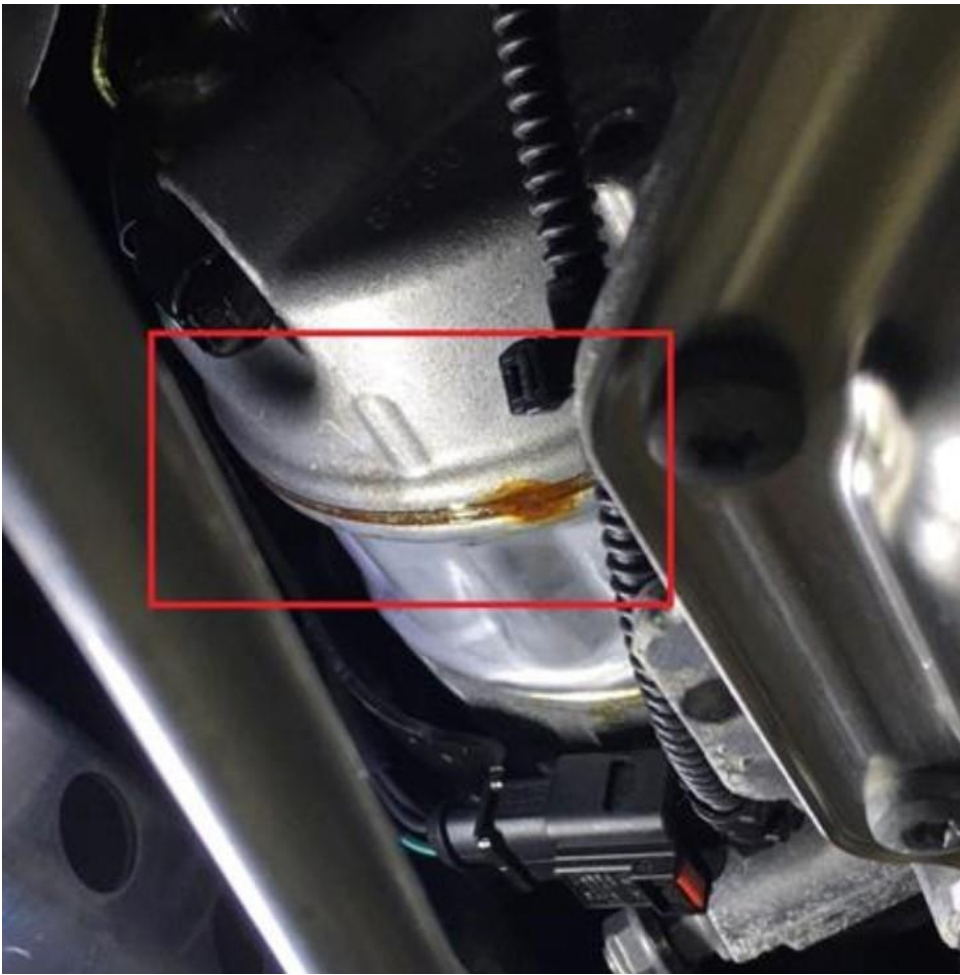
Figure 1

please refer to the examples shown below (Figures 1,2 and 3) of leaks found on the HVAC compressor

It has been observed that some HVAC components have been incorrectly diagnosed and replaced, after the components were returned for inspection no faults were found

The leaks in these scenarios were repaired after component replacement however as the parts were not at fault the actual fix of the leak would have been resolved by replacing O-rings only

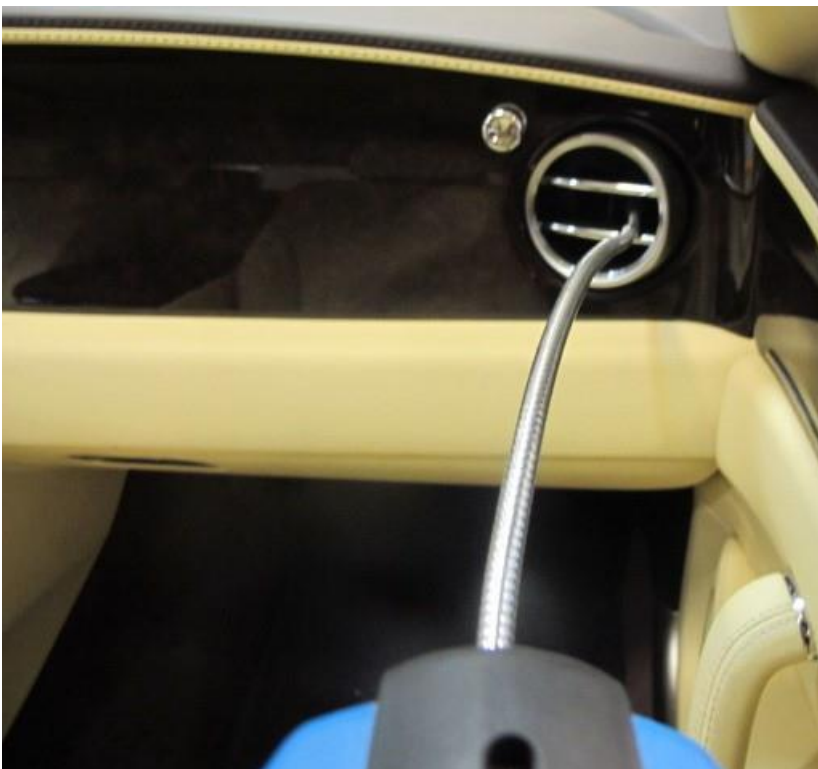
Figure 4

**⚠ CAUTION**  
CAUTION: In the event the HVAC sniffer tool traces a HVAC leak from any of the outlets (Figure 4)

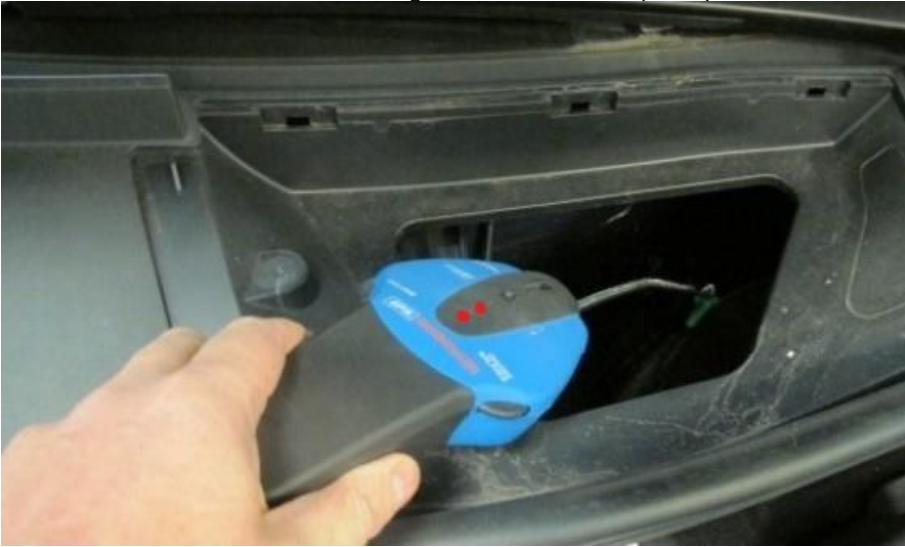
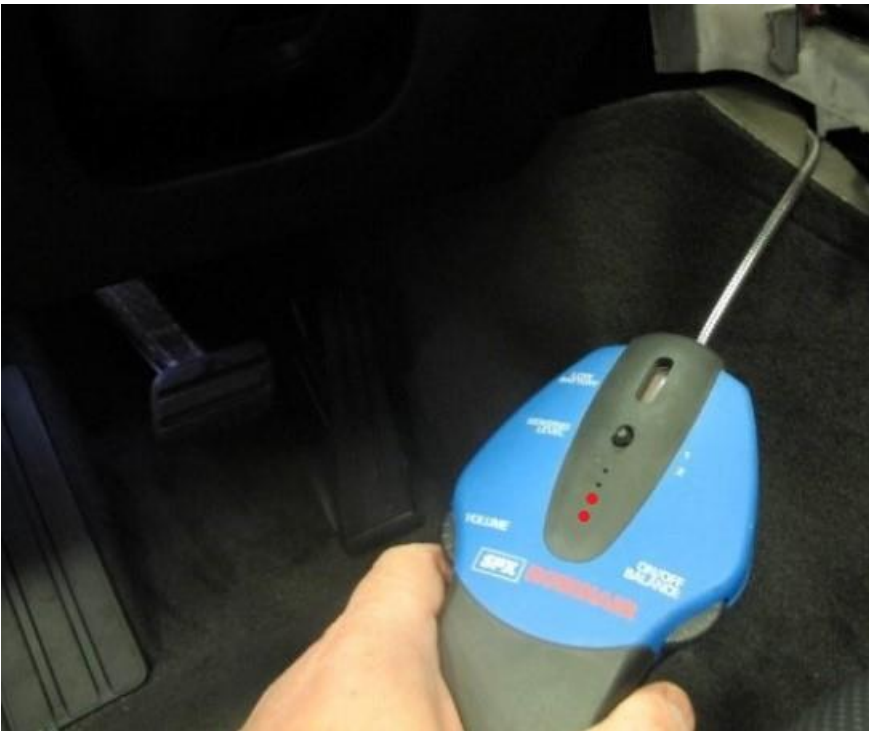
Figure 5

A complaint is received that refrigerant is evident within the cabin the operative MUST first ensure that a leak is not evident within the plenum chamber or around the centre console (Figures 5 and 6) as refrigerant could be leaking into the plenum chamber/cabin and recirculated back into the cabin as this could lead to misdiagnosis and/or incorrect part replacement
