Service Action

Code: 45D8

Subject: 2015 Jetta
Front Assist Software

December 19, 2014

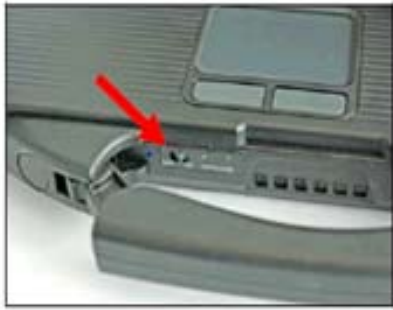
VAS 6150 & VAS 6150A
(Front panel behind handle)

The Bluetooth function of the scan tool **MUST BE PHYSICALLY SWITCHED OFF** prior to performing this update.
<See pictures>

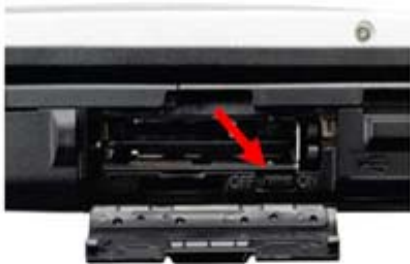
VAS 6150B
(Middle right side behind WIRELESS door)

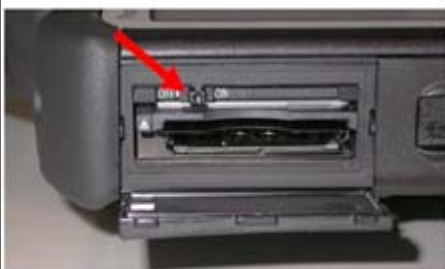
VAS 6160/-VPC
(Upper left side behind SC/EX door)

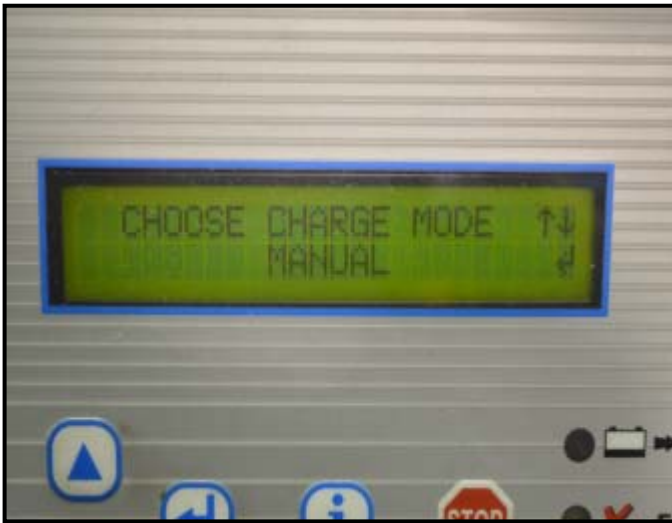
- ⇐ Install the inCharge 940 battery tester onto the vehicle, switch the tester on, then select the “manual” option <as shown>.
- Follow the on screen prompts to charge the battery during the SVM procedure.

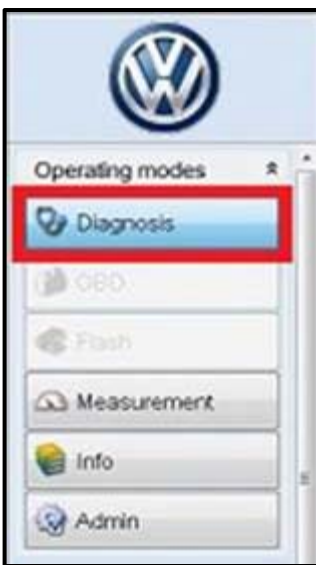
- Switch the ignition on.
- Apply the parking brake.
- Switch the headlights off.
- Attach an appropriate VAS tester to the vehicle.
- Start the ODIS program.
- ⇐ Upon ODIS startup, verify the “Diagnosis” operating mode is selected <as shown>.

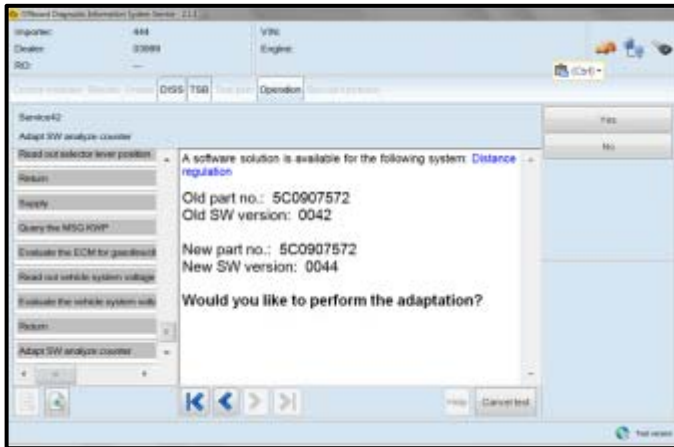
⇐ If the old and new software versions displayed are not the same <as shown>, Select “Yes” and follow the on-screen prompts to complete the test plan.

- Reference the Software Change Table above for affected control modules.

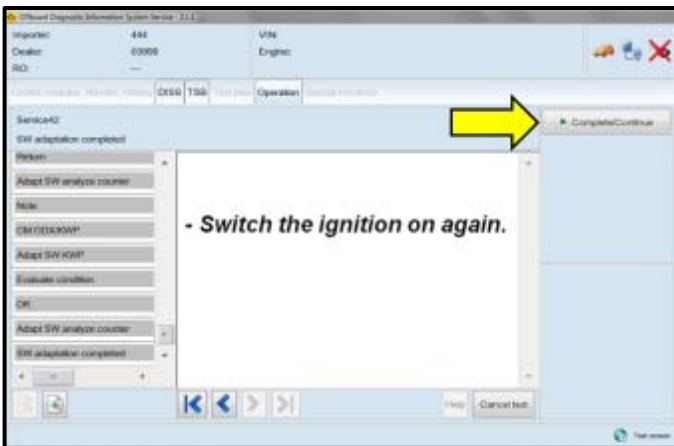
⇐ Switch the ignition on, then select "Complete/Continue" <arrow>.

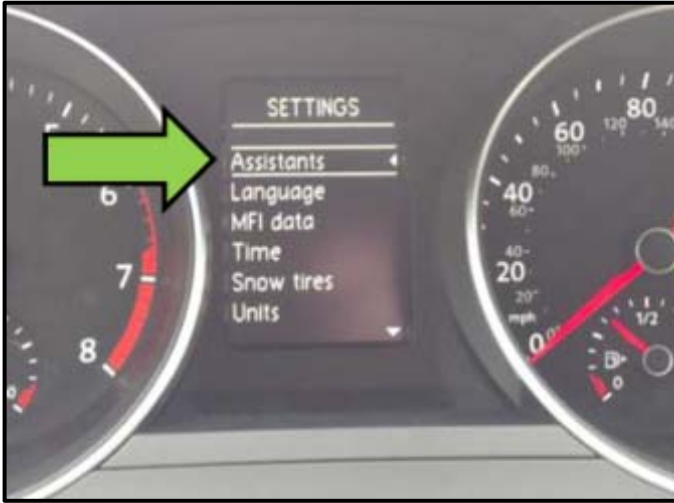
- ⇐ Using the steering wheel controls, navigate to the “Settings” menu in the MFI <as shown>.
- ⇐ Select “Assistants” <arrow>.

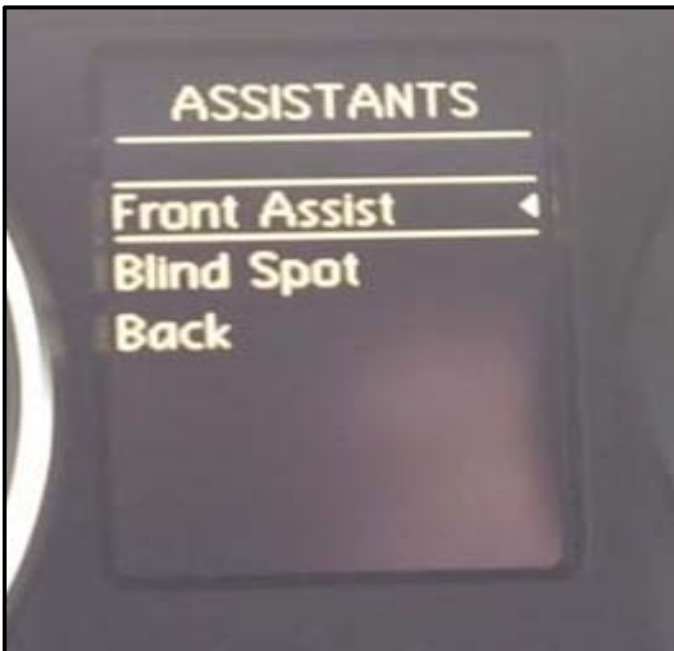
- ⇐ Select “Front Assist” <as shown>.

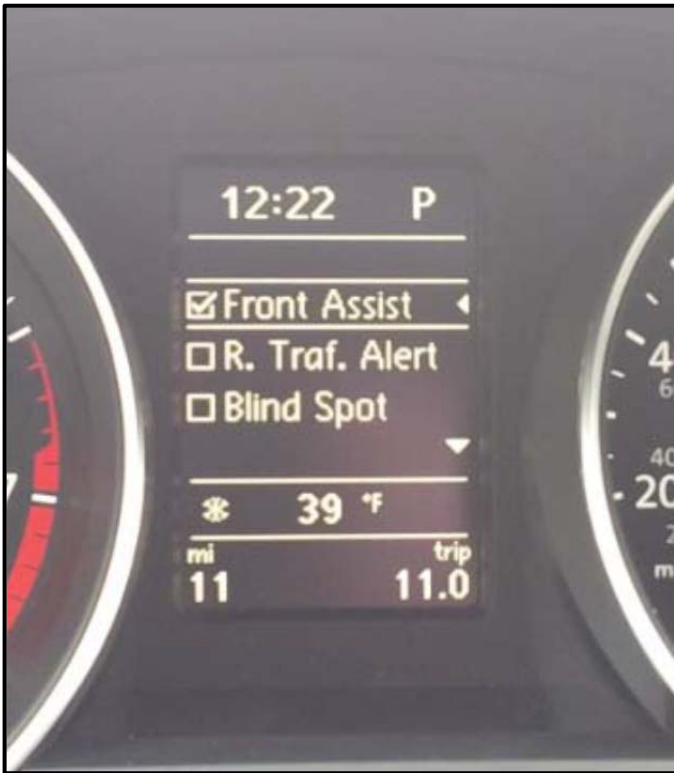
← Activate the “Front Assist” option <as shown>.

Note: Completion of this software update and activation of the Forward Collision Warning System (Front Assist) in the MFI serve as validation of the Front Assist system operation.
