Preliminary Information

PIT5990A Hoot Howl Whistle Type Wind Noise From the Front End or Interior While Driving At Highway Speeds Or Squeak Noise From IP Dash

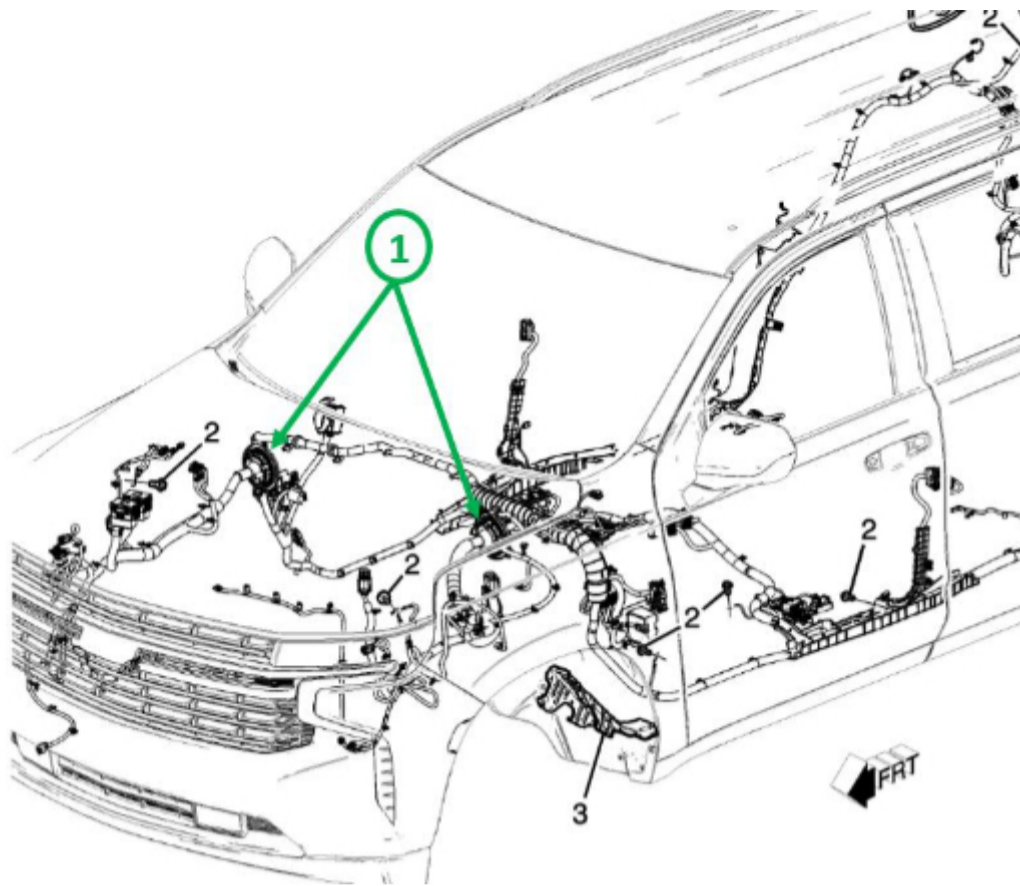
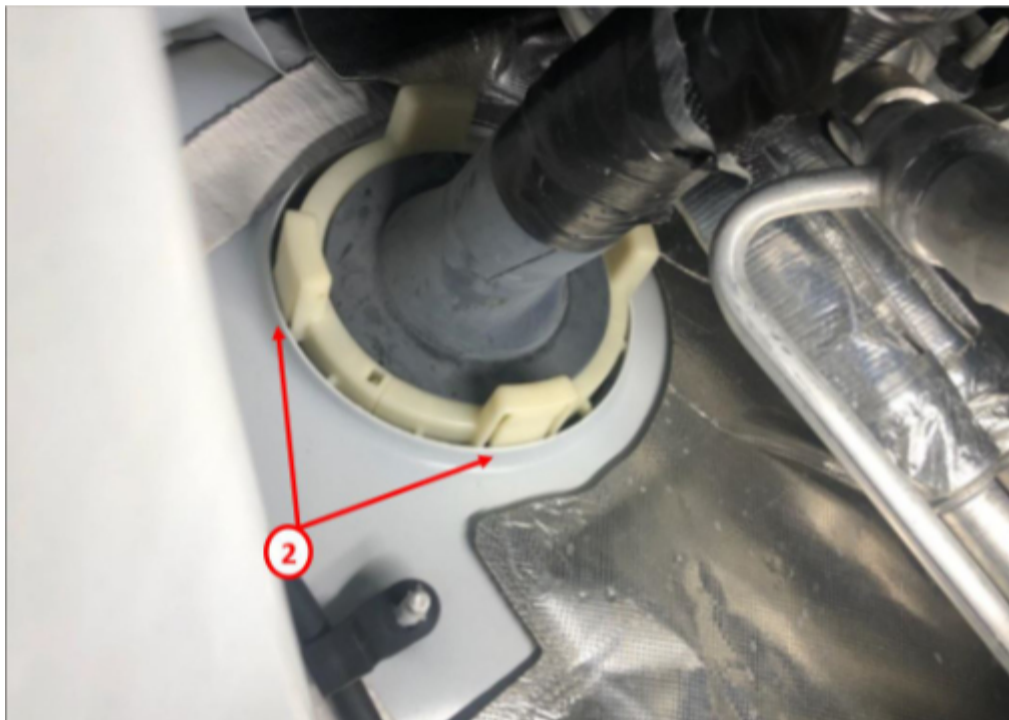
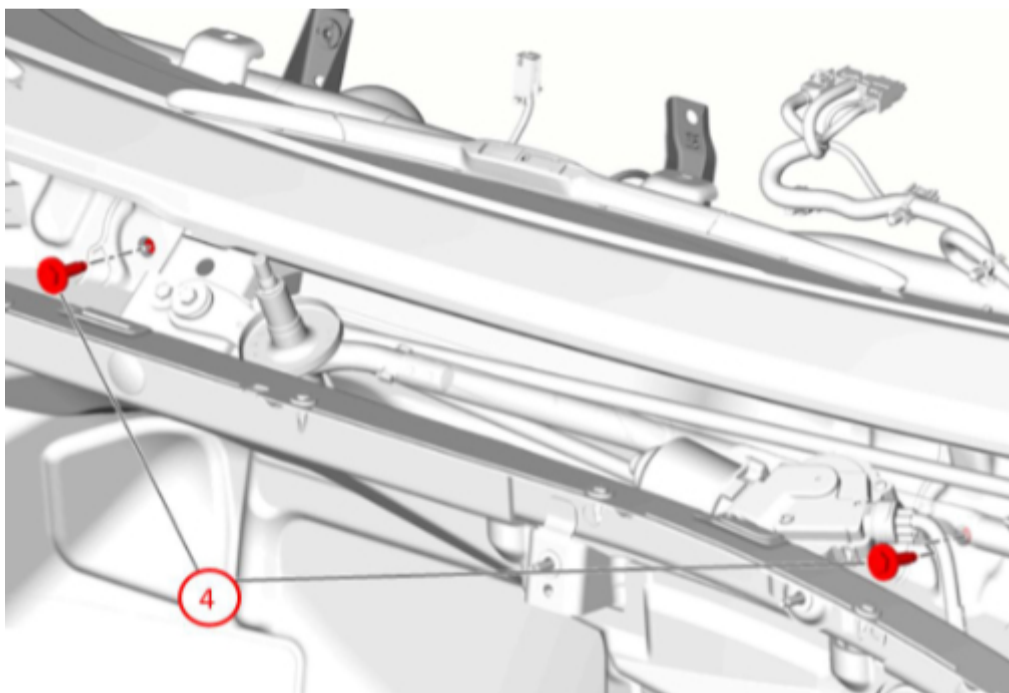
Involved Region or Country	North America
Condition	Some customers may comment of a hoot, howl, whistle type wind noise coming from either the left or right side of the dash / front end while driving at highway speeds. This noise may change depending on the HVAC setting being set to either fresh air or recirculation mode. In some cases, the complaint could be a squeak or creak noise from the I/P dash, which could occur while driving at any speed.
Cause	The cause of these concerns could be either of the following: <ol style="list-style-type: none"> 1. Either the left or right body harness pass-through (1) not fully seated into the cowl (2), as shown below. 2. Either the left or right I/P tie bar bolts loose or missing (4), shown below.

1. Fully seat the body harness pass-through so that each of the 4 retainers (3) are locked into position, as shown below.
2. Install and/or tighten the I/P tie bar bolts to 22 Nm (16 lb. ft).
