MAS003644 RU 23-35

# Rapid Update 646 MC20 & MC20 Cielo – Check side mirrors

Certain Maserati MC20 and MC20 Cielo (M240) MY23 listed in MODISCS+ are involved in a Rapid Update to verify the integrity of the wiring of the external side mirrors.

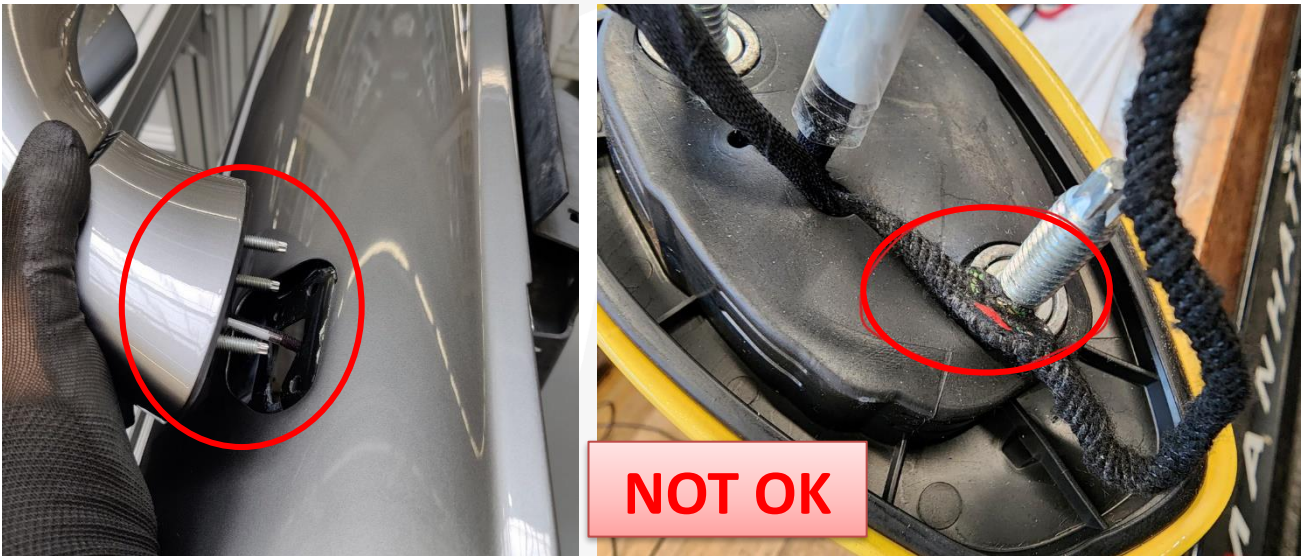
FIGURE 1

Due to an assembly problem, it is possible that on some cars the internal wiring to the external rearview mirror may have been pinched. In the long run, this can lead to deterioration of the wiring and lead to malfunctions in the mirror movement system.

1. Always check ModisCS+ to see if the vehicle is involved in this action and if it has not been previously performed.
2. Disconnect the 12V battery by following the procedure in the workshop manual:
  - a. **08.20.001 - BATTERY - Connection-disconnection of power supply**
3. Following the procedure indicated in the workshop manual, remove the side mirror.
  - a. **9.35.001 OUTSIDE MIRROR PASSENGER SIDE Removal-Refitting or Replacement**  
**NOTE: Both rear view mirrors must be inspected!**
4. Once removal has been carried out, check the integrity of the wiring, paying attention and identifying pinch marks or damage as shown in **Figure 1**.  
**Note:** Refer to the image below to understand the type of damage that can be found

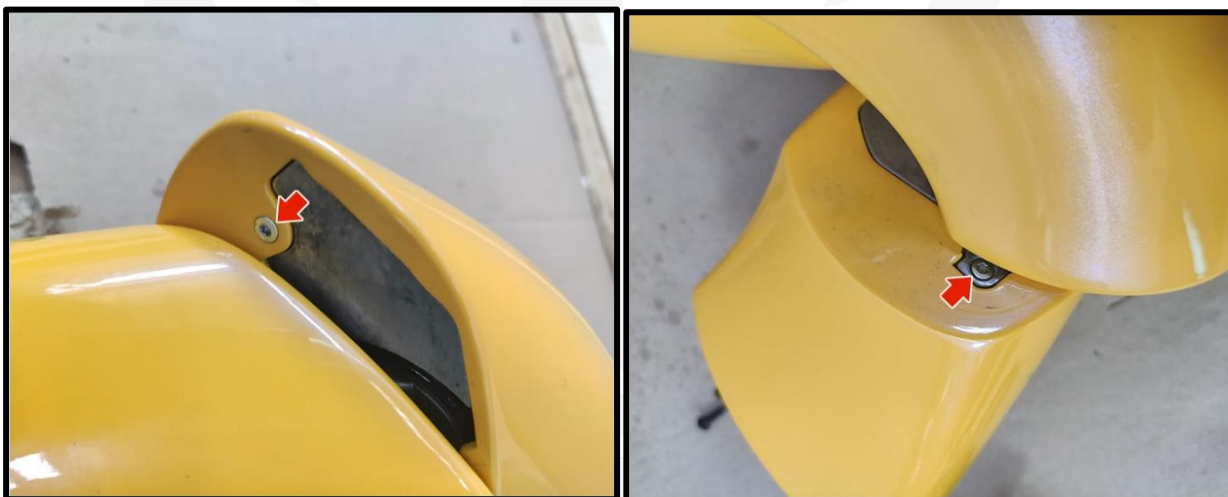
**FIGURE 4**

- Once the mirror has been connected to the vehicle's electrical system, close the external rear-view mirror to access the screws indicated in **Figure 4** and remove them.

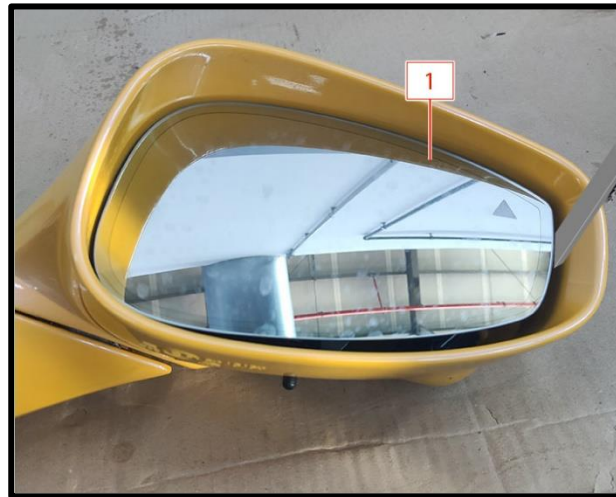
**FIGURE 6**

11. With the utmost care, using a plastic trim removal tool, remove the external glass of the rear-view mirror (1). **Figure 6**

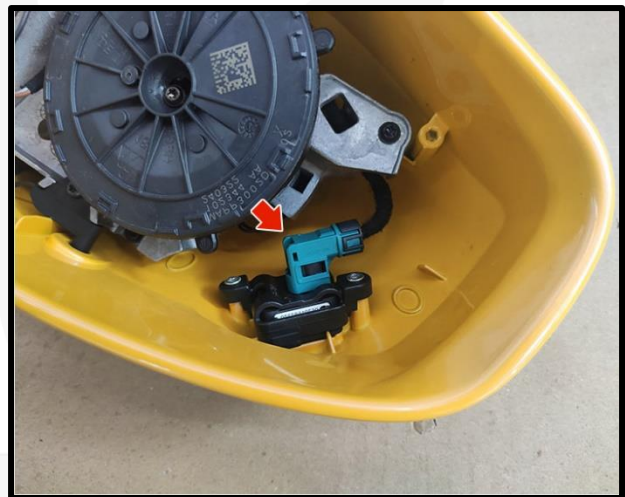
**FIGURE 7**

12. The internal mirror links are now visible. Disconnect the indicated connectors. **Figure 7**

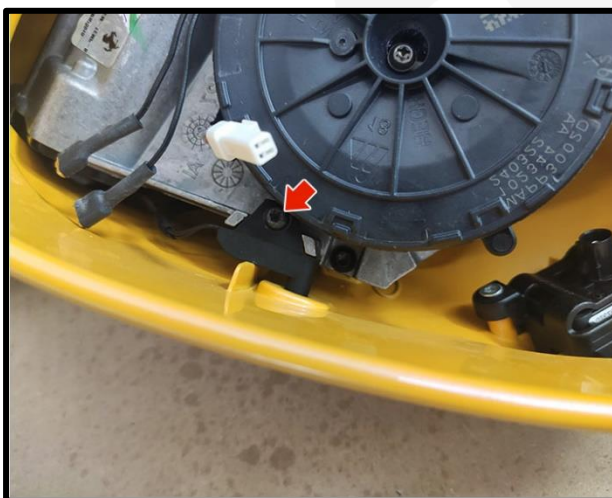
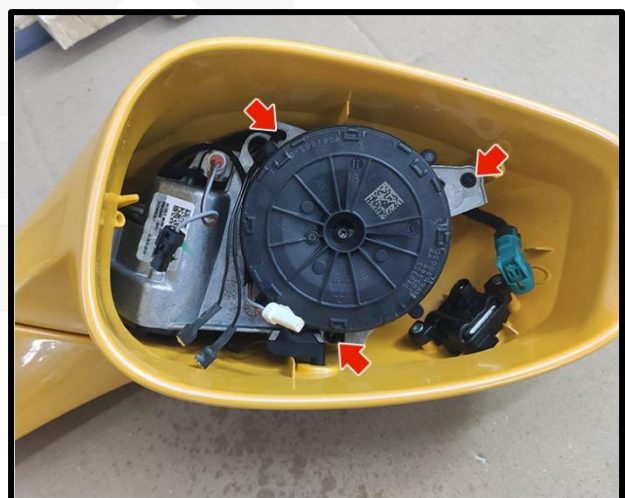
**FIGURE 8**

13. Undo the indicated screws. **Figure 8**

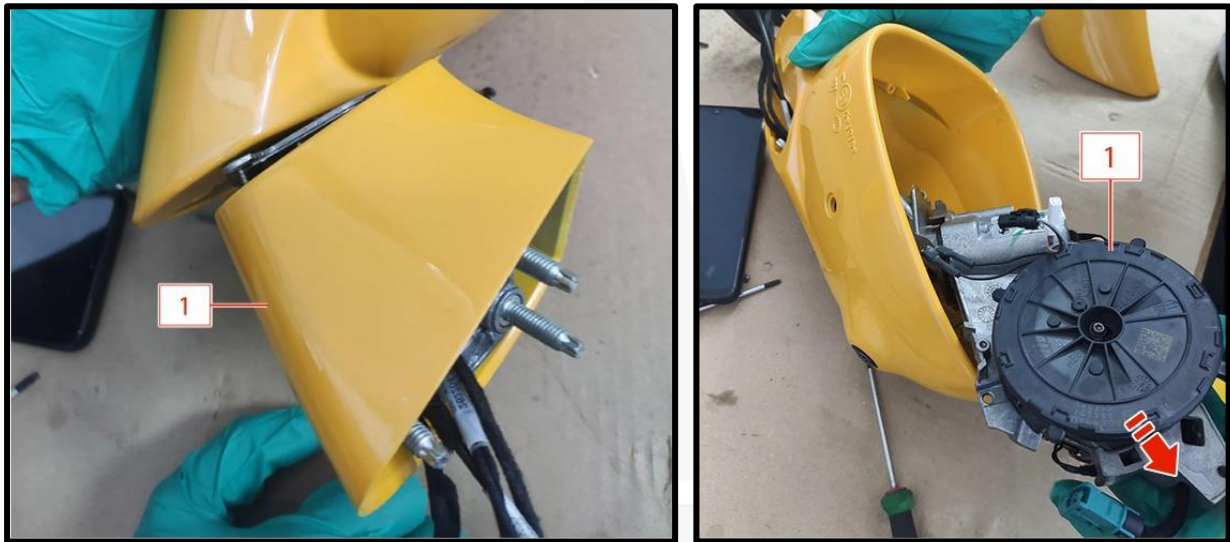
**FIGURE 10**

15. Slide the mirror base (1) and the entire mirror body outwards as shown. **Figure 10**

16. At this point it is possible to replace the rear-view mirror motor assembly, reusing the rear-view mirror assembly housing.
