# Creak or Click Type Noise From Rear Over Bumps or When Braking

YEAR(S)	MODEL(S)	ADDITIONAL INFORMATION
2021 - 2023	Mirai

Some 2021 – 2023 model Mirai vehicles may exhibit a creaking or clicking type noise from the rear suspension member. This condition may occur when braking or when driving over speed bumps and uneven surfaces. Follow the Repair Procedure in this bulletin to address this condition.

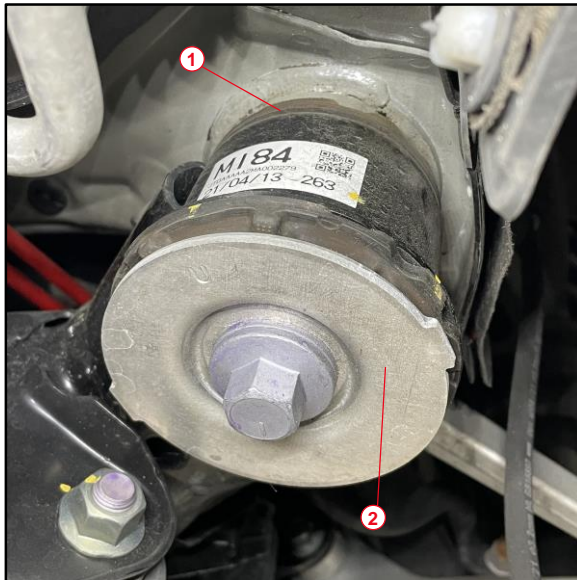
**Figure 1. Rear Member Front Left-hand Side**

2. Attach the ChassisEar™ (or equivalent), to the rear suspension member sub assembly front upper, front lower stoppers and rear lower stoppers.

<b>1</b>	<b>Front Upper Stopper</b>
<b>2</b>	<b>Front Lower Stopper</b>

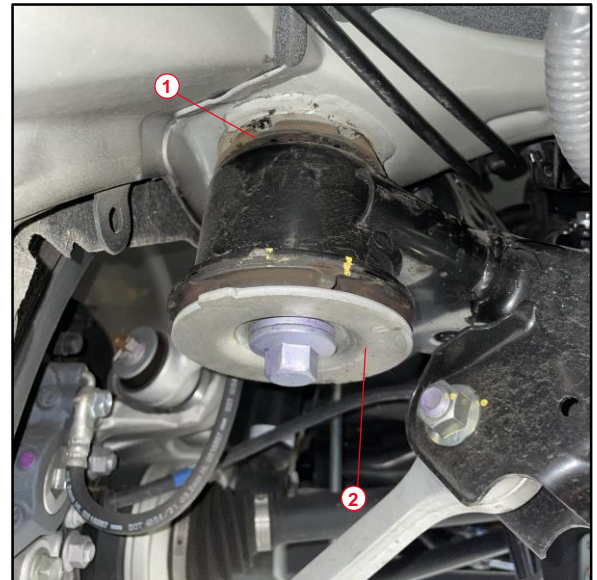
**Figure 2. Rear Member Front Right-hand Side**

<b>1</b>	<b>Front Upper Stopper</b>
<b>2</b>	<b>Front Lower Stopper</b>

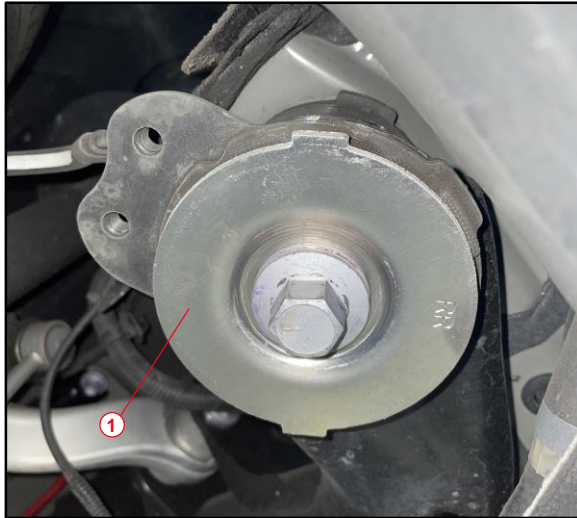
**Figure 3. Rear Left Hand Lower Stopper**

<b>1</b>	<b>Rear Lower Stopper</b>
----------	---------------------------

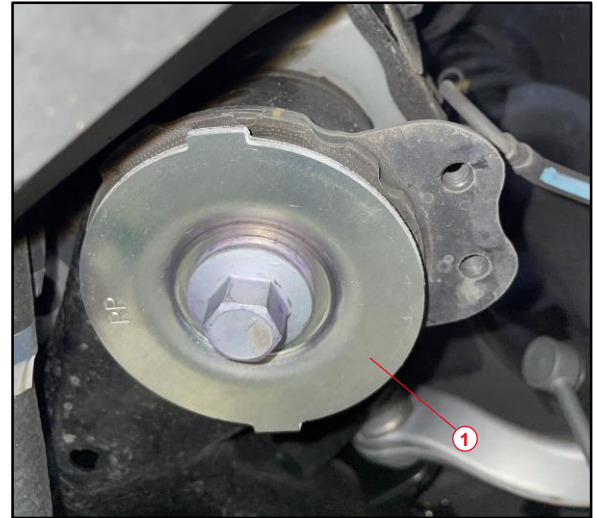
**Figure 4. Rear Right Hand Lower Stopper**

<b>1</b>	<b>Rear Lower Stopper</b>
----------	---------------------------

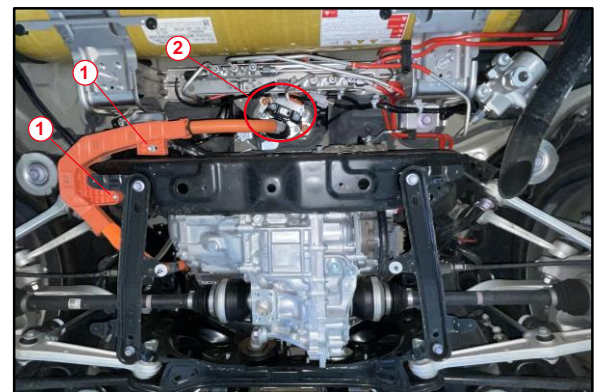
**Figure 5.**

5. Wearing insulated gloves, disconnect the motor cable.

<b>1</b>	<b>Bolts</b>
<b>2</b>	<b>Motor Cable</b>

**NOTE**  
Cover the motor cable connector once it is disconnected.

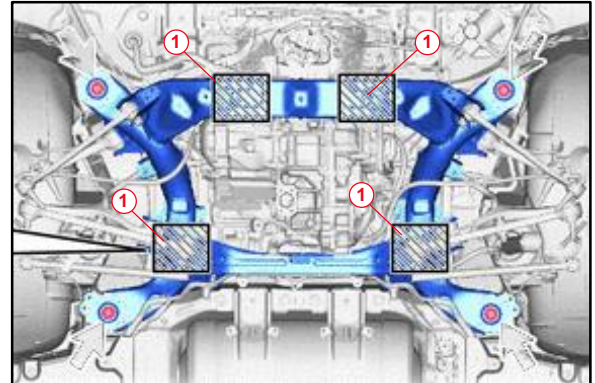
**Figure 6.**

6. Use an engine lifter or transmission jack to support the rear suspension member sub assembly.

<b>1</b>	<b>Support Locations</b>
----------	--------------------------

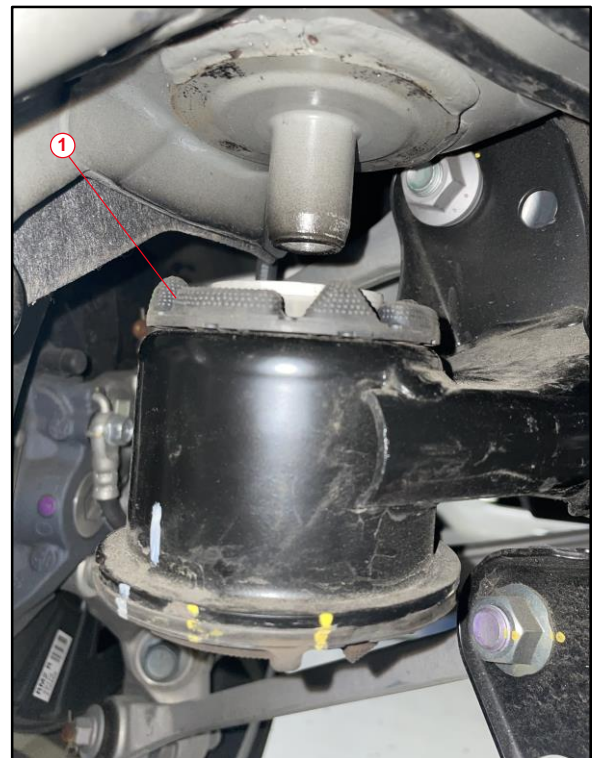
**Figure 7. Remove the Upper Stopper**

7. Remove all four rear suspension member sub assembly bolts.
8. Lower the rear suspension member sub assembly until there is enough clearance to remove and replace the front upper stoppers.

<b>1</b>	<b>Front Upper Stopper</b>
----------	----------------------------

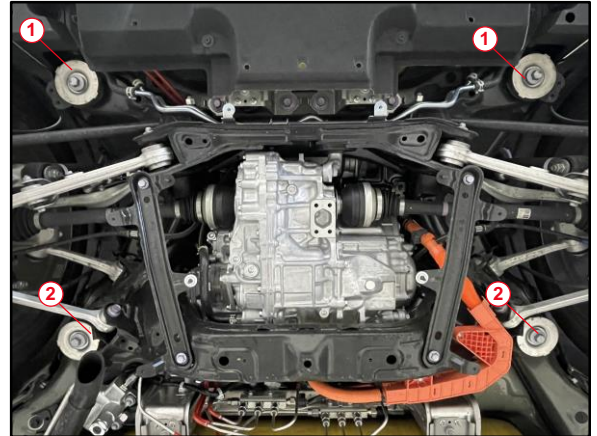
**Figure 8.**

9. Remove and replace ALL four lower stoppers, ensuring correct placement of stoppers.

<b>1</b>	<b>Rear Lower Stoppers</b>
<b>2</b>	<b>Front Lower Stoppers</b>

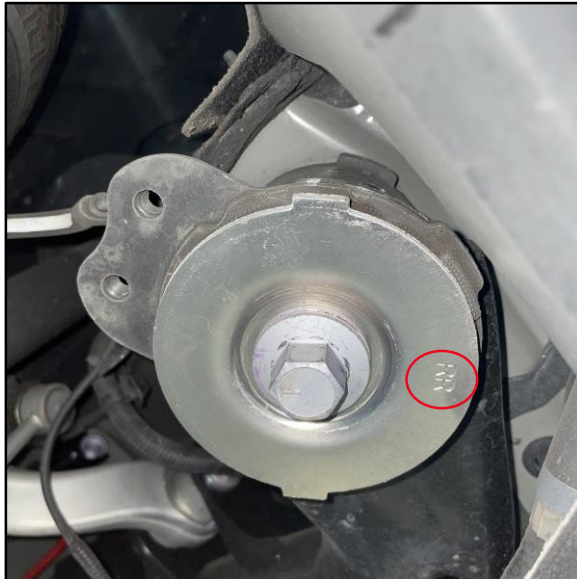
**Figure 9. Rear Lower Stopper**

10. Refer to the stamped marking on the lower stoppers. RR is for the rear lower stopper, and U is for the front lower stopper, as shown below.
