**WNP5 - Replacing Drain Hose on Heating/Fresh-Air Unit (Workshop Campaign)**

Model Line: **Cayenne (92A)**

Concerns: **Drain hose on heating/fresh-air unit**

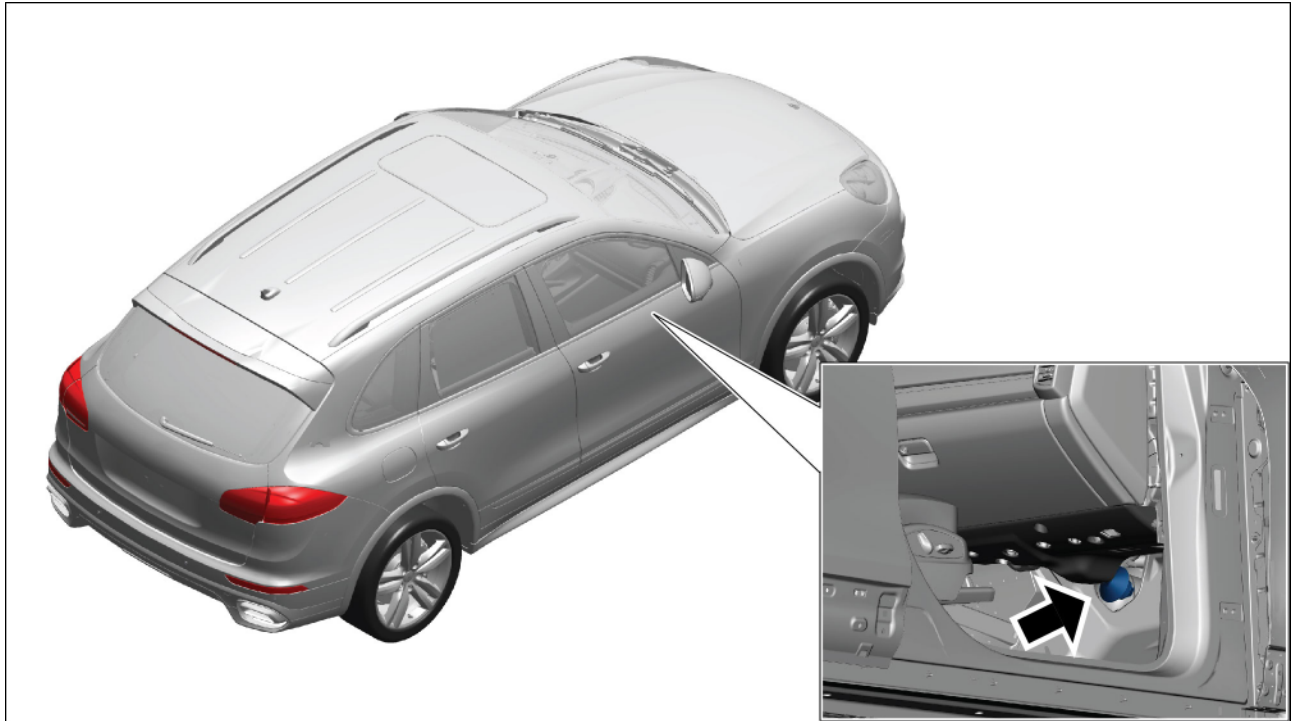
*Installation position of drain hose on heating/fresh-air unit*

**Arrow** – Drain hose on heating/fresh-air unit (**Replacing**)

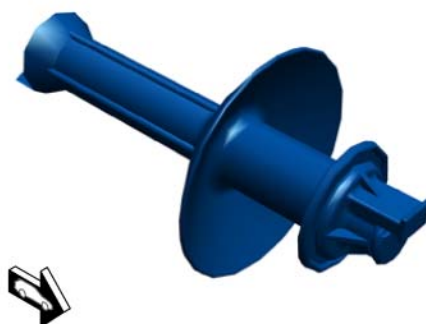
*Drain hose*

Note the installation position of the drain hose ⇒ *Drain hose*. The new drain hose must be installed in this position.

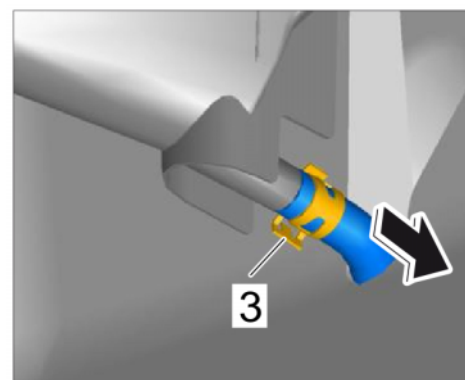
*Pulling off drain hose*

3.1 Loosen spring band clamp ⇒ *Pulling off drain hose -3-* and pull the drain hose off the heating/fresh-air unit.

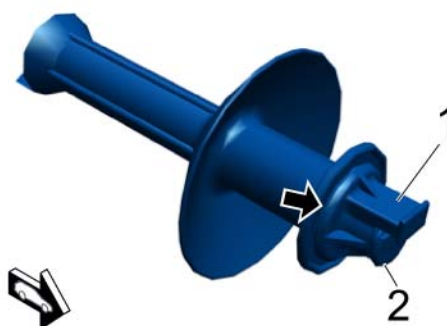
*Drain hose seating*

Lug ⇒ *Drain hose seating -1-* must point upwards and drain hose opening ⇒ *Drain hose seating -2-* must point downwards. It is also important that the drain hose is seated correctly along entire groove ⇒ *Drain hose seating -Arrow-* in the body wall. Tighten the drain hose from below if necessary.

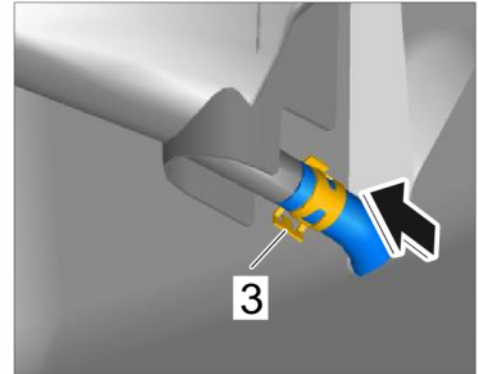
*Pushing on drain hose*

- 11 Fasten spring band clamp ⇒ *Pushing on drain hose -3-* to the drain hose.
- 12 Install the cover under the dashboard. ⇒ *Workshop Manual '702219 Removing and installing cover under dashboard'*
- 13 Enter the campaign in the Warranty and Maintenance booklet.
