GROUP	MODEL
Subsequent Repair Action	2017-2018MY Optima P/HEV (JF P/HEV) w/Nu 2.0L GDI
NUMBER	DATE
SC218YZ	September 2023

ENGINE REPLACEMENT INSTRUCTIONS FOR DTC P1326 (SC218YZ)

This bulletin provides information related to the Technical Service Bulletin previously published (SC218) titled "Engine Inspection/Replacement and KSDS S/W Installation". Specifically, this bulletin provides instructions on which procedures to follow if, after installation of the KSDS, any one of the subject vehicles return to the dealer with Diagnostic Trouble Code (DTC) P1326 (Knock Signal Range/Performance).

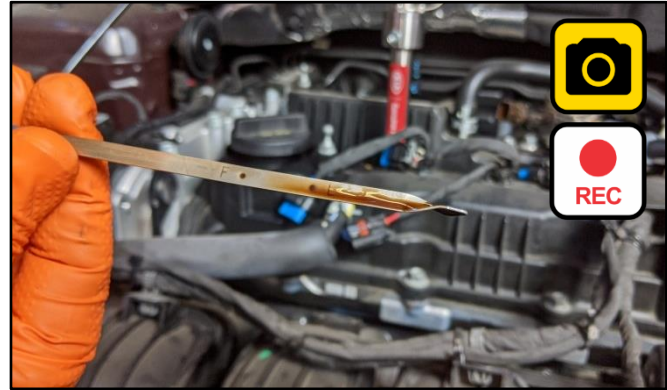
1. Start video showing vehicle and move in towards the dash VIN tag.
2. Measure and record oil dip stick level.
3. Note oil dip stick reading on the RO.
4. Take a picture of the oil reading on dipstick.
5. Inspect the inner/bottom of the oil cap and inside oil filler opening.

Record/Note findings: Oil sludge, varnish, burnt oil smell condition(s) found.

If oil lacquering, oil sludge or oil varnish is present, then the engine is therefore suspect to maintenance neglect. Review of the vehicle's maintenance history is required.

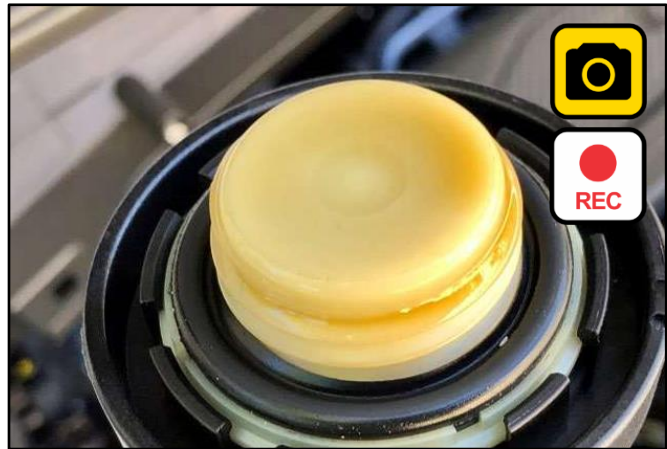
6. Inspect the inner/bottom of the oil cap and inside oil filler opening.

Record/Note findings: Oil sludge, varnish, burnt oil smell condition(s) found.

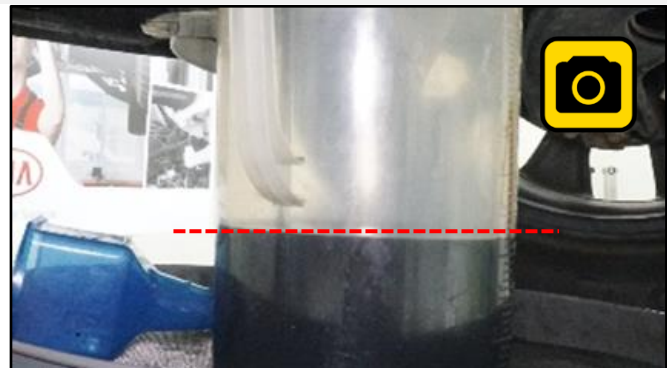
1. Remove oil filler cap, remove oil drain plug and drain oil into the supplied measuring container SST067BUCK and check oil level.
2. Record oil level reading on the RO.
3. Take photo of the drained oil container using KDS and attach to warranty claim PWA request.

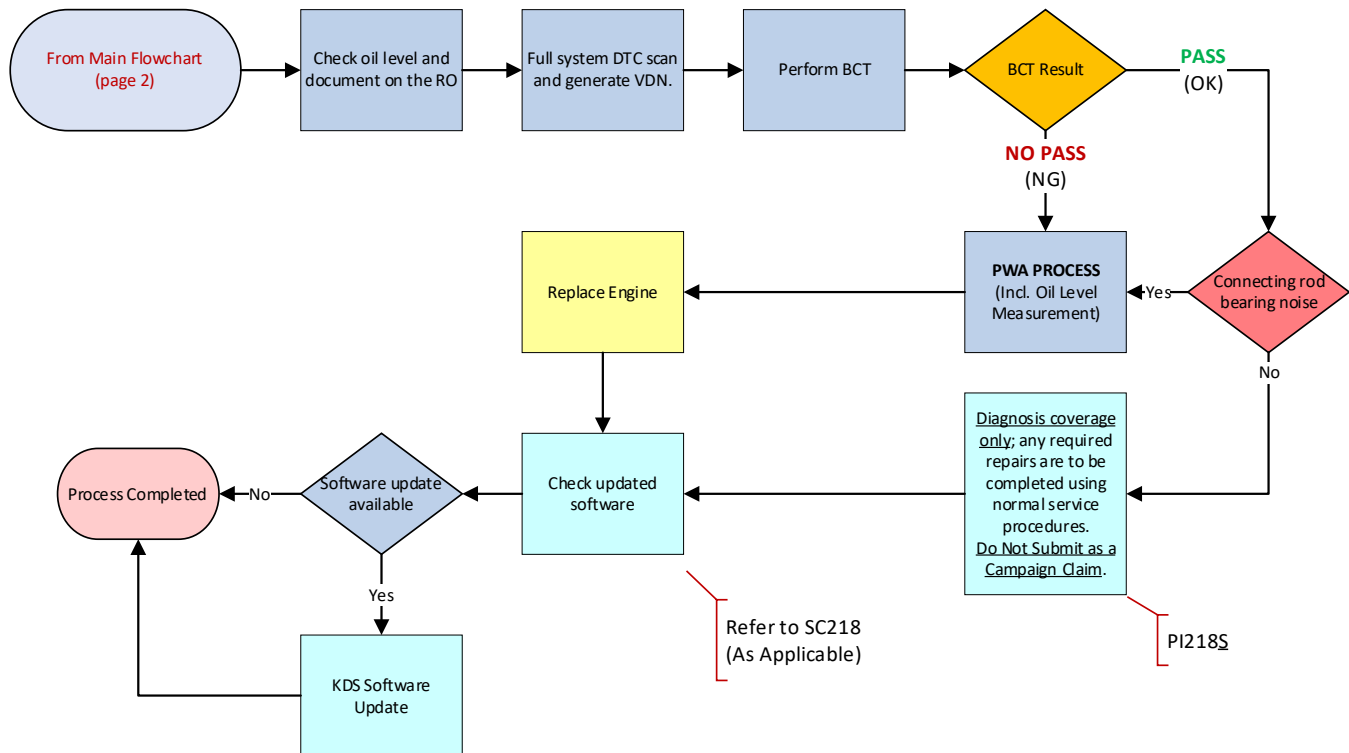
B. ENGINE NOISE

Techline PWA Required; Diagnosis only Campaign Possible

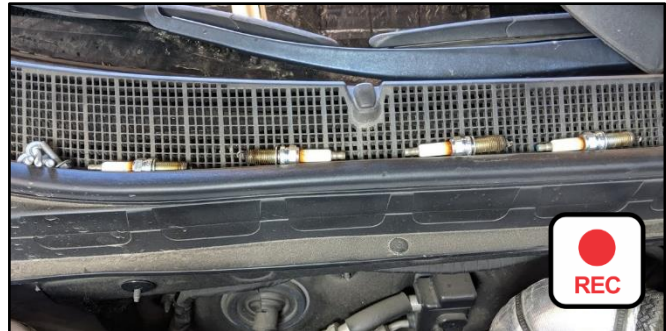
2. Show the removed spark plugs.

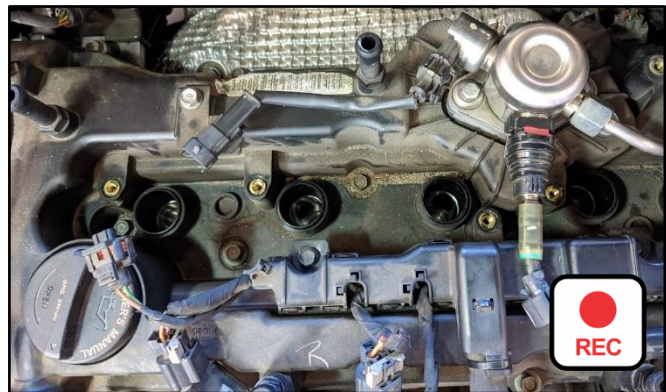
3. Show the empty spark plug holes from the engine.

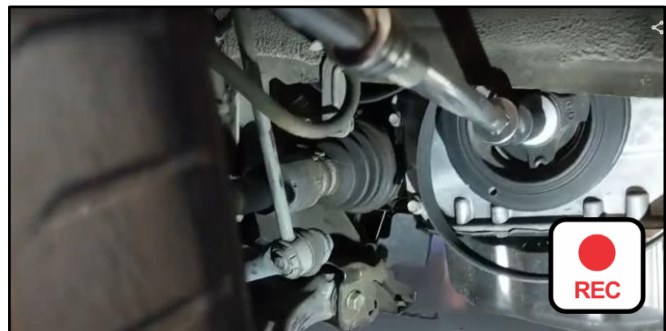
5. Show the removed drive belt and attached torque wrench to crank bolt.

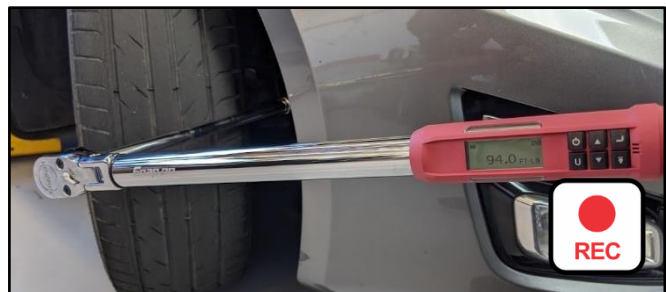
6. Show the engine being cranked and torque specification exceeding 94 lb.ft. torque.

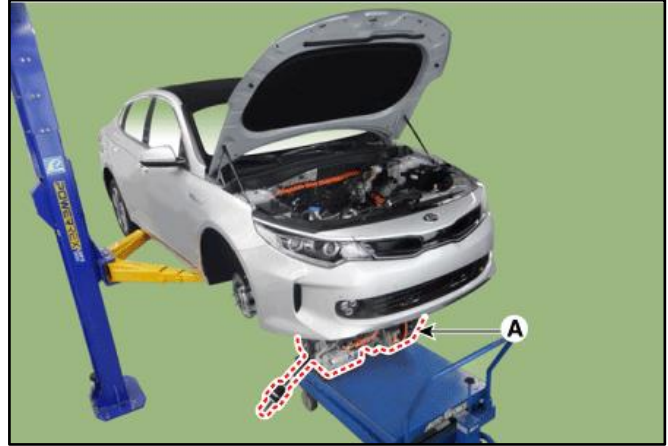
1. Replace the engine assembly by referring to the "Engine Mechanical System → Engine And Transaxle Assembly → Engine And Transaxle Assembly → Repair Procedures" chapter in the applicable Shop Manual on KGIS.
