Technical Service Bulletin

46 Brake noise analysis and handling

46 23 48 2034181/24 September 14, 2023. Supersedes Technical Service Bulletin Group 46 number 23-41 dated February 7, 2023, for reasons listed below.

Model(s)	Year	VIN Range	Vehicle-Specific Equipment
All Audi Vehicles	2015 – 2025	All	Not Applicable

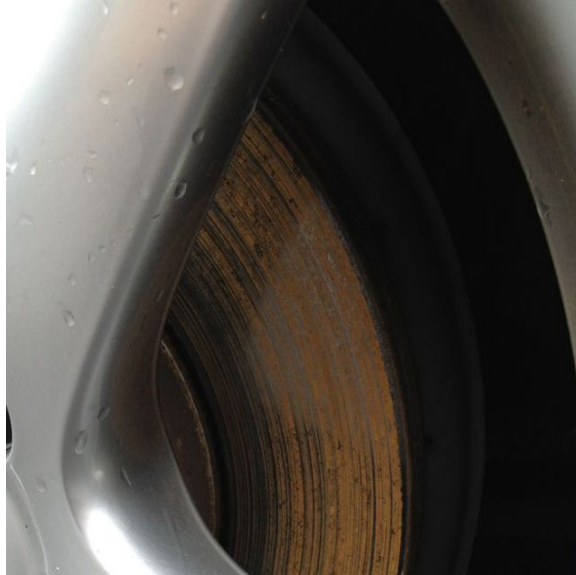
- Discs are covered with rust. Rust can form when the vehicle has not been driven for a long period of time (Figure 1).

Figure 1. Disc covered with rust.

1. **Check the overall condition of the brakes** to determine if the brake noise is caused by one of the causes listed in the *Technical Background* section of this bulletin. If the noise is not a result of one of these causes, proceed with the following steps 2-4.
2. **Determine the location of the brake noise** (e.g., left front, front axle, rear axle, etc.):
 - Knowing the location of the noise on the vehicle is critical to properly addressing the concern.
 - It may be necessary to have an assistant listening from inside or outside of the vehicle to accurately determine the location.
3. **Obtain a sound or video recording and fill out the questionnaire:**

4. Clean the brake pads and discs:

A) With careful consideration of the traffic situation, perform up to 5 ABS stops from speeds above 50 mph. Between each ABS stop, allow the brake components to cool by driving the vehicle for more than one minute at speeds greater than 50 mph.

B) Let the vehicle sit for two hours to cool down.

C) Manually clean all the brake components. Remove all brake dust from components (springs, retaining clips, pistons, caliper, pins, etc.).

Clean all contact points between pads/clips/caliper and add the correct lubrication paste to the contact areas (review ELSA for the correct paste for each application).

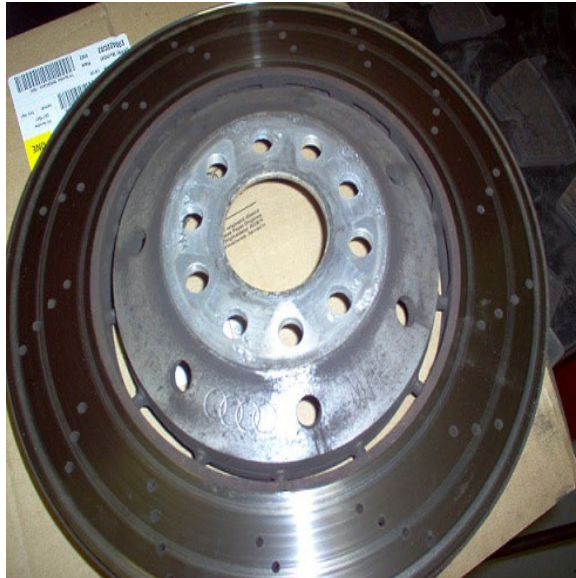
- Discs are grooved (Figure 2).

Figure 2. Grooved disc.

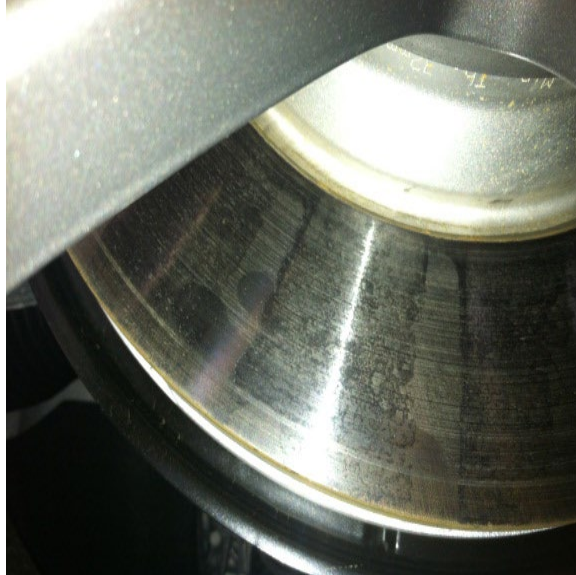
7. There is chemical contamination on the braking surface of the brake disc due to wheel or tire cleaner being sprayed directly onto the brake disc (Figure 3 and Figure 4).

Figure 3. *Discoloration on the brake disc due to chemical contamination from the cleaner that was sprayed directly onto the disc.*

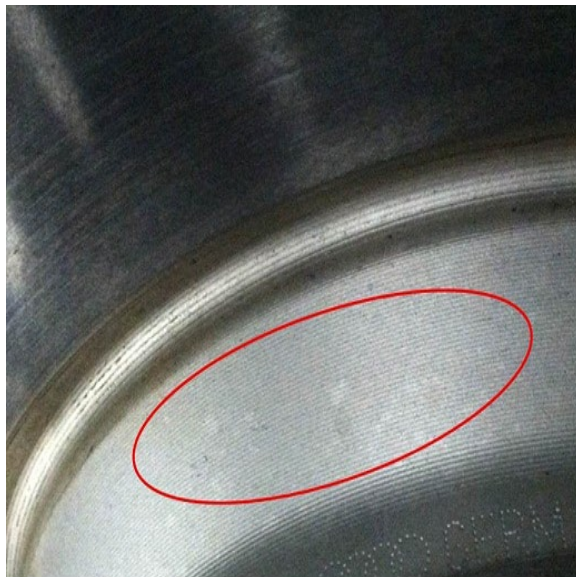
Figure 4. *Small spots and discoloration due to chemical contamination from the cleaner that was sprayed directly onto the disc.*

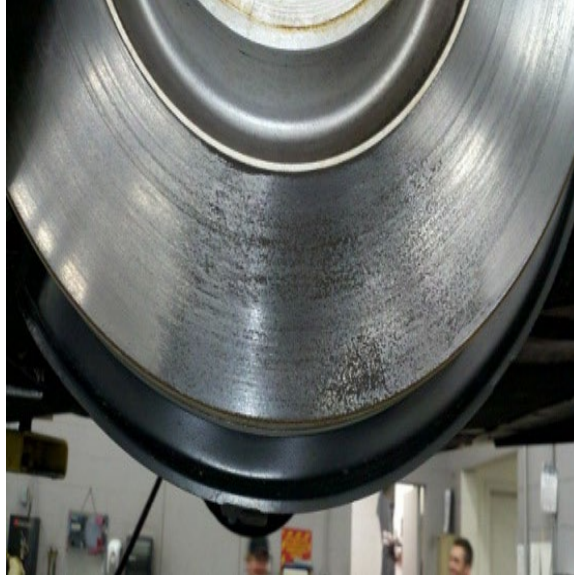
8. There are “pad marks” on the brake disc as a result of brake pad material transferring to the discs (Figure 5). Pad marks can occur when a vehicle has been parked for long periods of time in a wet or snowy environment.

Figure 5. Brake pad material has transferred to the discs.

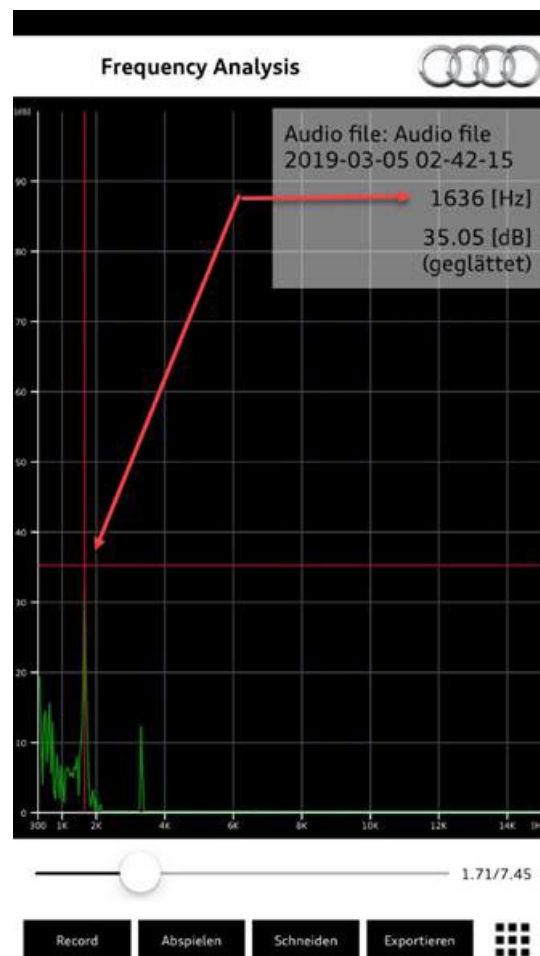
- Completed Brakes Acoustic Questionnaire.
- Sound or video recording (sound recording preferred from Audi frequency app, see TSB 2051095: *Audi frequency analysis*).
- Frequency analysis (screenshot preferred showing peak frequency, see figure 6).

Figure 6. Example of a frequency analysis screenshot.

- A) 1.6 KHz from front brakes. Inspect front pads.
- B) 3.2 KHz/11 KHz from front brakes. Inspect front discs and pads.

- A) 1.6 KHz to 1.7 KHz from front brakes. Inspect front discs.
- B) 3.2 KHz from front brakes. Inspect and if needed, suggest to clean and lube the guide pins in the caliper carrier using anti-seize paste G052560A2.
- C) 7.8 KHz from front brakes. Inspect front pads.

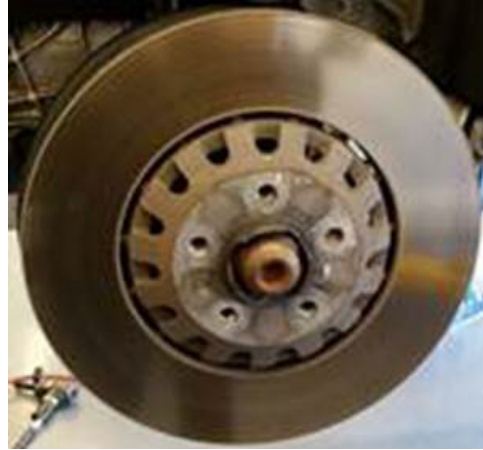
- Photos of the affected brake discs and pads that clearly show the condition of the braking surface (see Figures 7 through 11).
-

Figure 7. Example of the whole disc.

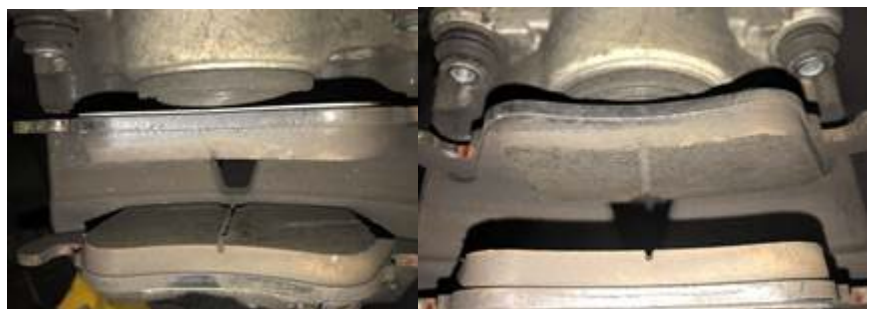
Figure 9 and 10. Example of Inner and outer with an adhesive pad.

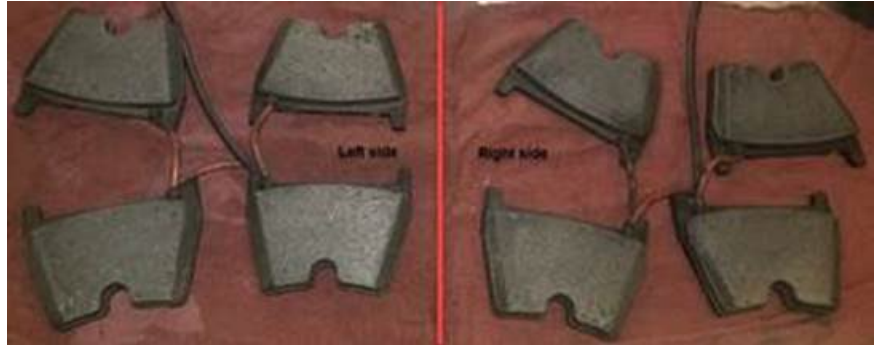
Figure 11. Example of pads without adhesive (mark position for reinstallation if not replaced).

**Note:** Do not alter the brake pads when performing the cleaning procedure.
