# VW Elsa Newsletter

Edition 70: January 27, 2014

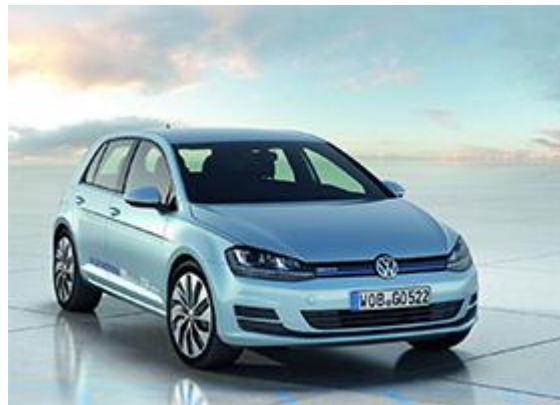
For vehicles with HID headlights, the headlight range can be manually adjusted to the vehicle loading condition once the low beams are switched on (Figure 1, adjustment knob 2). This feature helps ensure proper aiming of the vehicle headlights.
