### 87 Rattle and / or knocking noises from the engine compartment

87 23 56 2071621/1 October 5, 2023.

Model(s)	Year	VIN Range	Vehicle-Specific Equipment
RS 3	2022 – 2024	All	Not Applicable

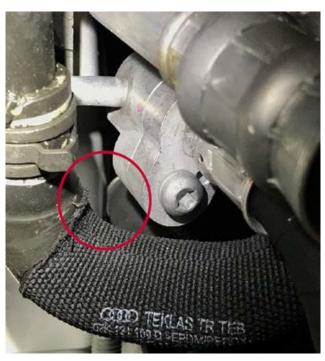
A refrigerant line may be in contact with the right front longitudinal member.

2. Contact between the refrigerant line and the longitudinal member is identifiable visually.

*Figure 2.* Refrigerant line in contact with longitudinal member.

4. Create at least a 1.5 cm gap between the refrigerant line and the longitudinal member. It should be possible to move the line away from the longitudinal member by carefully bending it slightly. If necessary, secure the line with a tie wrap.

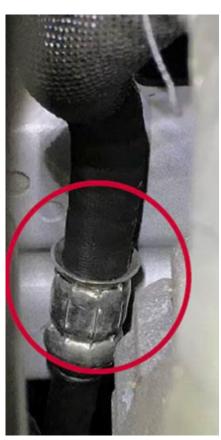
3. Figure 3 shows this contact at a different angle.

**Figure 3.** Alternative view of refrigerant line contact with longitudinal member.
