## Technical product information

<b>Topic</b>	Rotating display/screen noise - Diagnosis for complaints relating to noise during operation and/or during a drive cycle
<b>Market area</b>	Australia E04 Bentley rest Asia and Australia (6E04),China 723 Volkswagen (Anhui) Automotive CO (6723),China 796 VW Import Comp. Ltd (Vico), Beijing (6796),Germany E02 Bentley rest Europe (6E02),Japan E03 Bentley Japan (6E03),Korea, (South) E08 Bentley South Korea (6E08),United Arab Emirates E06 Bentley Middle East and Africa (6E06),United Kingdom E01 Bentley UK (6E01),United States E05 Bentley USA and rest America (6E05)
<b>Brand</b>	Bentley
<b>Transaction No.</b>	2065895/3
<b>Level</b>	EH
<b>Status</b>	Approval
<b>Release date</b>

Rotating display/screen noise - Diagnosis for complaints relating to noise during operation and/or during a drive cycle

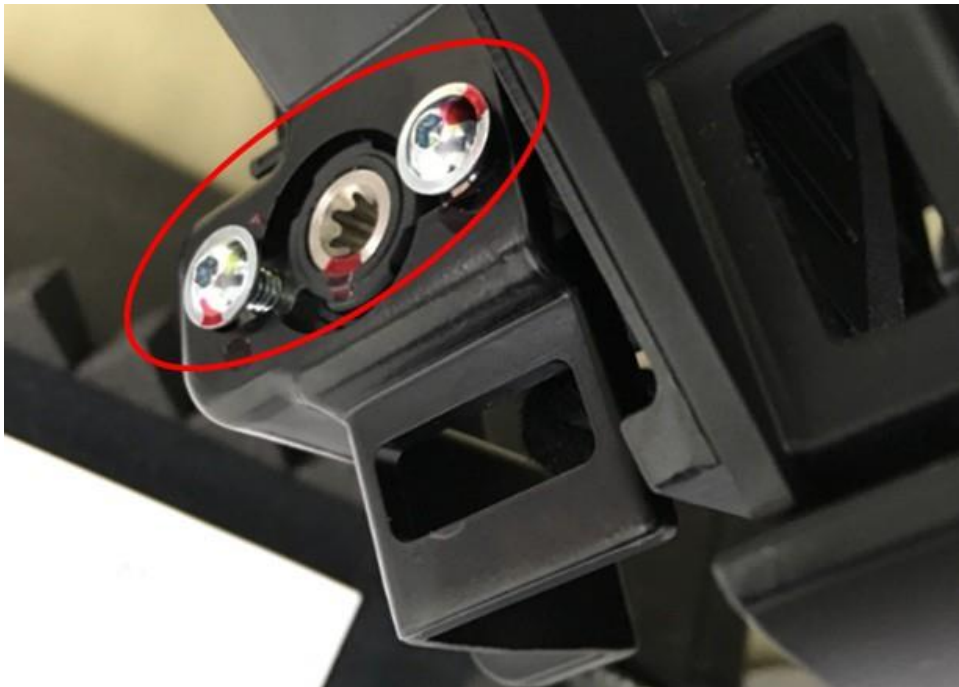
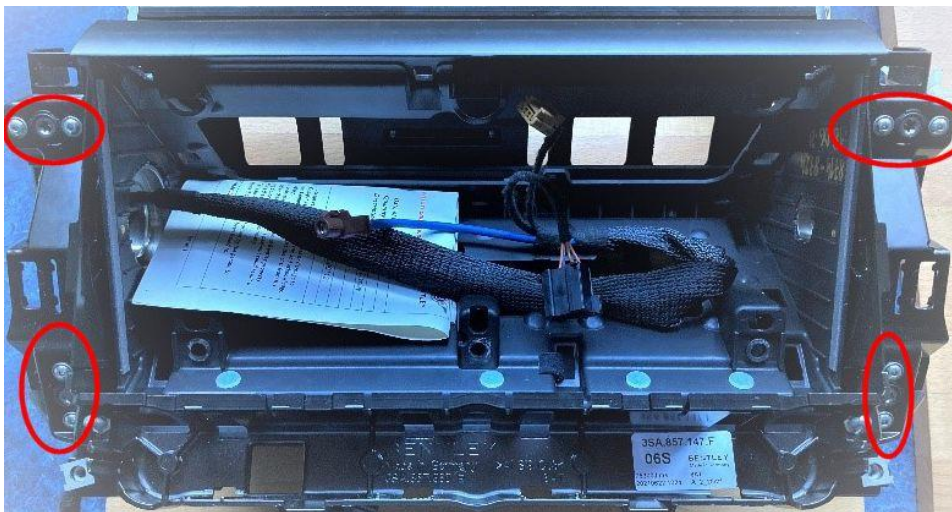
Figure 2

- Refer to Rep.Gr 91 - Remove the rotating display
- Referring to Figures 2 and 3 - Check and if necessary tighten the fixing screws highlighted (3Nm), there are 8 fixing screws in total.

- Referring to Rep.Gr 91 - Refit the rotating display and retest.

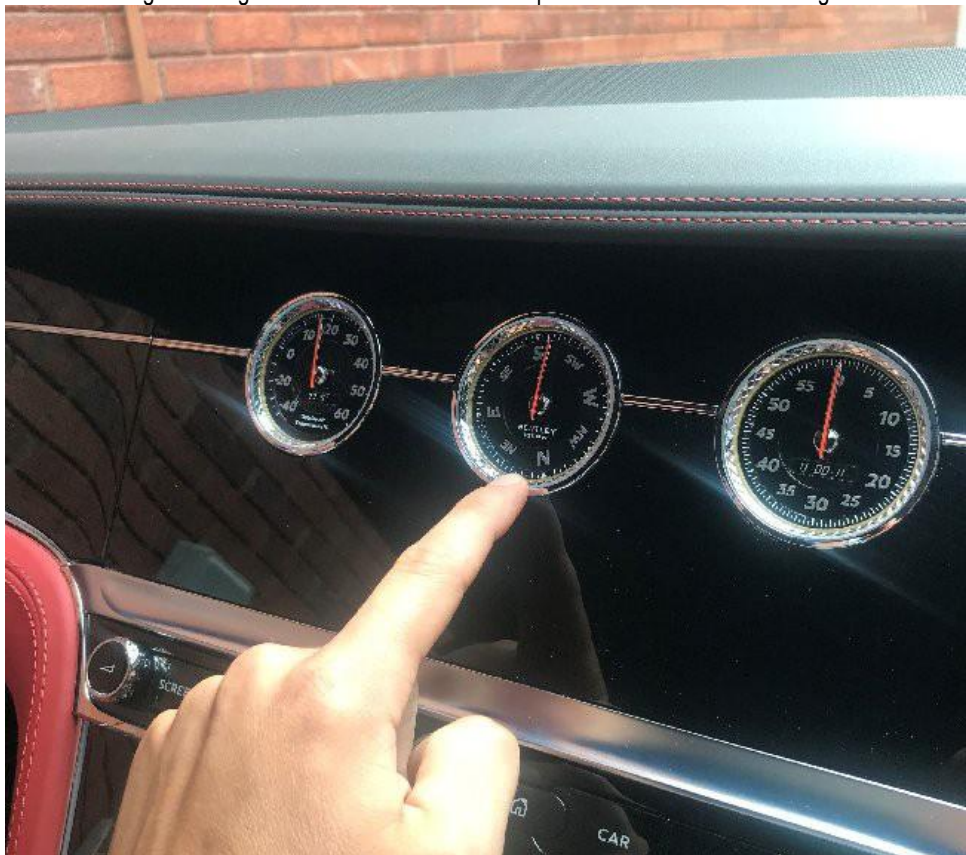
Figure 4

When noise is evident from the dials, press on outer bezels (Figure 4) If the noise disappears when the bezels of the dials are pressed - Referring to Gr.91 - Replace the applicable dial(s)

In the event a graunching noise is evident from the compass when the vehicle is being driven - Referring to Gr.91 - Replace the compass

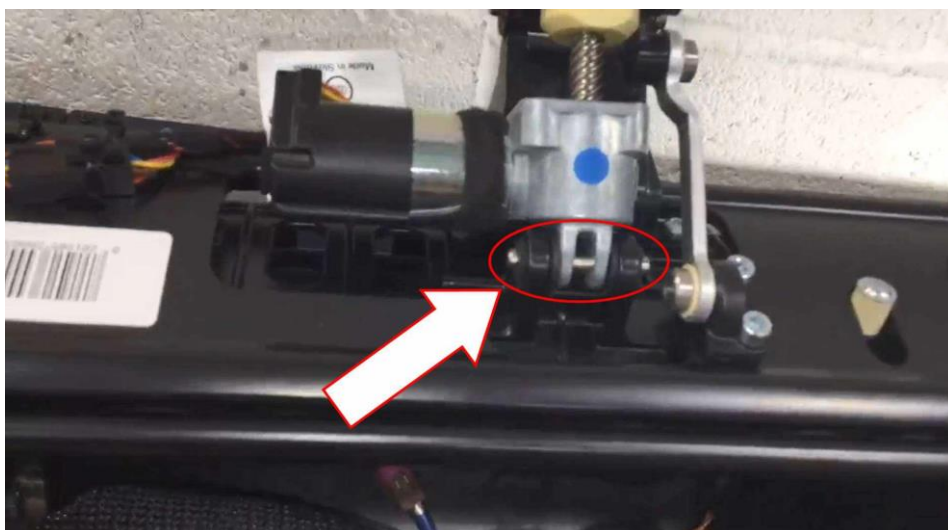
Figure 5

TIP: This symptom can in some cases be evident due to excessive movement within the rotating display motor pivot assembly (Figure 5)

- The operative should consider the motor pivot assembly

NOTE: To check the motor pivot assembly for excessive movement the rotating display should be removed – Refer to Rep.Gr 91

- Should the movement be as shown in the video, the rotating display unit should be replaced
