Technical Service Bulletin

GROUP CAMPAIGN	NUMBER 23-01-003G-1
DATE OCTOBER, 2023	MODEL(S) G70 (IK) G80 (RG3) GV70 (JK1) GV80 (JX1)

SUBJECT: TORQUE CONVERTER REPLACEMENT
(SERVICE CAMPAIGN T27G)

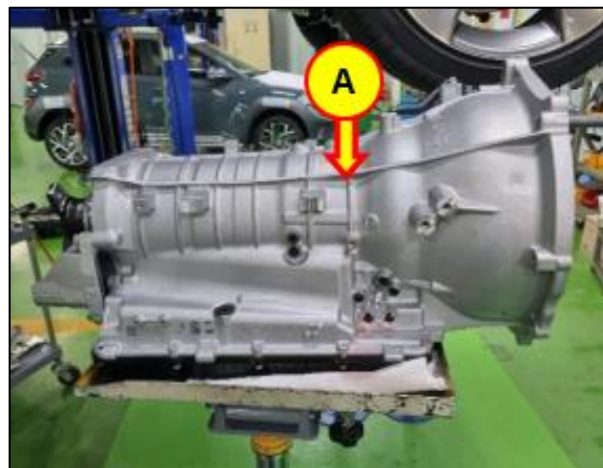
2. Remove the transmission (A).
Refer to the applicable shop manual, **Automatic Transmission System > Automatic Transmission System > Automatic Transmission > Repair procedures.**

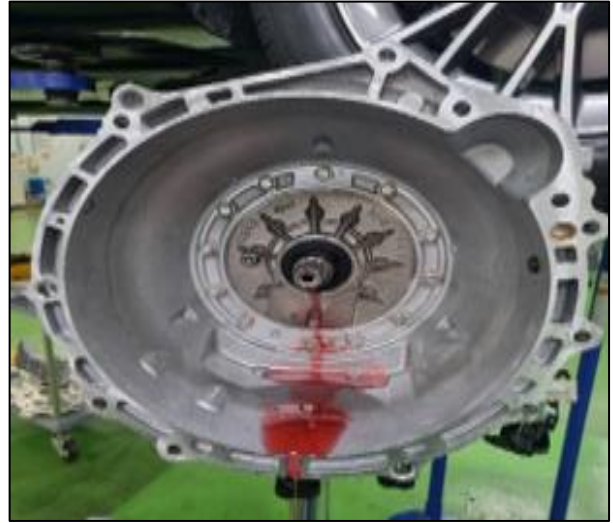
4. Lay the removed torque converter on a bench.
Use a paper towel or shop rag to wipe off the residual ATF.

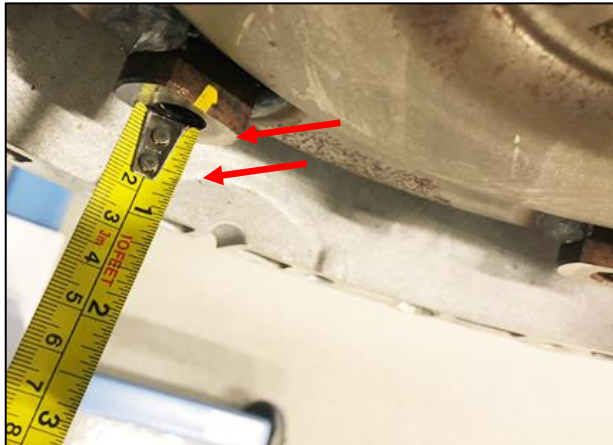
6. Continue to pull up on one of the bolts and rotate the torque converter in both directions while pushing inward on the boss until the torque converter is fully installed in the converter housing to the specified depth.

The depth is measured from the bolt hole on the lug to the edge of the transmission case.

Specification: Approximately 1.0 inch (26.4mm)

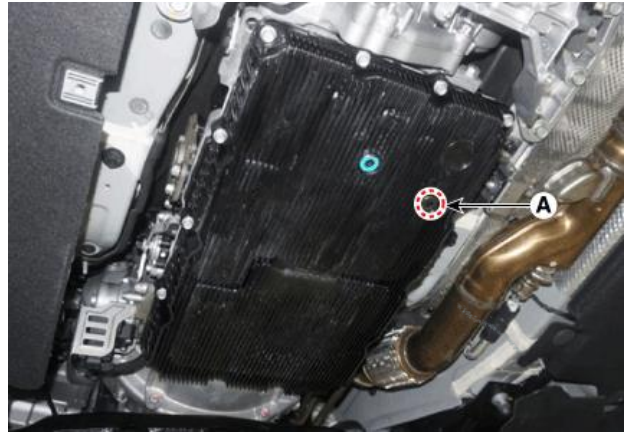
10. Remove the oil level check plug (A).

Use a fluid pump or suction gun to add **SP-IV-RR** ATF through the fill plug until ATF flows from the oil level check plug (A).

Reinstall the oil level check plug (A).

Reinstall the fill plug.

Use only **SP-IV-RR** ATF, P/N **00232-19052**.
