Technical product information

Topic	Electronic Parking Brake (EPB) functionality issues
Market area	Australia E04 Bentley rest Asia and Australia (6E04),China 723 Volkswagen (Anhui) Automotive CO (6723),China 796 VW Import Comp. Ltd (Vico), Beijing (6796),Germany E02 Bentley rest Europe (6E02),Japan E03 Bentley Japan (6E03),Korea, (South) E08 Bentley South Korea (6E08),United Arab Emirates E06 Bentley Middle East and Africa (6E06),United Kingdom E01 Bentley UK (6E01),United States E05 Bentley USA and rest America (6E05)
Brand	Bentley
Transaction No.	2062184/8
Level	EH
Status	Released for publishing
Release date	03-Oct-2023

New Continental GT/GTC and New Flying Spur

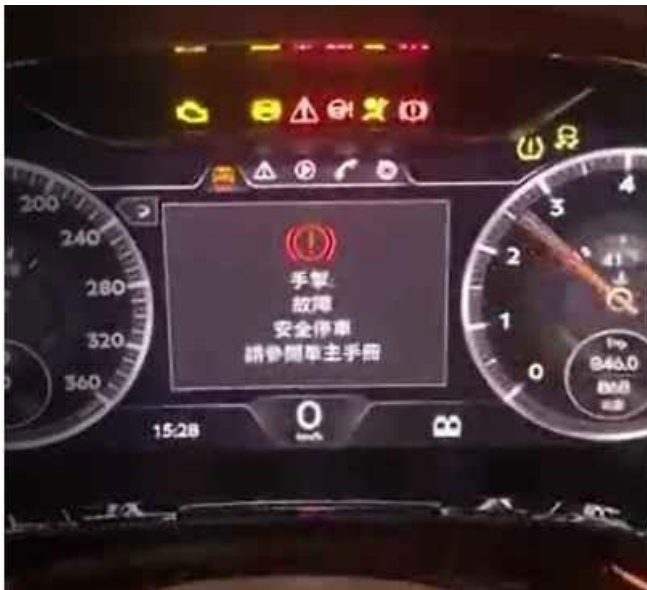
Figure 1

- Electronic Parking Brake (EPB) found not operating to specification
- EPB may not hold the car effectively
- Parking brake components showing signs of wear
- Parking brake warning light may also be evident within the DIP (See example shown in Figure 1)

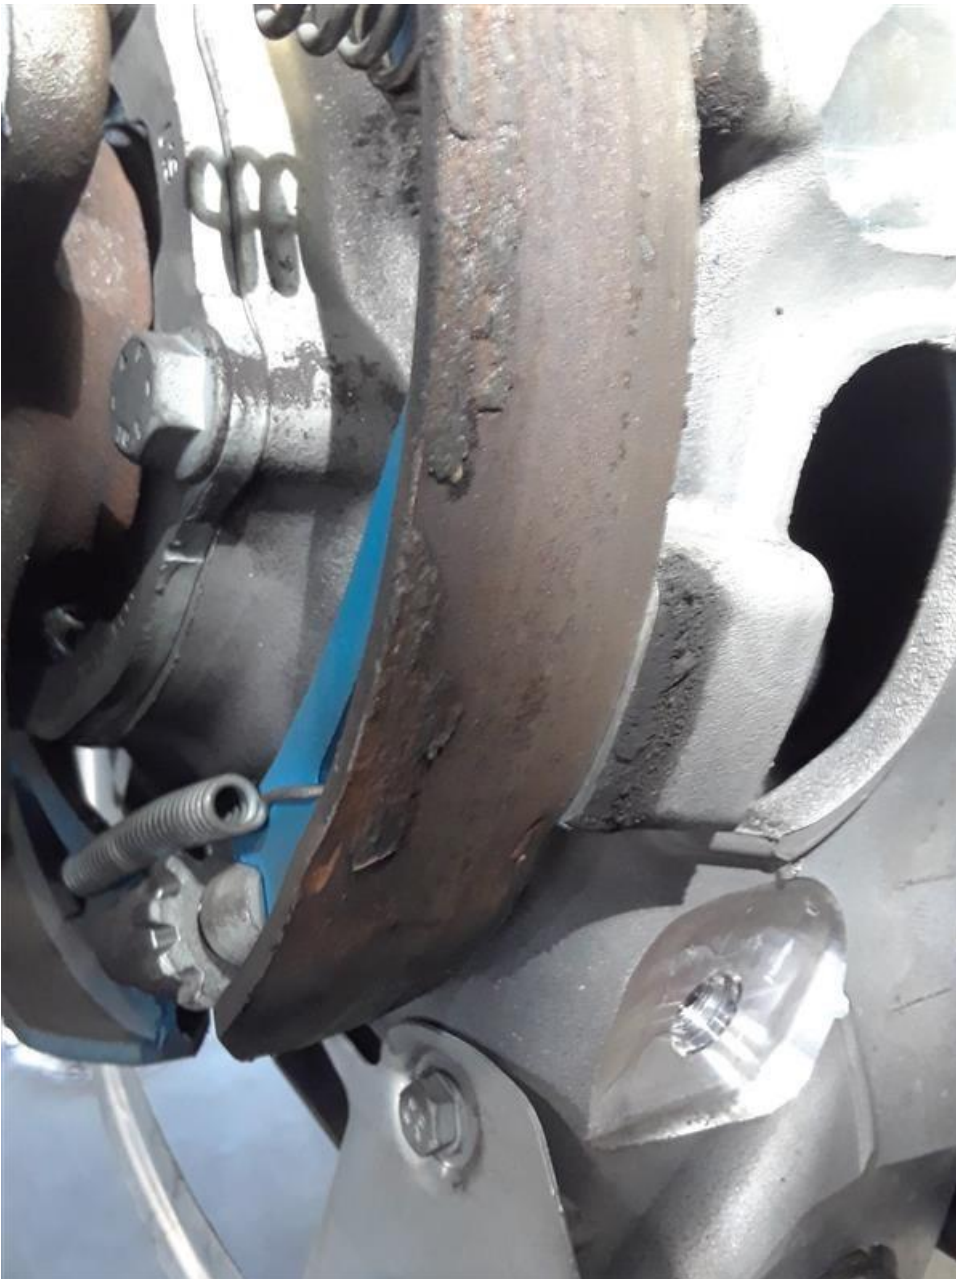
- Right and left hand (EPB) Actuators
- Right and left hand rear brake shoes (EPB) - See example shown in Figure 2

1) Carry out a full inspection of the (Electronic Parking Brake EPB) system including the following components:

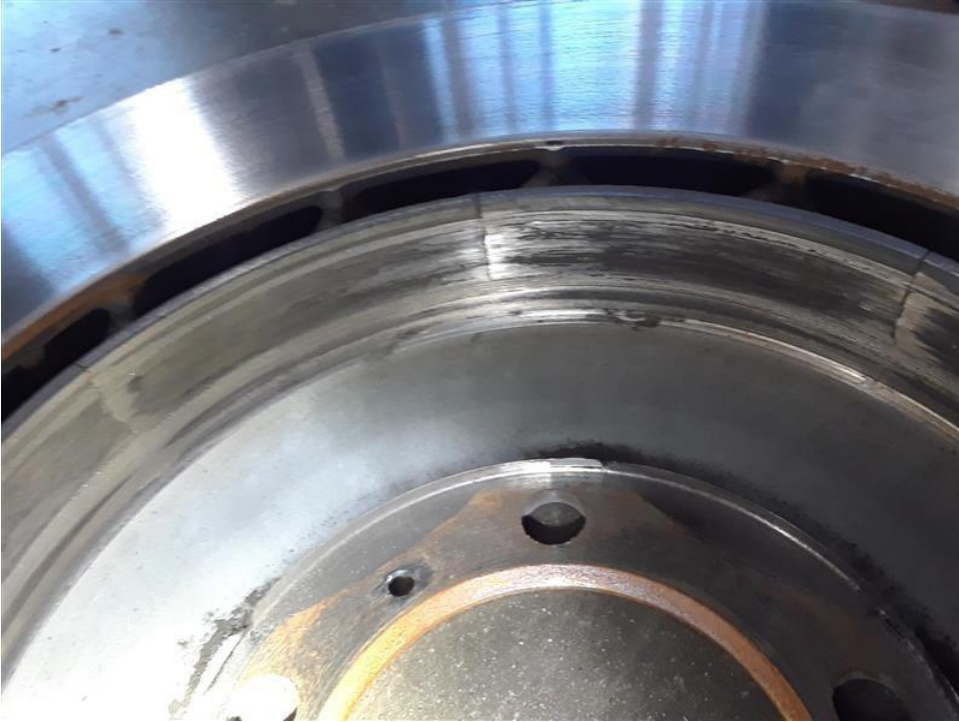
- Right and left hand rear brake discs - See example shown in Figure 3
