Technical Service Bulletin

GROUP	NUMBER
DRIVESHAFT AND AXLE	23-DS-003G
DATE	MODEL(S)
NOVEMBER 2023	GV60 (JW1) GV70 (JK1) GV70 (JK1A) GV80 (JX1)

SUBJECT:	E-LSD ACTUATOR DIAGNOSIS AND REPLACEMENT
-----------------	--

This TSB supersedes 23-DS-001G-1 to add GV60 (JW1) and GV70 (JK1A), expand the applicable vehicles production dates, and include updated actuator dates.

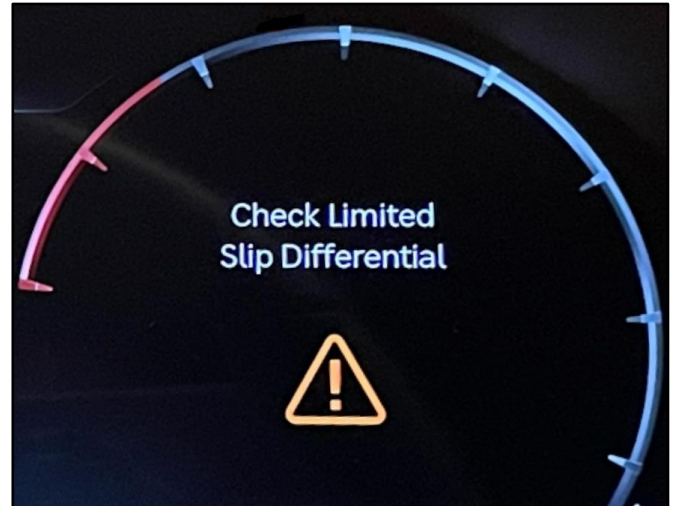
1. Confirm E-LSD warning message, "Check Limited Slip Differential" is displayed in the cluster.

If any of the following DTCs are present, P188213, P188900, or P189600, continue with E-LSD actuator replacement.

If other DTCs are present, follow the shop manual for repairs.

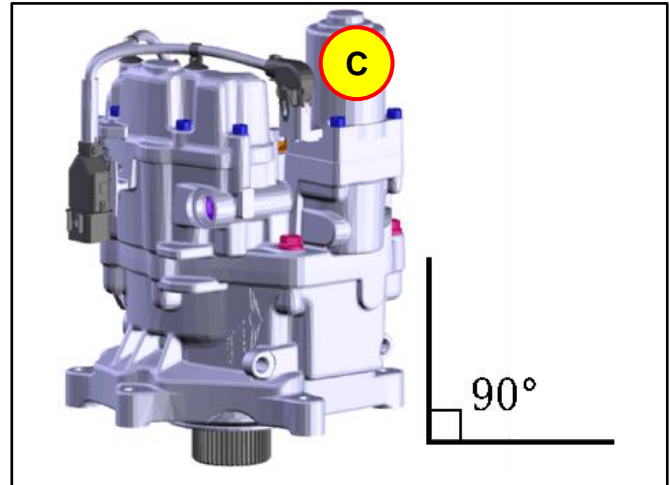
3. **GV60**

Place the E-LSD onto a work bench.

Rotate the E-LSD to point the actuator (C) at a 90-degree angle.

During removal and installation of the actuator, maintain the E-LSD at a 90-degree angle to not spill fluid. Low fluid levels may damage the E-LSD.

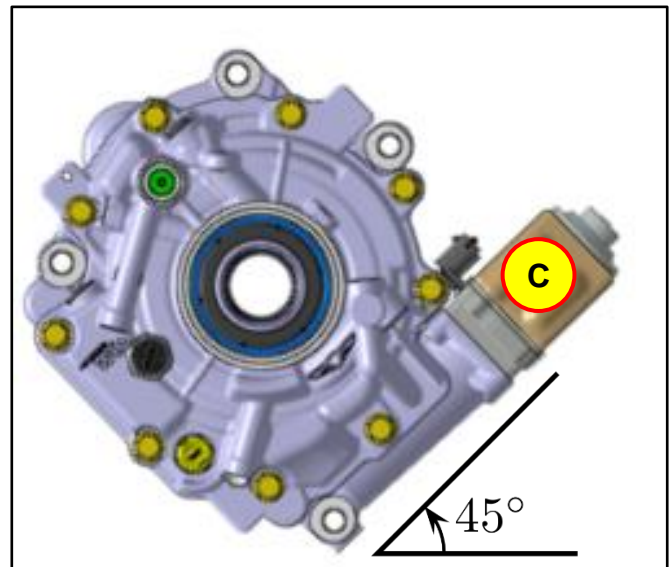
GV70 and GV80

Place the E-LSD onto a work bench.

Rotate the E-LSD to point the actuator (C) at a 45-degree angle.

During removal and installation of the actuator, maintain the E-LSD at a 45-degree angle to not spill fluid. Low fluid levels may damage the E-LSD.

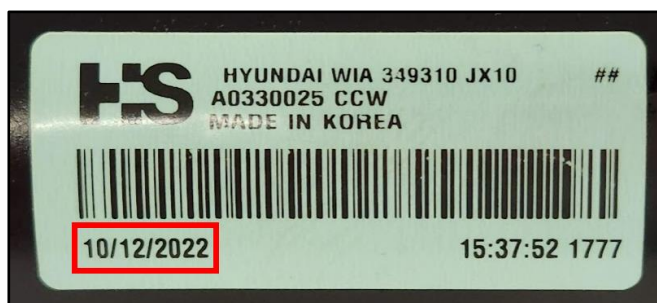
- Confirm date on the new actuator label.

GV60 (JW1): 06/01/2023 or after

GV70 (JK1) and GV80 (JX1): 05/31/2023 or after
