Glass Sunroof does not Open: Observe Specified Procedure (125/22)

Model Line: **Macan (95B)**

Equipment: **Large roof system (M No. 3FU)**

Concerns: **Glass sunroof**

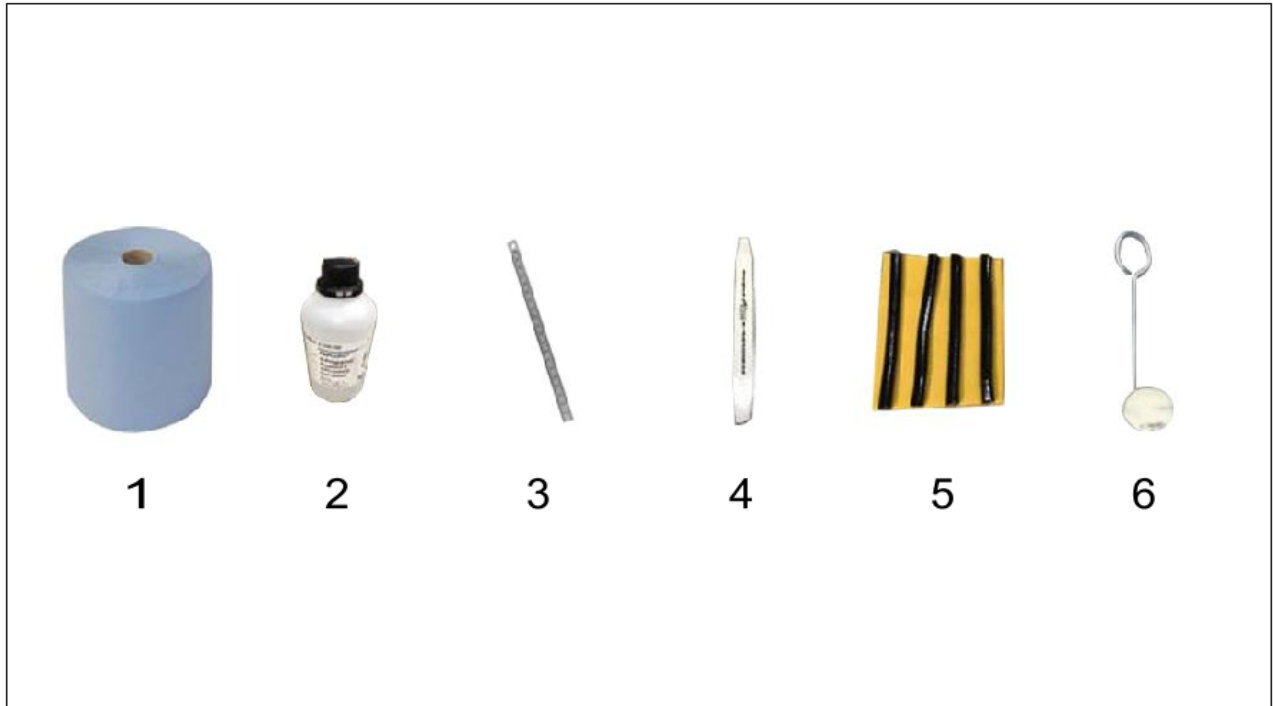
Required tools and materials

- 1 – Standard workshop paper towels
- 2 – Cleaning solution
- 3 – Steel bar
- 4 – Spacer wedge
- 5 – Butyl cord
- 6 – Primer applicator

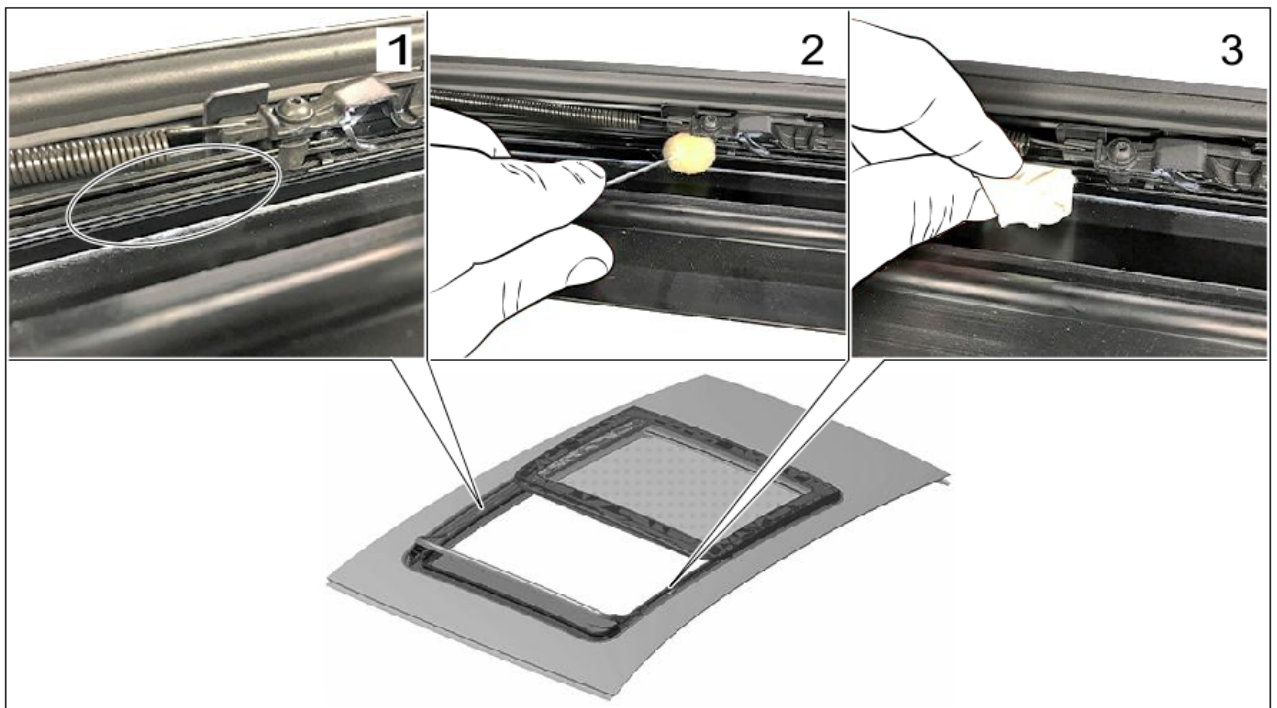
Cleaning areas

- 2.2.1 Pre-clean the marked area ⇒ *Cleaning areas -1-* of dust, stains, drops of fluid and other visible dirt.
- 2.2.2 Clean the ducts on the guide rails using cleaning solution and primer applicator or standard workshop paper towels ⇒ *Cleaning areas -2-*.

- 2.2.3 Dry the ducts on the guide rails using workshop-available paper towels ⇒ *Cleaning areas -3-*.
- 2.3 Install butyl lock ⇒ *Butyl lock -4-*.
 - 2.3.1 Cut two pieces of 20 mm of butyl cord.
 - 2.3.2 Press the first 20 mm of butyl cord into the guide rail channel completely using a plastic wedge.

- 2.1 Open the glass sunroof.
- 2.2 Clean ducts on the guide rails.

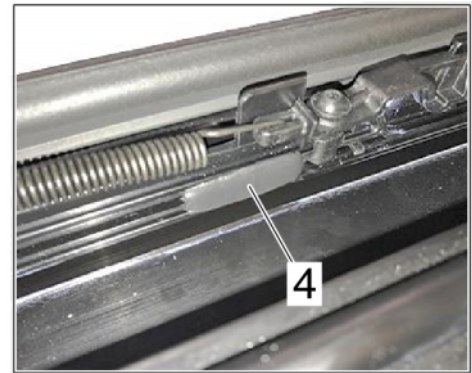
Butyl lock

- 2.3.3 Affix a second piece of 20 mm butyl cord over the top.

Make sure that the butyl cord is attached, pressed on and affixed without gaps at the designated position. Defects between the butyl cord and the component or between the layers from several butyl cords can cause consequential faults. The repair may have to be repeated.

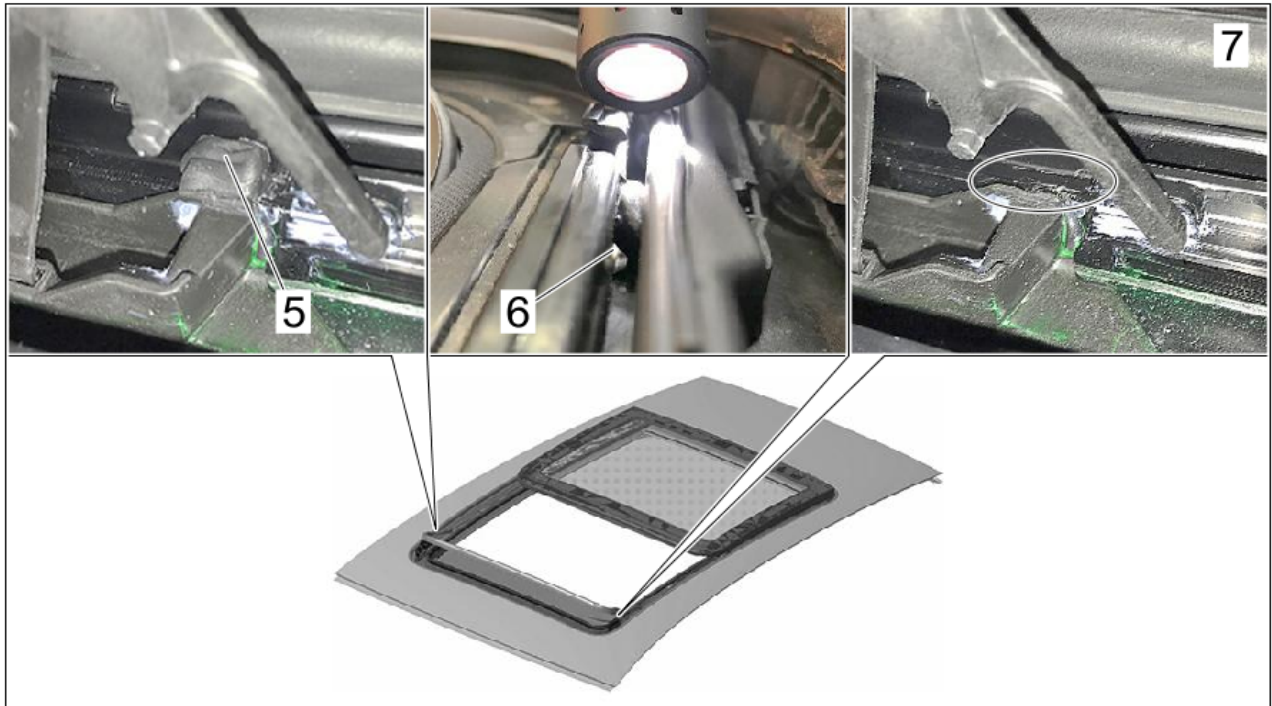
Front butyl locks

- 3 Check front butyl lock ⇒ *Front butyl locks -5-* for leaks as described below and replace it if necessary.

- 3.1 To check for leaks, illuminate the front butyl lock ⇒ *Front butyl locks -5-* from the front using a commercially available electric torch.
 If there are **no** imperfections in the front butyl lock, ⇒ *Front butyl locks -5-* continue with Step 4.
 In the event of visible defects, remove the ⇒ *Front butyl locks -6-* front butyl lock ⇒ *Front butyl locks -5-* completely ⇒ *Front butyl locks -7-* and replace it as described below.

- 3.1.1 Thoroughly clean the butyl lock area ⇒ *Front butyl locks -7-* using cleaning solution and primer applicator or standard workshop paper towel and dry it with a standard workshop paper towel ⇒ *Front butyl lock area -8-*.

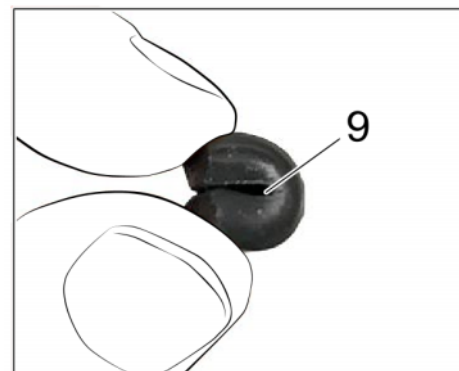
Bending butyl cord

3.1.2 Cut 20-mm butyl cord to size, bend it 180° in the middle ⇒ *Bending butyl cord-9-* and press it as a front butyl lock ⇒ *Front butyl locks-5-* into the guide rail channel to close it fully.

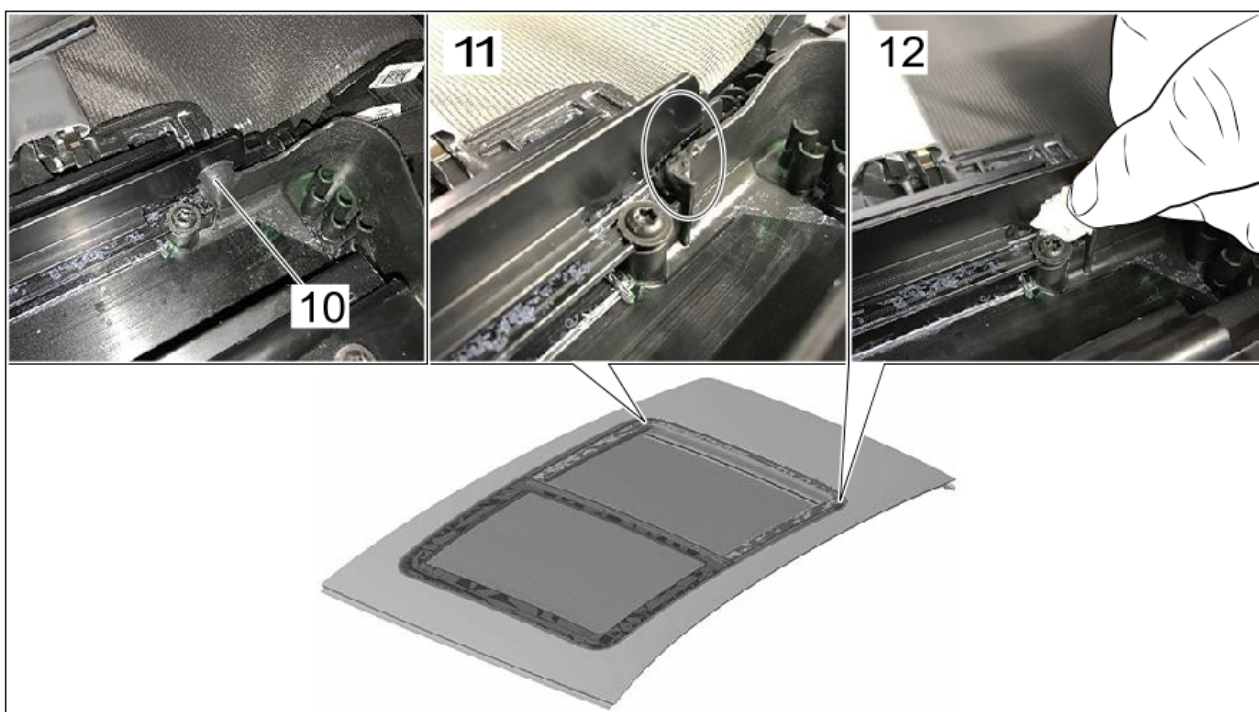
Rear butyl locks

4 Check rear butyl lock ⇒ *Rear butyl locks-10-* for leaks as described below and replace it if necessary.

4.2 To check for leaks, illuminate the rear butyl lock ⇒ *Rear butyl locks-10-* from the rear using a commercially available electric torch.

In the event of visible defects, remove the rear butyl lock ⇒ *Rear butyl locks-10-* completely ⇒ *Rear butyl locks-11-* and replace it as described below.

- 4.2.1 Thoroughly clean the butyl lock area ⇒ *Rear butyl locks -11-* using cleaning solution and primer applicator or standard workshop paper towel and dry it with a standard workshop paper towel ⇒ *Rear butyl locks -12-*.

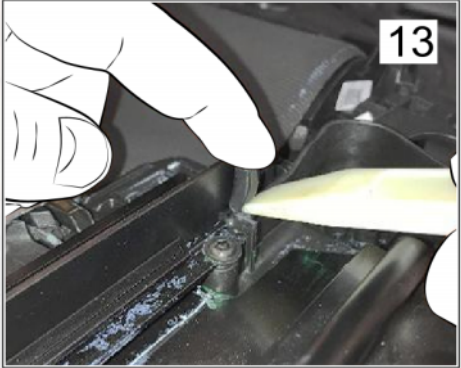
- 4.2.2 Cut 10-mm butyl cord and press it up into the duct in the butyl lock area first using a plastic wedge and close it completely ⇒ *Rear butyl cord -13-*.

- Rear butyl cord*
- 4.2.3 Fold the top end of the butyl cord down and reshape it by pressing on it to the rear ⇒ *Rear butyl lock -14-* of the butyl lock.

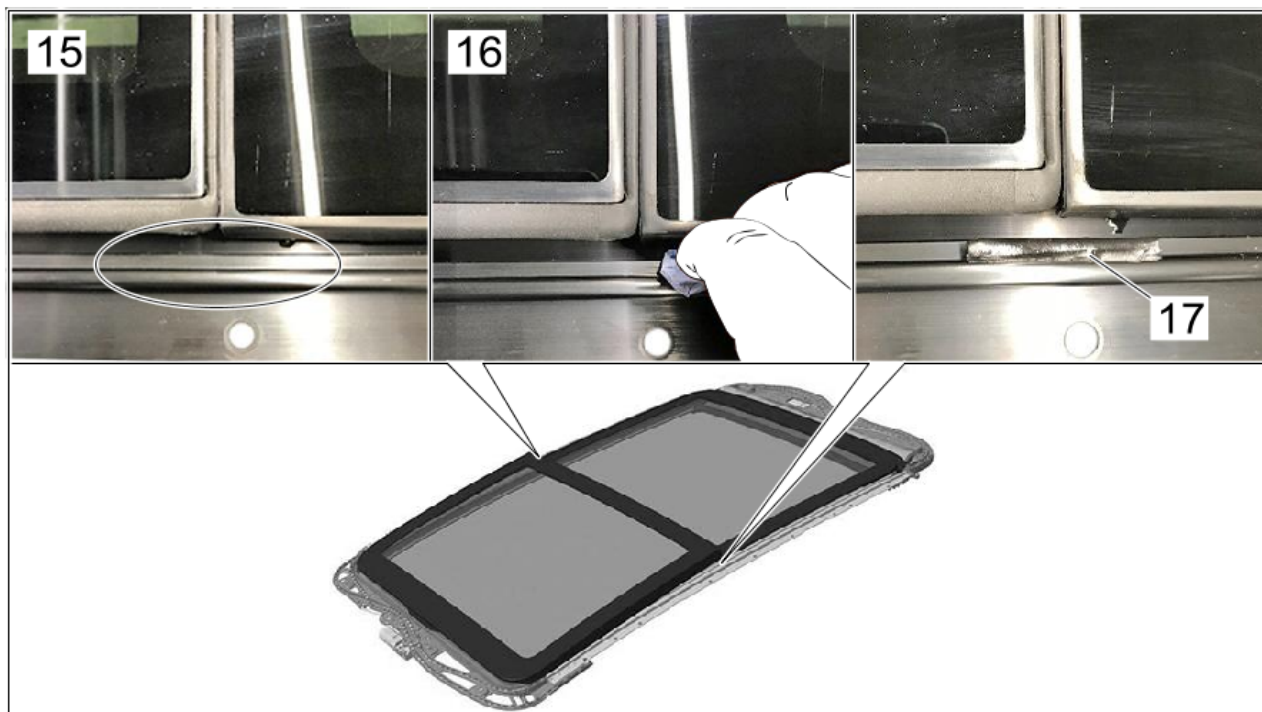
Butyl lock centered on roof assembly frame

- 5 Install additional butyl lock ⇒ *Butyl lock centered on roof assembly frame -17-* on the upper bar of the guide rail for the roof assembly frame at a center position between both glass panels ⇒ *Butyl lock centered on roof assembly frame -15-*.

- 5.1 Removing roof assembly (panoramic roof).
 Procedure:
 ⇒ *Workshop Manual '600619 Removing and installing roof assembly (panoramic roof)'*
- 5.2 Thoroughly clean the upper bar of the guide rail close to the butyl lock ⇒ *Butyl lock centered on roof assembly frame -15-* to be installed with cleaning solution and dry it with standard workshop paper towel ⇒ *Butyl lock centered on roof assembly frame -16-*.
- 5.3 Cut 60-mm butyl cord and affix it centrally between the two glass panels on the upper bar of the guide rail for the roof assembly frame ⇒ *Butyl lock centered on roof assembly frame -17-*.

Make sure that the butyl cord is attached, pressed on and affixed without gaps at the designated position. Defects between the butyl cord and the component or between the layers from several butyl cords can cause consequential faults. The repair may have to be repeated.

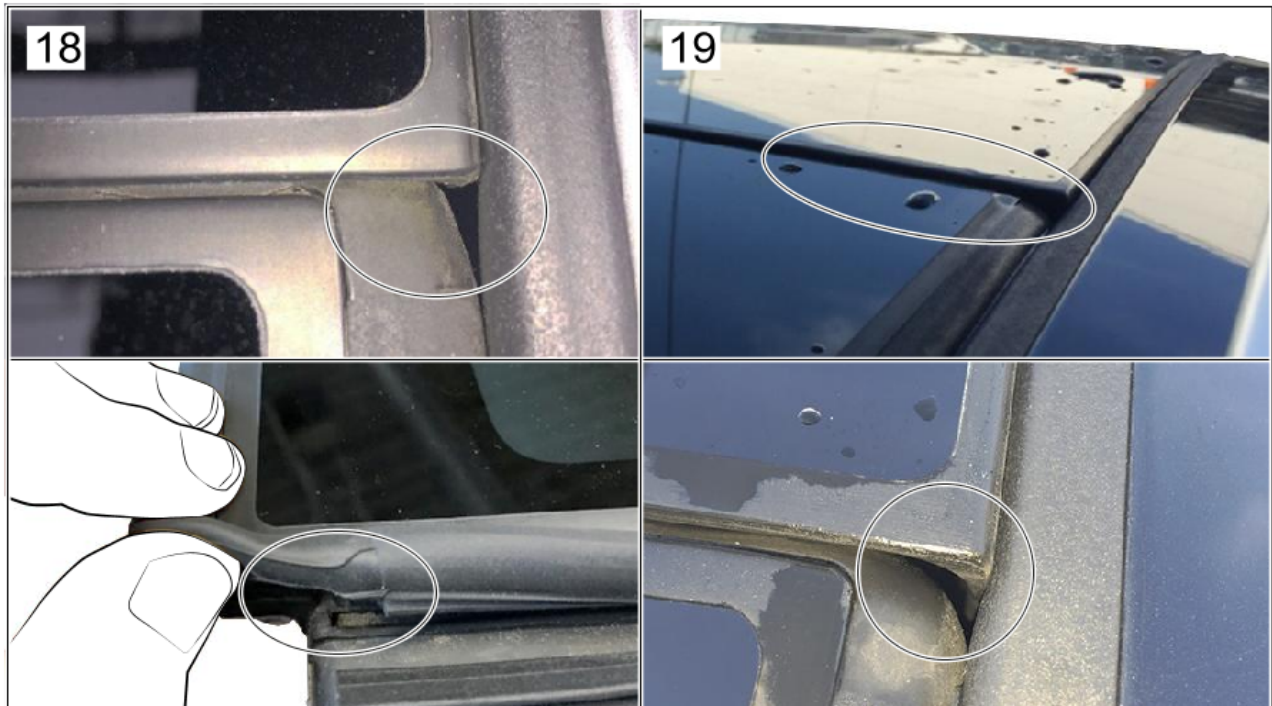
Gaps at seals on panoramic sunroof

Examples of gaps between the seals on the glass sunroof:

- Seal on glass panel not installed fully on bar ⇒ *Gaps at seals on panoramic sunroof-18-*
- Glass panel incorrectly installed ⇒ *Gaps at seals on panoramic sunroof-19-*

- 6.1 If there are **no** gaps: The work is finished.
If there are **gaps**:
- 6.1.1 Correct the install of the seals if necessary.
 - 6.1.2 Correct installation positions of the glass panels if necessary.
 - 6.1.3 Only if the gaps in the seals cannot be eliminated by means of 6.1.1 and 6.1.2:
Replace seals on roof assembly.
For instructions, see:
⇒ *Workshop Manual '605455 Replacing seals for roof assembly'*
