PRODUCT SAFETY RECALL

SUBJECT: Front Passenger Air Bag Inflator

MODELS: 2003-2004 Pontiac Vibe

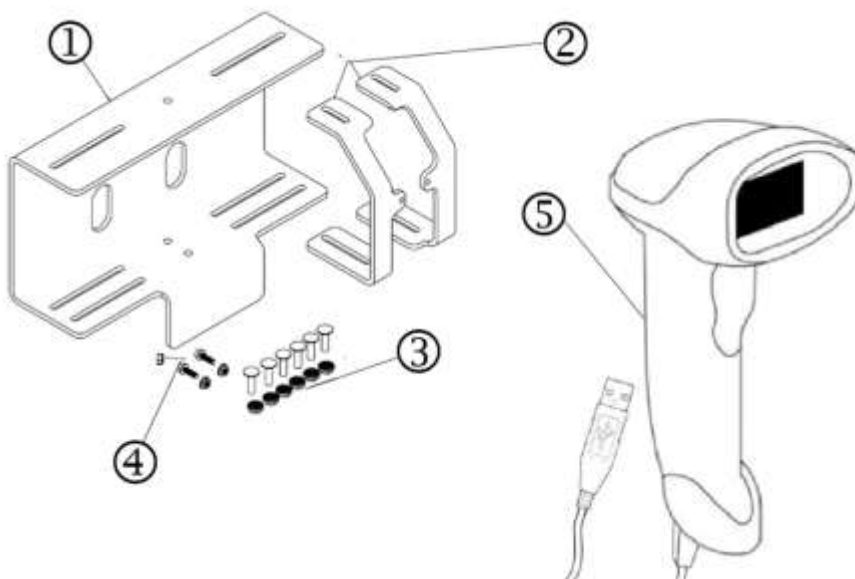
3607811

- (1) Mounting Bracket (2) Support Bars (3) Support Bar Hardware (4) Air bag Mounting Hardware (5) Barcode Scanner

Beginning the week of November 11, 2013, select dealers will be shipped an air bag mounting bracket and bar code scanner, EL-51377 and EL51378, respectively. These tools are essential to perform the service procedure described in this bulletin. The tools are being furnished at no charge. Only those dealers with an involved vehicle currently assigned to them will be shipped an air bag mounting bracket and bar code scanner.

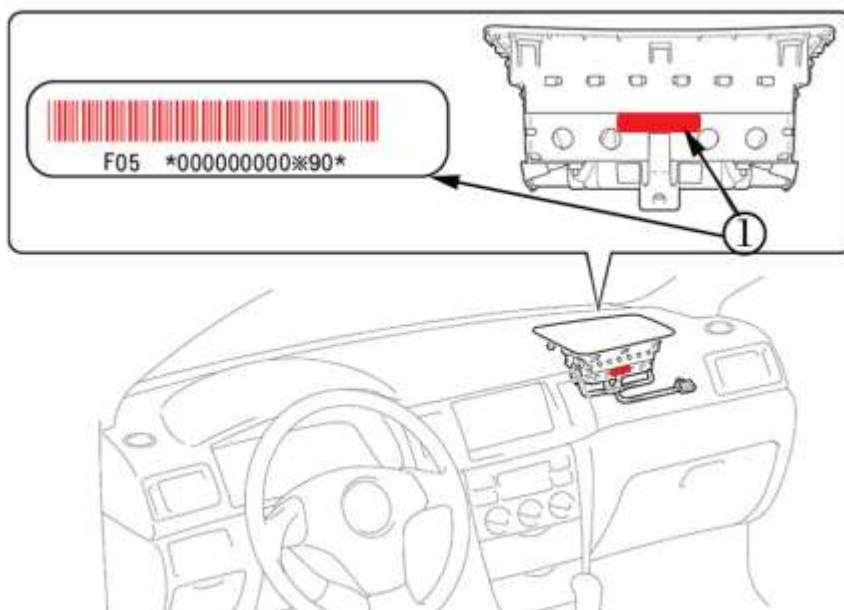
7. Locate passenger air bag barcode label (1). Refer to illustration.

8. Determine if an 'X' is present on the barcode label. The 'X', if present, will be located in the lower right-hand corner of the bar code label.
 - If an 'X' is NOT present, proceed to step 9.
 - If an 'X' is present, the air bag module has already been repaired. Re-install the air bag module. Refer to *Air bag Instrument Panel Module Replacement* in SI. Proceed to step 25.

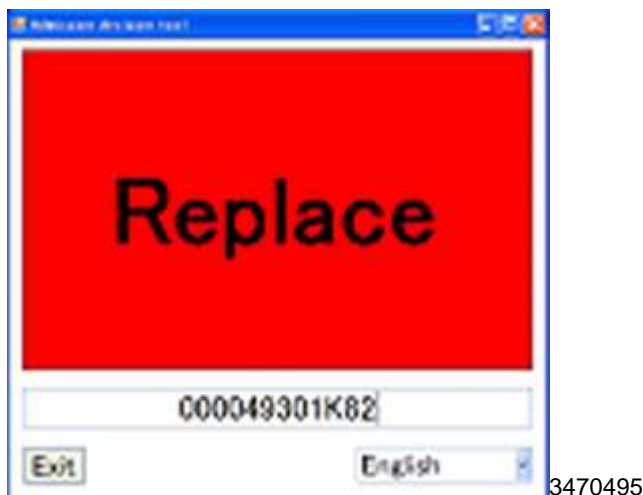
- If the scan tool result screen indicates the passenger air bag inflator requires replacement, proceed to *Safety Precautions and Passenger Air bag Inflator Module Replacement* in this bulletin.

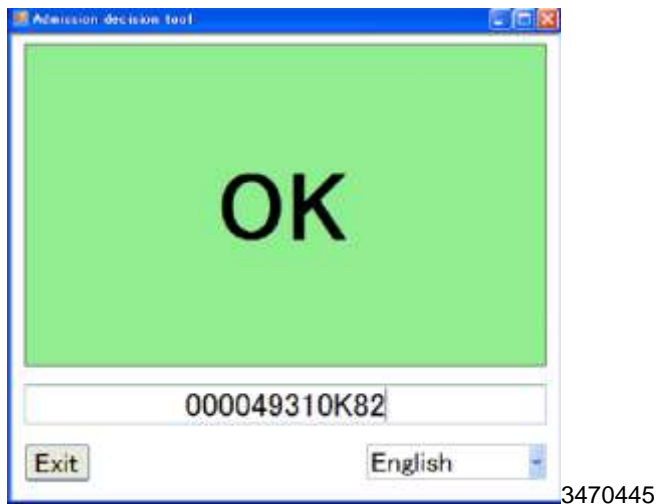
- If the scan tool result screen indicates the passenger air bag inflator does NOT require replacement, re-install the air bag module and install the instrument panel (I/P) compartment. Refer to *Instrument Panel Compartment Replacement* in SI. No further action is required.

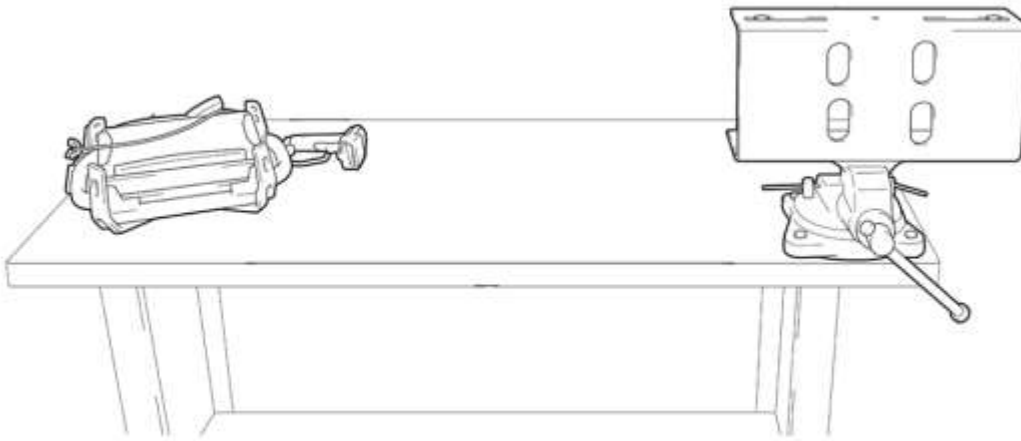
3607819

Danger: To avoid personal injury or death, it is critical to use an air bag module bracket when replacing an inflator module. Carefully read and follow the instructions below:

- Confirm the bracket assembly is installed securely in the vice.
 - Confirm there are no loose objects or people exposed to the back side of the bracket for safety in the unlikely event of air bag deployment due to improper work procedures. The air bag is NOT being replaced due to an inadvertent deployment concern.
 - Confirm that no objects, tools or people are within 3 feet (1 meter) of the back side of the bracket.
 - Confirm that no objects, tools or people are within 2 feet (0.6 meters) of the sides of the bracket.
 - BEFORE starting work and periodically while working on the air bag module, touch a metallic part of the work bench to discharge static electricity in the body.
1. Mount the air bag module bracket securely in a vice.

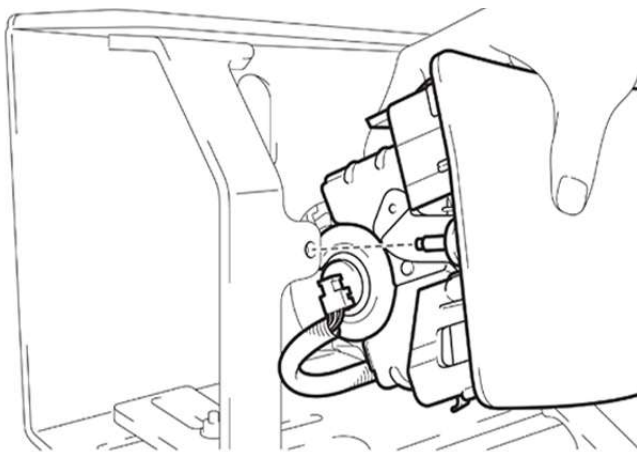
3607829

2. Position the two mounting studs on the air bag assembly into the holes on the bracket support bars.

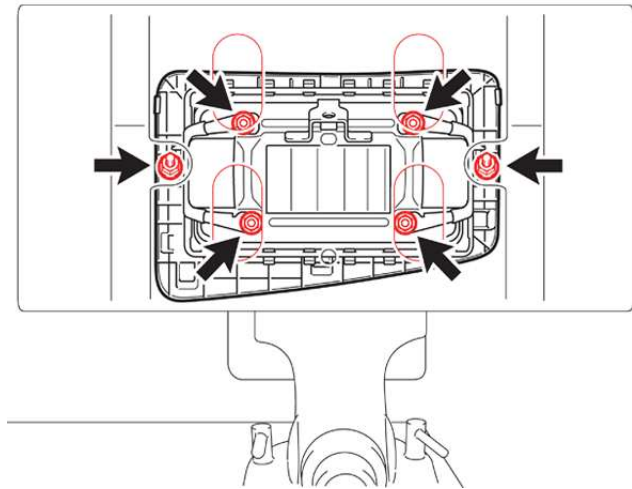
3607904

3. Loosely install the air bag to the support bars with the nuts supplied in the bracket kt.
4. Position the air bag so that all four stopper plate nuts can be removed through the access holes.
5. Tighten the two nuts holding the air bag to the support bars.
6. Confirm the following steps have been completed BEFORE proceeding to the next step:
 - The mounting bracket is secure in the vise.
 - The air bag module is secured to the support bars of the bracket.
 - The support bars are secured on the mounting bracket using one (1) bolt/nut at the top of each support bar and two (2) nuts/bolts at the bottom of each support bar.

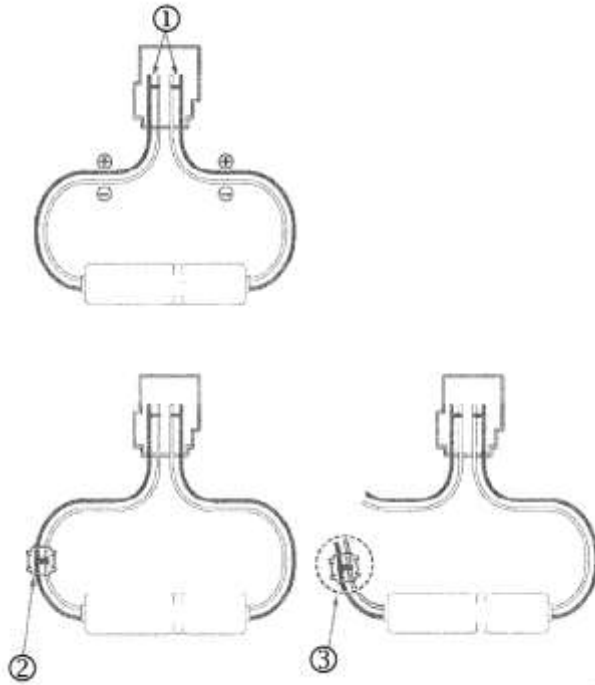
3470510

Note: The connector of an air bag inflator has a short-circuiting mechanism that eliminates voltage difference when disconnected (1). To allow for the replacement of the inflator module, a new short circuit using an electro tap (2) **MUST** be created **BEFORE** cutting the wires (3) and removing the inflator.

7. Create a short circuit before disconnecting the inflator wire harness.

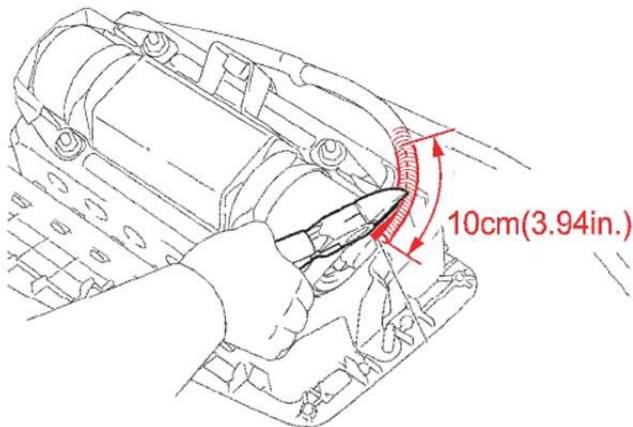
3470432

Caution: **DO NOT** damage the internal wires when cutting open the corrugate tube. **DO NOT** use a knife or razor blade to cut the tube to avoid damaging the wires. This step may be performed on either end if the inflator.

7.1 Cut open the corrugated tube on the yellow harness approximately 10 cm (4 in) using snippers.

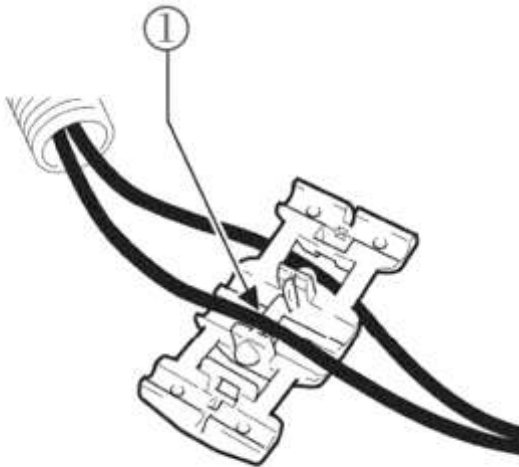
3470361

7.3 Short-circuit the two wires using the electro tap. Place one wire (1) in the electro tap as shown in the illustration.

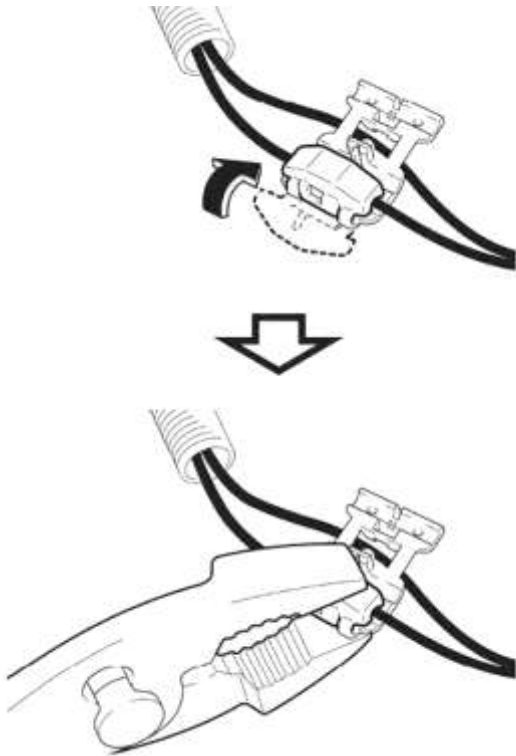
3470357

Note: Simultaneously working on the two wires tends to cause a mistake. Be sure to set the wire in the electro tap one wire at a time. Lock the electro tap firmly using pliers. If locked by hand, the electro tap may unfasten.

7.4 Fold and pinch the half of the electro tap where the first wire was just placed using pliers to lock firmly.

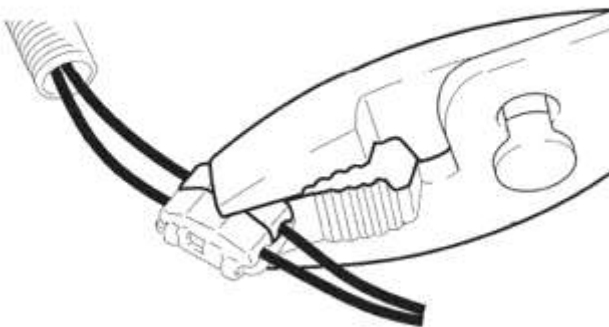
3470369

7.5 Set the other wire in the electro tap and lock in a similar way with pliers.

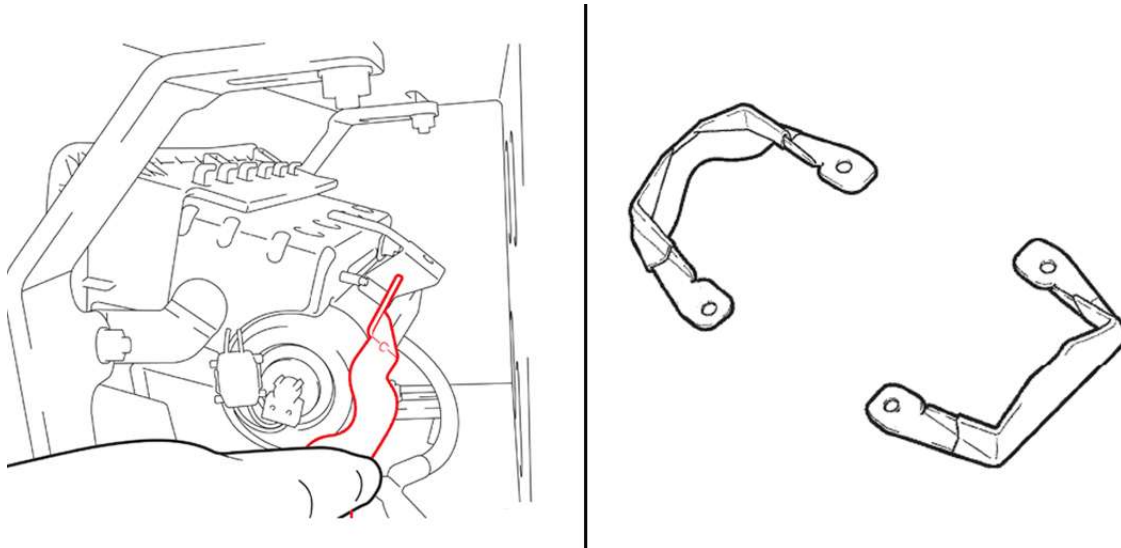
3607850

10. Remove the stopper plates.

11. Discard the 4 nuts and 2 stopper plates as they are not to be reused.

12. Remove the inflator.

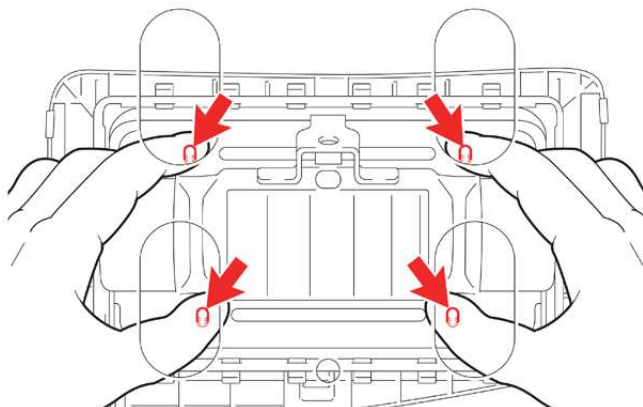
3607857

12.1 Gently push in the 4 studs to loosen the inflator for removal.

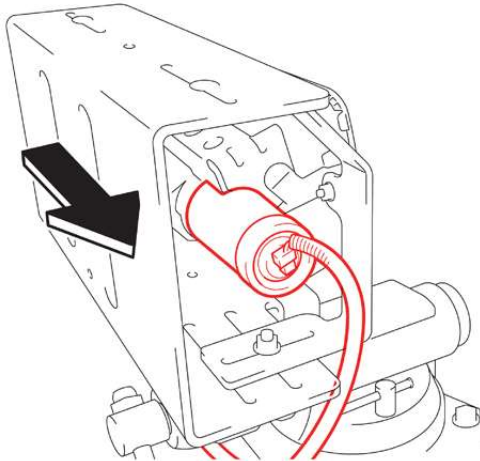
3607866

12.2 Remove the inflator from the air bag assembly and place it on a safe work surface.

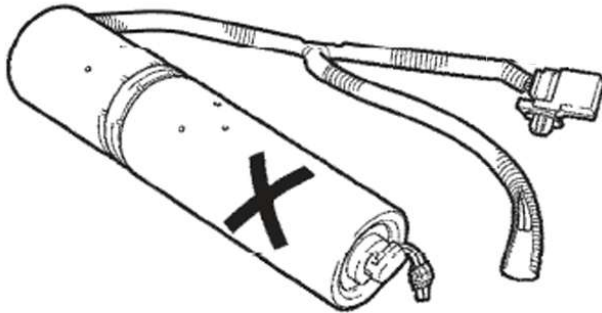
3470416

12.3 Put a mark on the removed inflator and store it in the provided replacement part box. Refer to the packaging instructions that were included with the new inflator module kit.

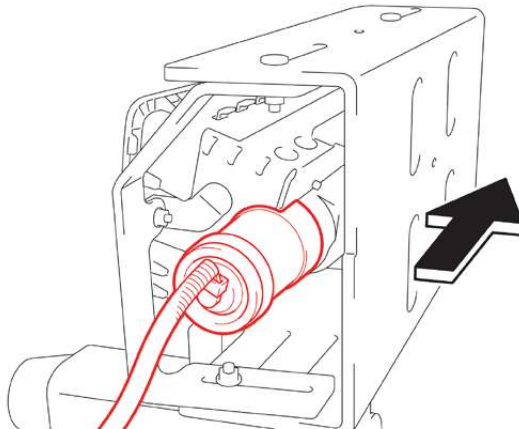
3607873

13. Carefully slide the new inflator into the air bag assembly.

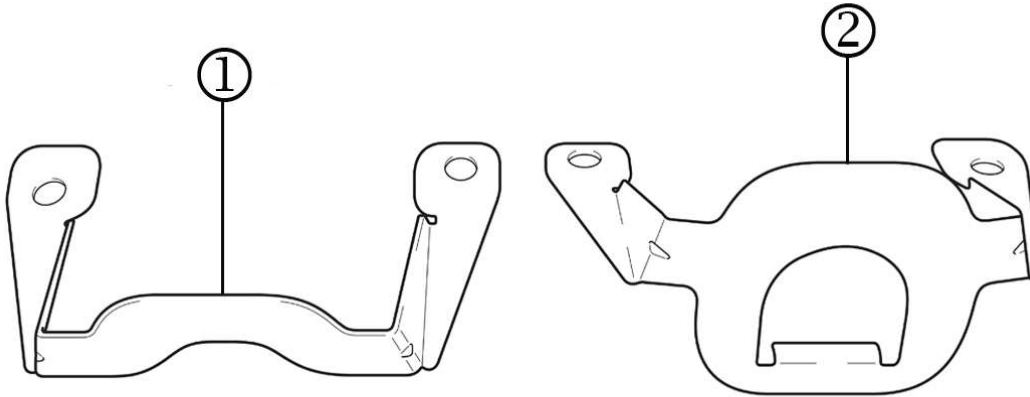
3607880

14. Confirm the identification of the stopper and the position determining plate. **THEY ARE DIFFERENT.** Refer to the illustration: (1) Stopper Plate (2) Position Determining Plate.

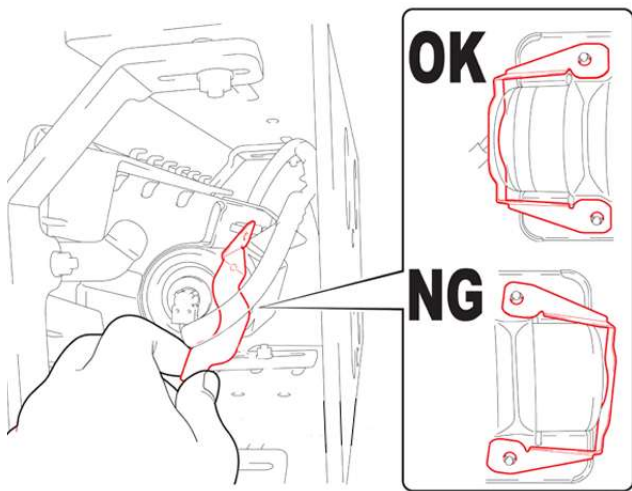
3607886

Warning: Confirm the stopper plate to inflator fitment is correct. **DO NOT** pinch the harness between the inflator and the stopper plate.

15. Loosely install a *new* stopper plate.

15.1 Place the **NEW** stopper plate on the air bag assembly on the side where the harness is already connected.

15.2 Confirm the end of the inflator sits flat against the stopper plate. If they do not align the inflator is installed backward.

15.3 Install **NEW** stopper plate nuts by hand. They will be torqued on a later step.

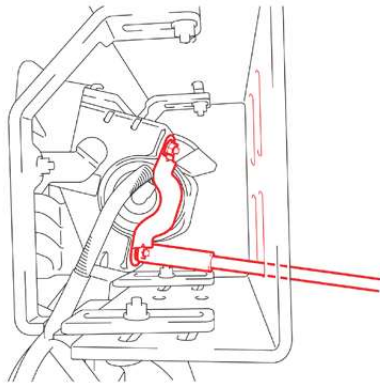
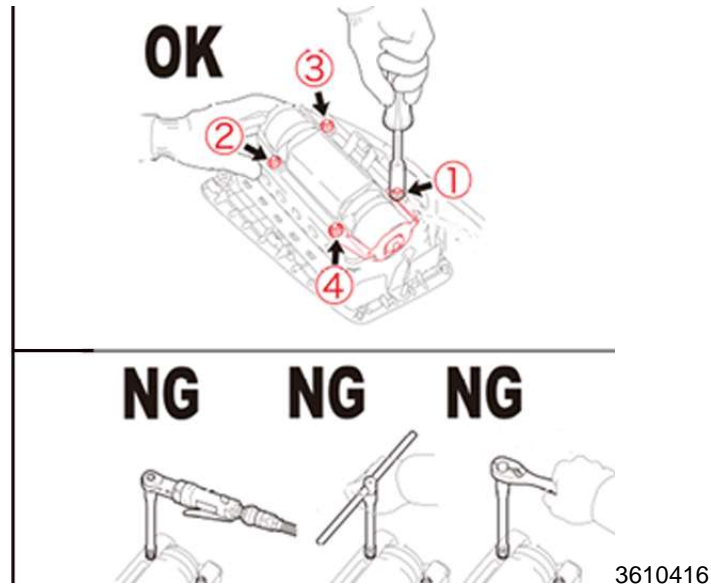
Caution: There will be some resistance when tightening the nuts because they are self-locking. Confirm the nuts are tightened correctly. **DO NOT** use a power tool, T-handle, or ratchet when tightening the nuts to avoid over-torquing.

18. Tighten four (4) **NEW** plate nuts evenly in several increments in the order shown in the illustration using a 10 mm socket driver while pushing the inflator. (You will encounter some resistance during tightening because these nuts are self-locking nuts.)

Torque Specification: 3.9 Nm (35 in-lb)

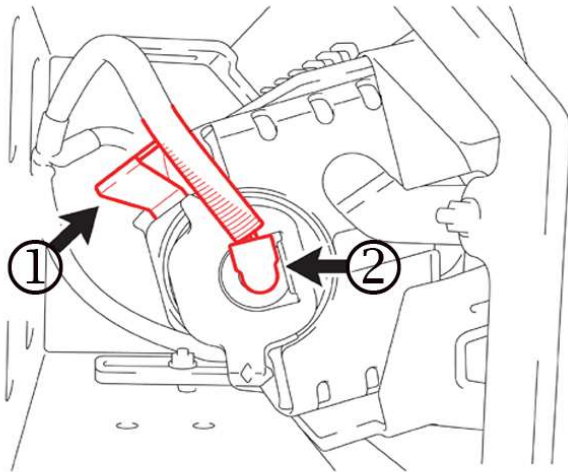
3610412

Warning: The connector should be connected **IMMEDIATELY** after removing the seal. Once the connector is installed it **CANNOT** be removed. If the connector is installed in the incorrect orientation the terminals may be bent or the connector may not fully engage.

19. Connect the inflator connector (2).

19.1 Remove the connector seal from the inflator.

19.2 Confirm the alignment of the harness connector as shown in the illustration, and then connect the harness. The connector wires should lead toward the center mounting bracket (1) on the air bag assembly.

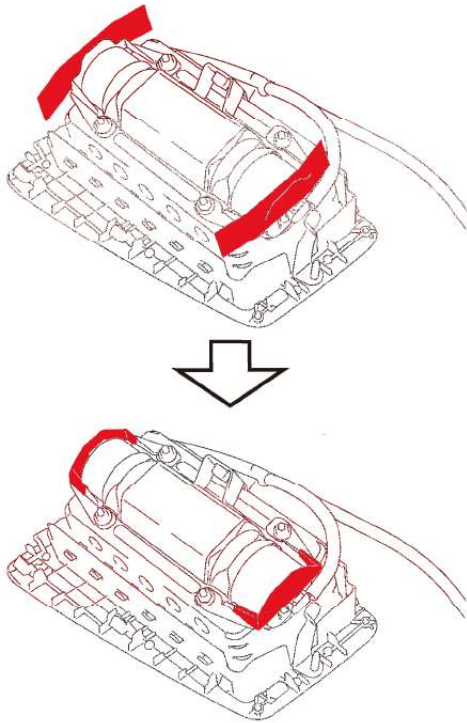
3470478

21. Attach the felt tape to the edges of the stopper and position determining plate.

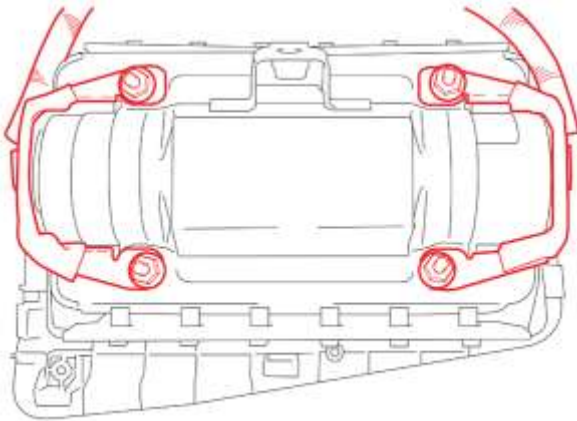
3610415

22. Inspect the air bag before installing it into the vehicle.

22.1 Confirm that the 4 **NEW** plate nuts are installed and tight.

22.2 Confirm the **NEW** stopper and position determining plates are installed.

22.3 Confirm the flats on the position determining plate and inflator are aligned.

22.4 Confirm the orientation of the inflator; the yellow wires should face the right side of the vehicle and the red wires should face the left side of the vehicle.

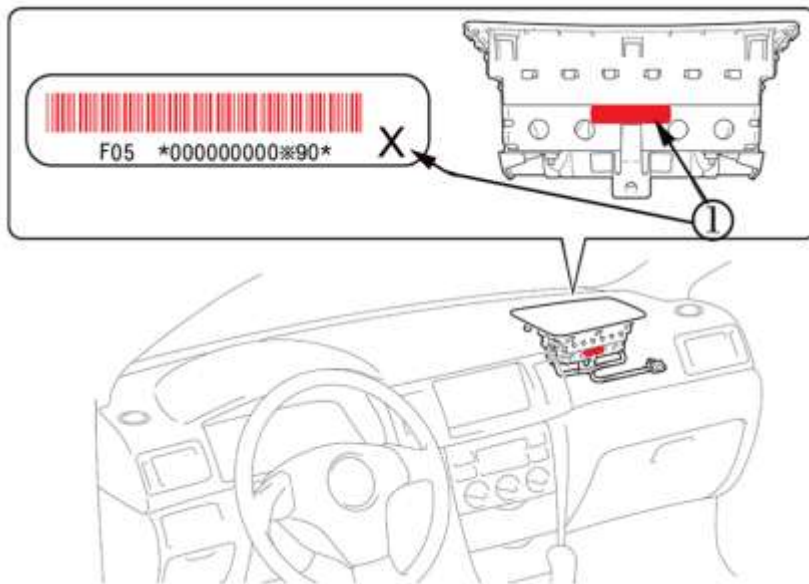
3610495

22.5 Using a pen or marker, put an 'X' in the lower right-hand corner of the air bag bar code label (1).
