## STAR ONLINE PUBLICATION

**Case Number:** S2308000126

**Symptom/Vehicle Issue:** Check Engine Light (CEL) P257F, P152E, or P0073

JEEP WRANGLER (JL)

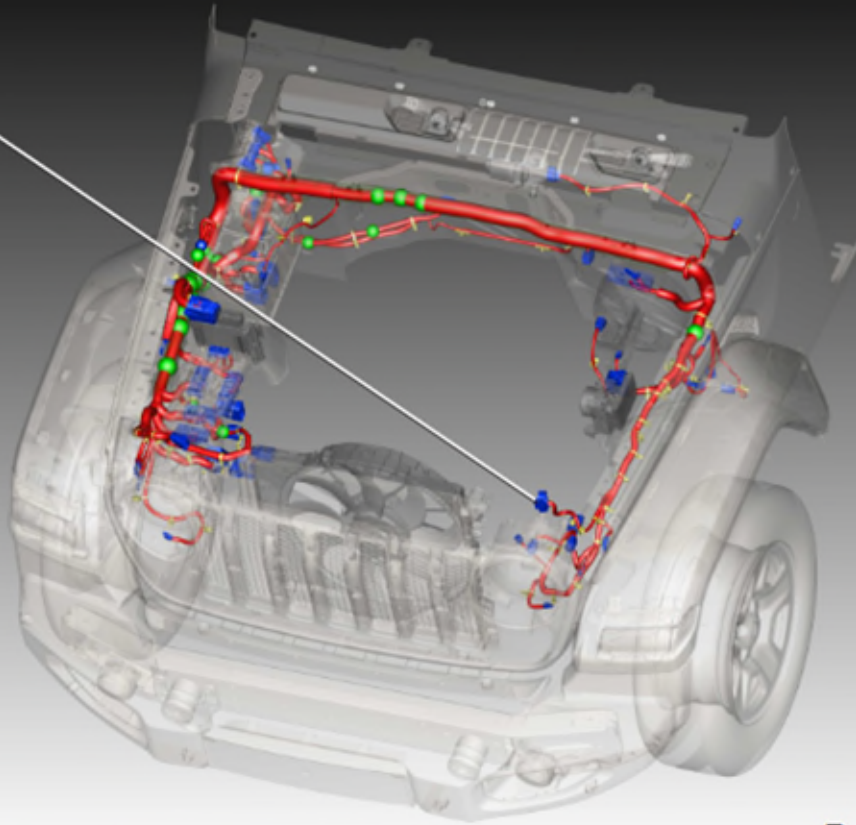
CONNECTION:  
XY103A

Dash Harness

**Discussion:** Locate the XY103A connector; in the front left corner under the hood of the vehicle. Disconnect the connector and inspect for any loose pins, repair as necessary. Reconnect the connector ensuring a full connection. Rescan and clear any DTC's. For any DTC's that remain perform published diagnostics in Service Library (SL).
