Technical Service Bulletin

57 Paint damage on leading edge of front door

57 23 27 2072290/1 December 11, 2023.

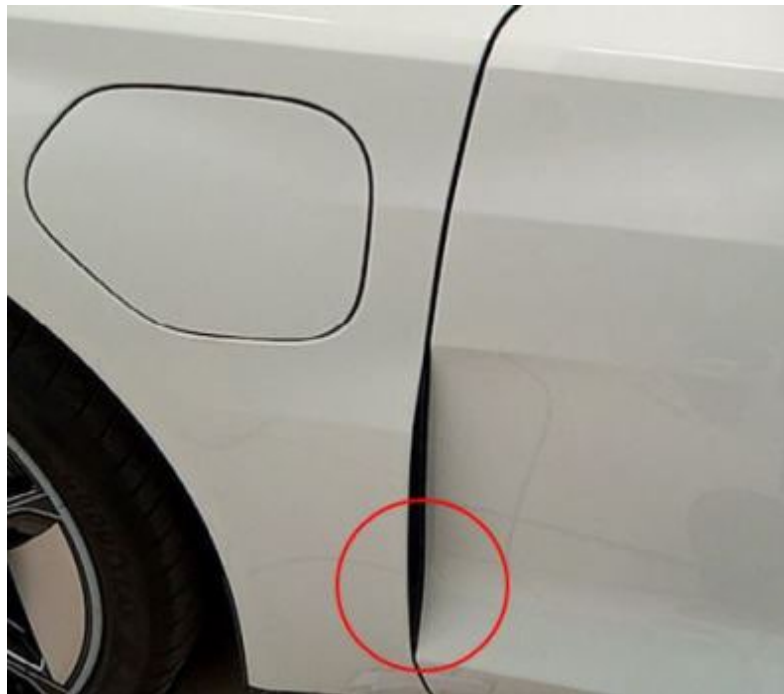
The contact between the front door and the end panel on the front fender is confirmed. Figure 1 shows the area where the abrasions can be found. This condition may be found on one or both front doors.

Figure 1. Area of front door affected by the contact.

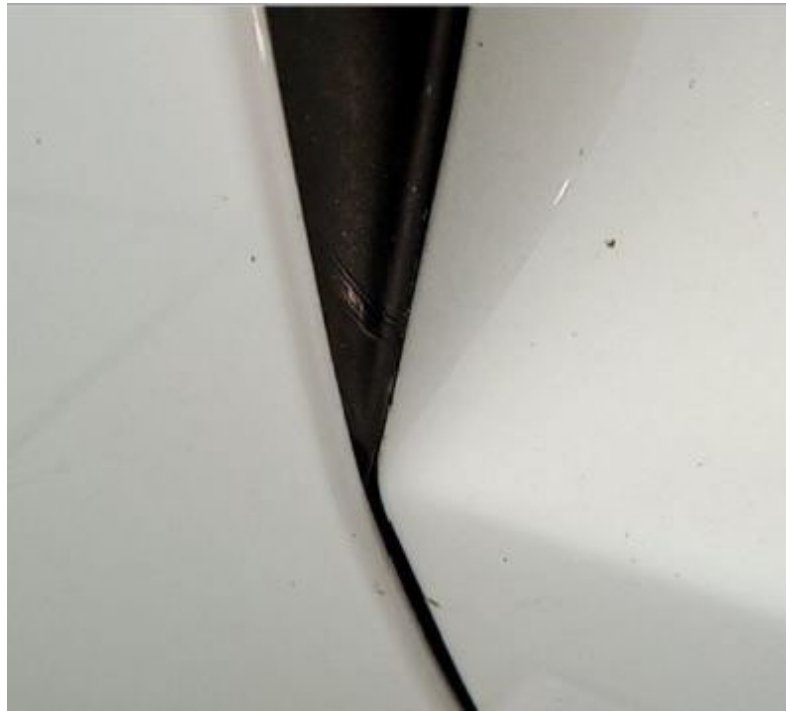
- When opening or closing the front door, the leading edge makes contact with the end panel on the front fender.

Figure 2 shows the contact when the door is opened.

Figure 2. Contact between the front door and the end panel on the front fender when the door is opened.

The front fender end panel has been modified in production to prevent intrusion into the path of the opening or closing front doors.

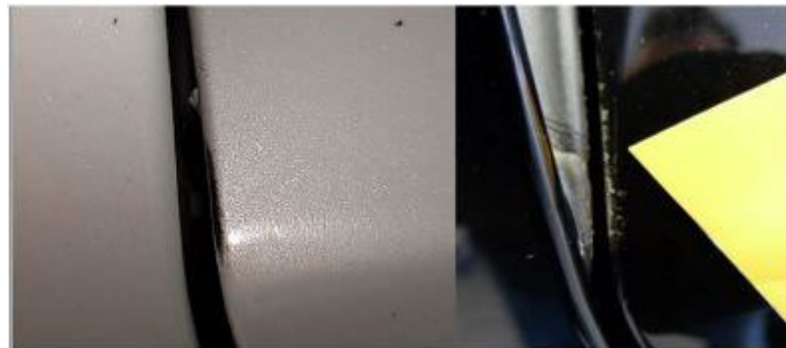
Figure 3 shows a close-up image of the abrasions.

Figure 3. Abrasions in the area of contact.

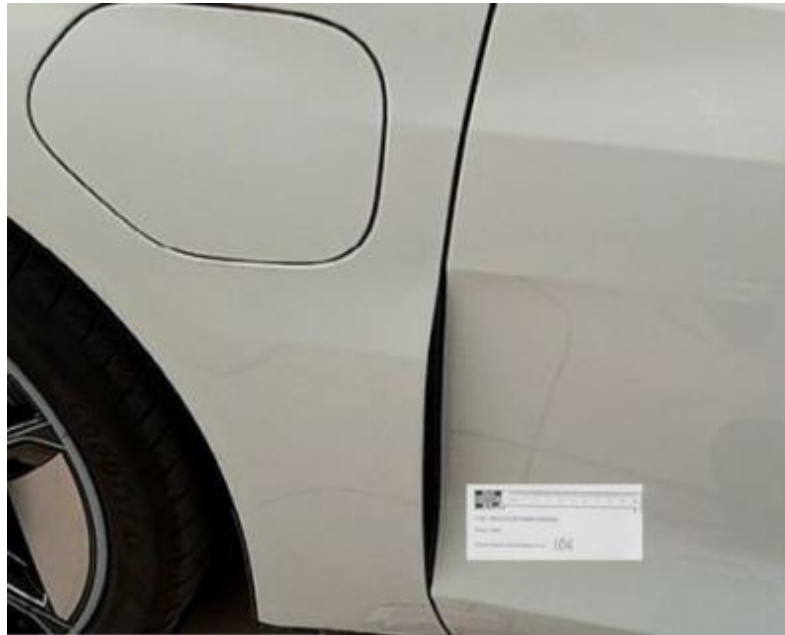
Figure 4. Photos taken showing the location of the paint abrasions.

1. Please take photos of the customer's concern and upload them into Doc-IT with the repair order. Photos should:

- Have a date stamp and VIN reference.
- Be taken in focus and with sufficient light.

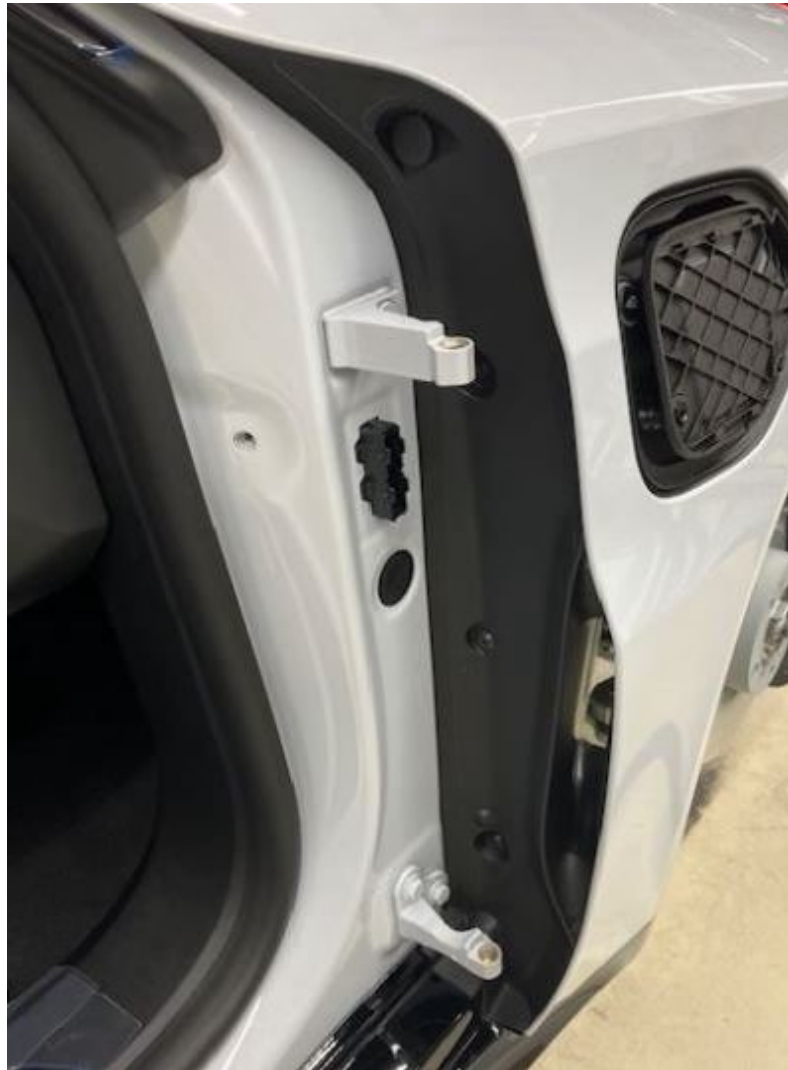
Figure 5. Front door removed.

2. Remove and repair the damage to the painted surface of the front door as specified in ElsaPro.

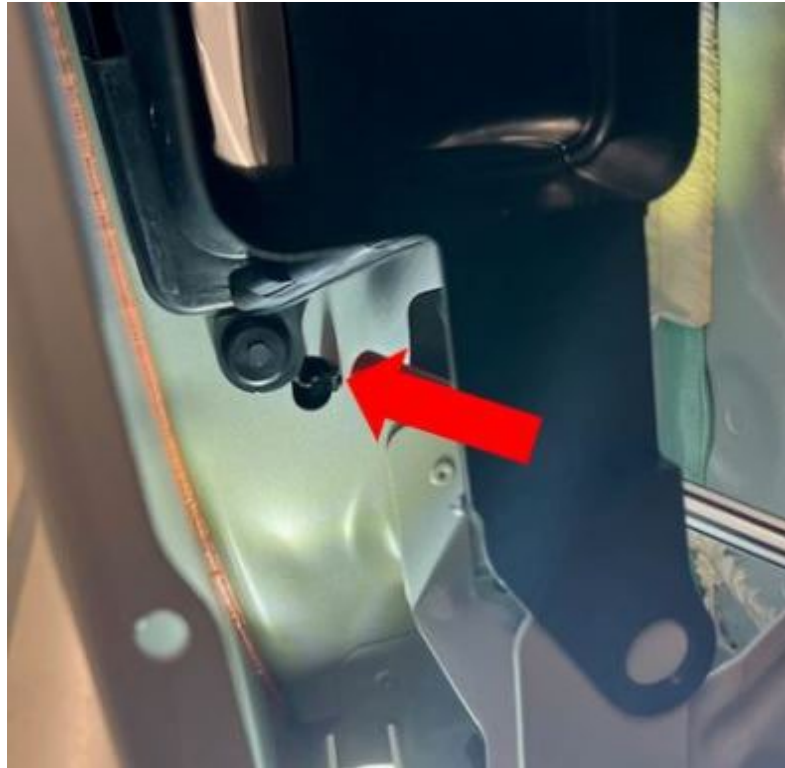
Figure 6. Fully engaged fender end panel trim fastener.

3. Replace the fender end panel trim. Ensure that the new trim is fully secured and that all fasteners are engaged completely and not damaged.

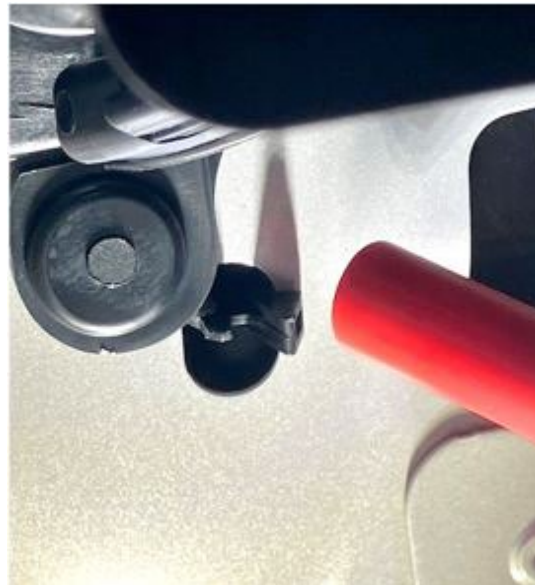
4. Figure 7 shows a close-up of a fully engaged and undamaged fender end panel trim fastener.

Figure 7. Fender end panel trim fastener properly engaged.

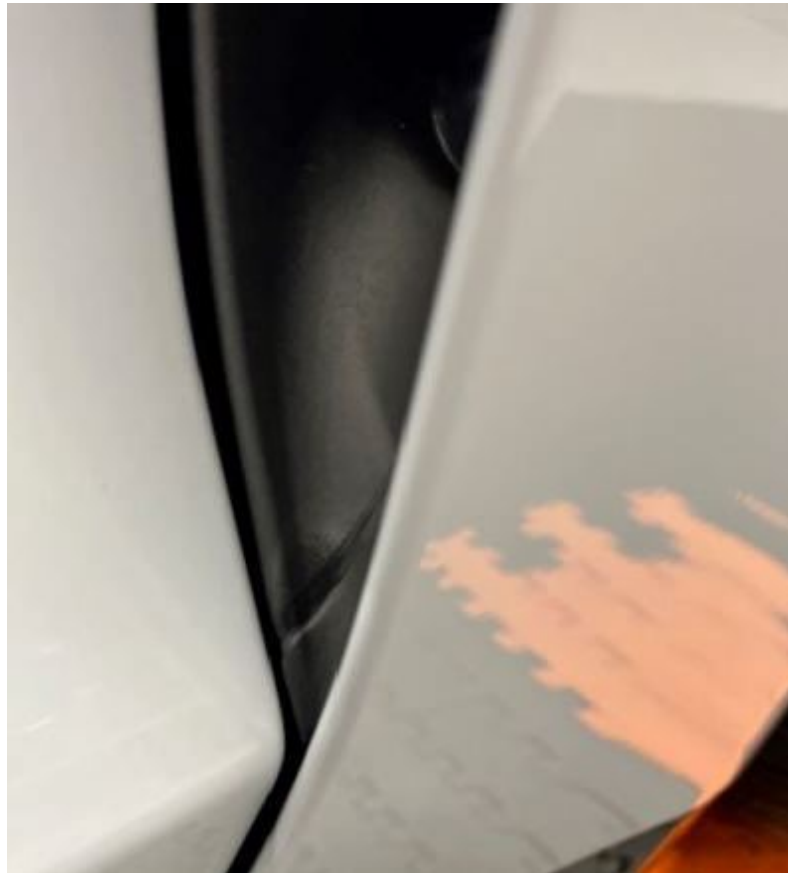
Figure 8. Appropriate clearance restored between the front door and the fender end panel trim.

5. Check that the door moves freely during opening and closing without any contact with the fender end panel trim.
