# **Technical Service Bulletin**

#### 90 PSS Instrument cluster: Superimposed content in the information display

90 23 62 2072430/1 December 15, 2023.

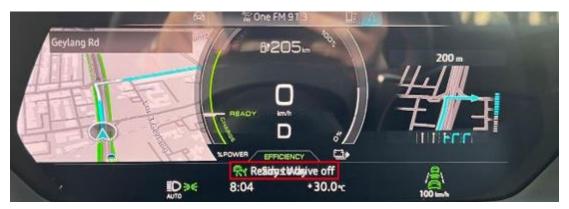
The complaint only occurs in classic performance layout (with power meter in center of display). The concern does not occur in the two other layouts.

In Figure 1, the area affected when the issue is occurs is marked in red.

Figure 1: Superimposed content inside red square.

Software issue in the instrument cluster.

This bulletin will be updated when more information is available. A solution is currently under development.

- 1. Explain to the customer that a solution is expected to be available by the end of the 2nd quarter of 2024 (subject to change) and that no repairs are necessary at this point. Do not replace any components for this condition since this will not resolve the customer's concern.
- 2. Create a PSS record in the PSS application through the Pending Service Solutions (PSS) link in AccessAudi (under *Related Links >> Service*).
