# Service Bulletin

Bulletin No.: PIT5012E

**Subject:** Antenna Mast Broken Off From Antenna Base Mount Low Profile Antenna Available

**Models:** 2010 - 2014 Cadillac SRX  
2010 - 2014 Chevrolet Equinox  
2010 - 2014 GMC Terrain

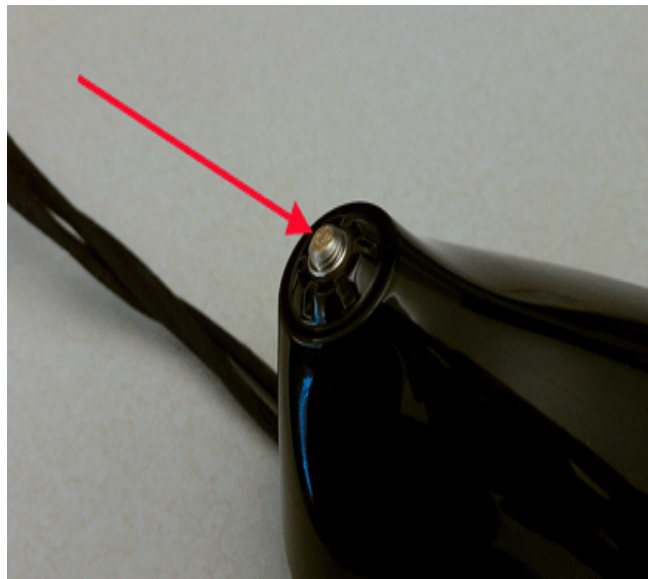
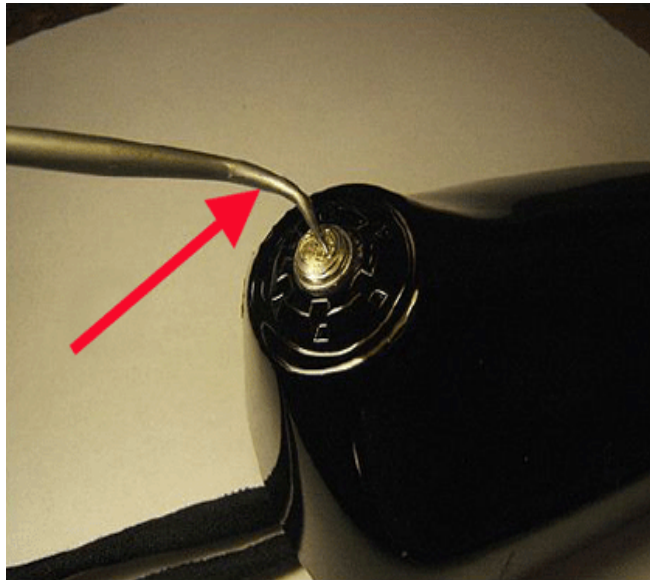
2610911

Antenna mast broken off of the roof mounted antenna base leaving the stud in the antenna base

It is not necessary to replace the roof antenna mounting base. It was determined through review of returned parts that the broken antenna mast stud can easily be removed from the antenna base using needle-nose pliers or flat blade screwdriver or use a pick to walk the broke stud out of the antenna base.

Replace only the antenna mast. Do NOT replace the antenna base.

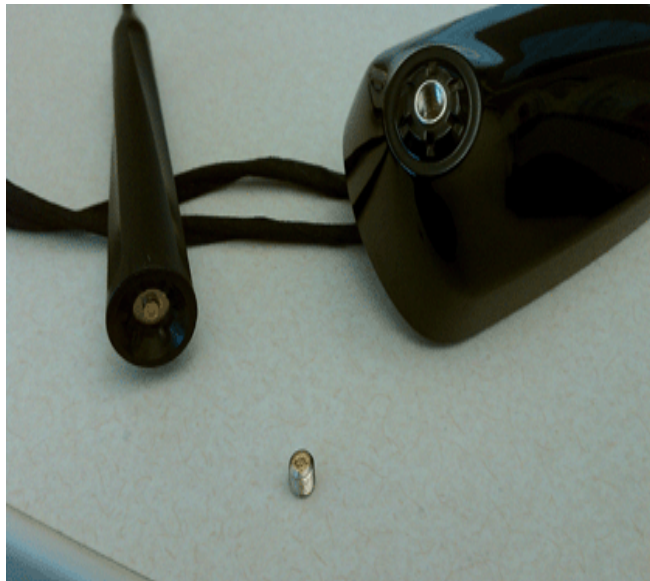
2581644

There are two different length antenna masts available in the dealer parts catalog group 9.647, depending on your customer's needs. The original height antenna mast (280mm) and a shorter antenna mast (180mm). Note there is a slightly reduced AM and FM reception when using the shorter antenna mast.
