Reman Turbo Compound Inspection

Volvo

Model Years	Models
2019-2021	VN

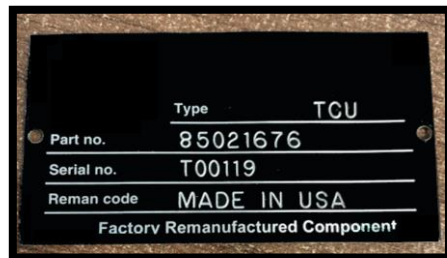
1. Park the vehicle on level surface.
2. Apply the parking brake.
3. Place the gear level in neutral.
4. Install the wheel chocks.
5. Locate the serial number tag on the lower side of the TC unit.

6. Compare the serial number on the TC unit to the listed serial numbers listed above.
 1. If the serial number on the TC unit does not match the listed ones above, not further action is needed.
 2. If the serial number on the TC unit is on the list above continue to **step 7**.
7. Use operation (**2921-03-02-01 Turbo compound, Replacement**) in Impact to replace the TC unit with a reman one.
