Technical Service Bulletin

15 Engine: Cylinder head cover - oil residue Q5 (inline 4-cyl., 2.0 ltr. TFSI)

15 24 47 2072716/1 January 18, 2024.

Model(s)	Year	VIN Range	Vehicle-Specific Equipment
Q5, and Q5 Sportback	2021 – 2023	All	DPVA Engine

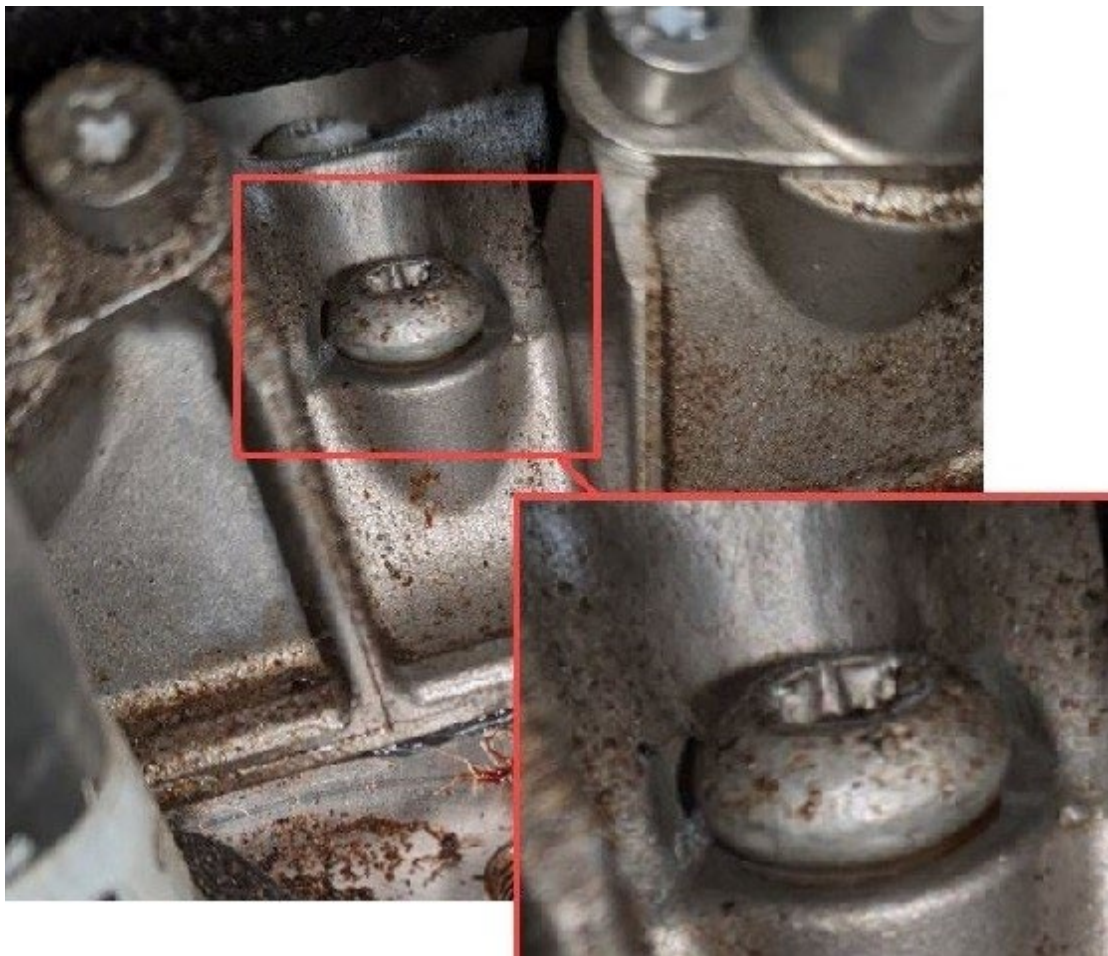
- The cylinder head cover is leaking in the area around the threaded connection on one or multiple bolts (Figure 1).

Figure 1: Oil on the threaded connection.

In cases, burrs on the cylinder head cover bolts can cause the bolts to become loose. This can cause oil residue in the area around the threaded connection.

- Please replace the affected bolt(s).
- Please ensure that replacing the bolts remedies the leaking.
