Technical Service Bulletin

90 PSS Instrument cluster: Superimposed content in the information display

90 24 73 2072430/2 January 24, 2024. Supersedes Technical Service Bulletin Group 90 number 23-62 dated December 15, 2023 for reasons listed below.

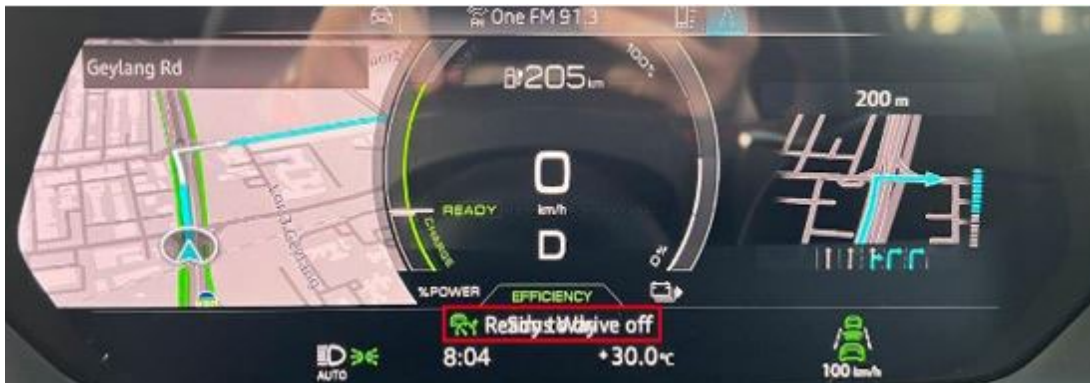
The complaint only occurs in classic performance layout (with power meter in center of display). The concern does not occur in the two other layouts.

In Figure 1, the area affected when the issue is occurs is marked in red:

Figure 1: Superimposed content inside red square.

Software issue in the instrument cluster.

1. Explain to the customer that a solution is expected to be available by the end of the 2nd quarter of 2024 (subject to change) and that no repairs are necessary at this point. Do not replace any components for this condition since this will not resolve the customer's concern.
2. Create a PSS record in the PSS application through the Pending Service Solutions (PSS) link in AccessAudi (under *Related Links* >> *Service*).
