QUALITY ACTION

CAMPAIGN BULLETIN

Right Rear Panel Seam Seal

Reference: PD100

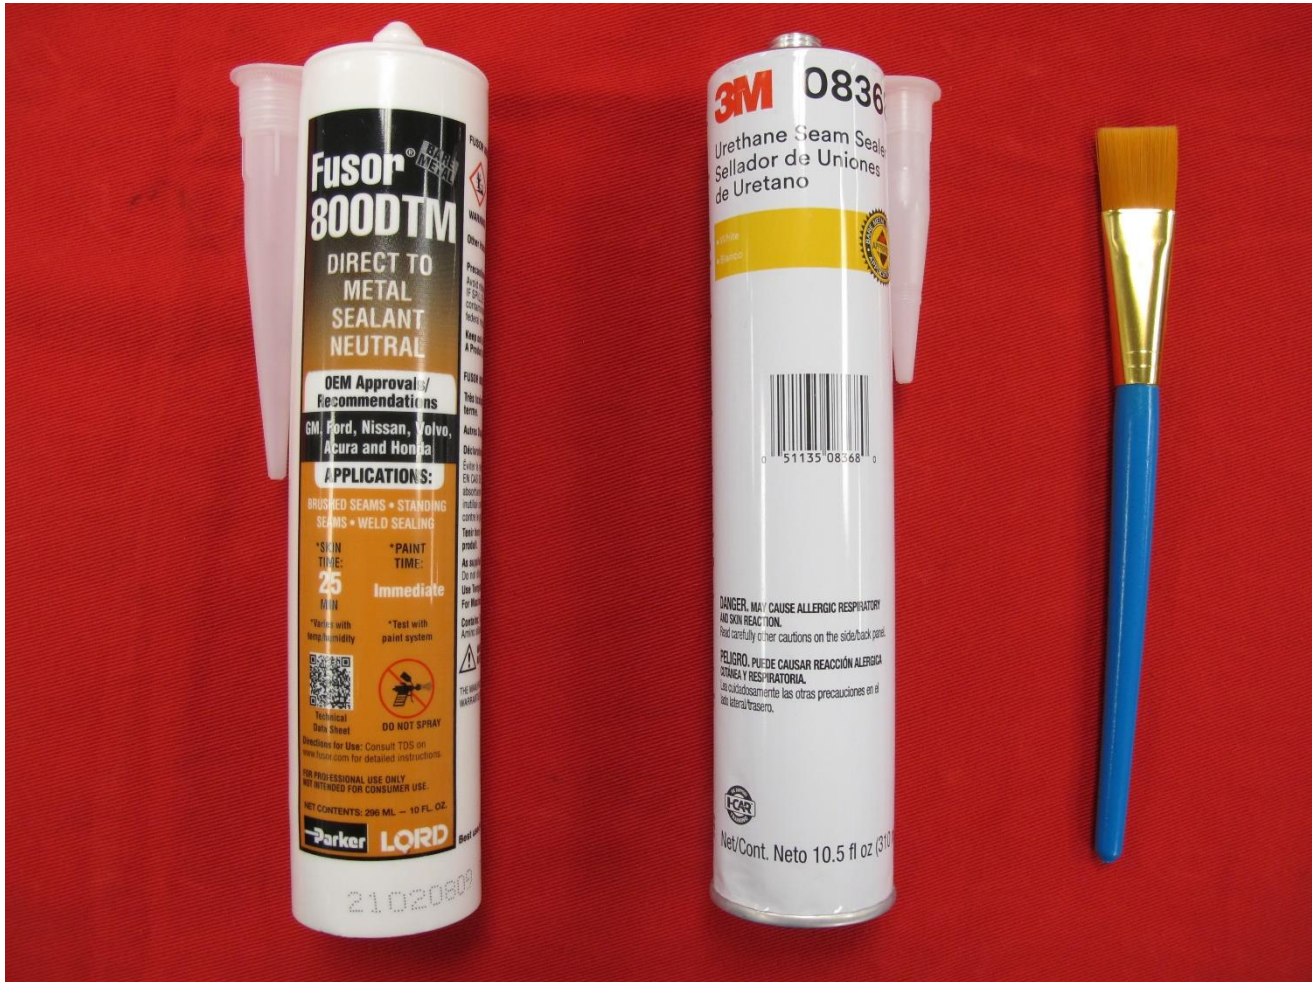
REQUIRED EQUIPMENT:

1. **Seam Sealer:** LORD Fusor 800DTM or 3M Urethane Seam Sealer #08368.

2. **Flat Brush:** 1" size or #10.

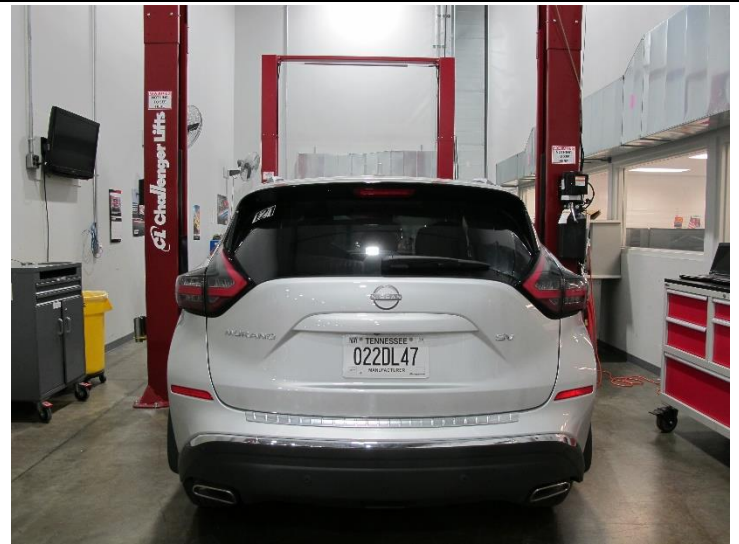
Figure 1

1. Place the vehicle on a suitable lift (Figure 1).

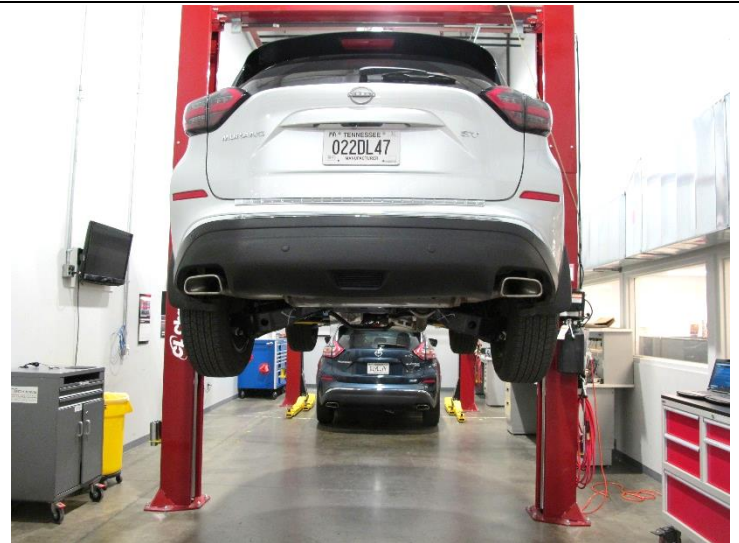
Figure 2

2. Raise the vehicle until the rear exhaust outlets are slightly higher than eye level (Figure 2).

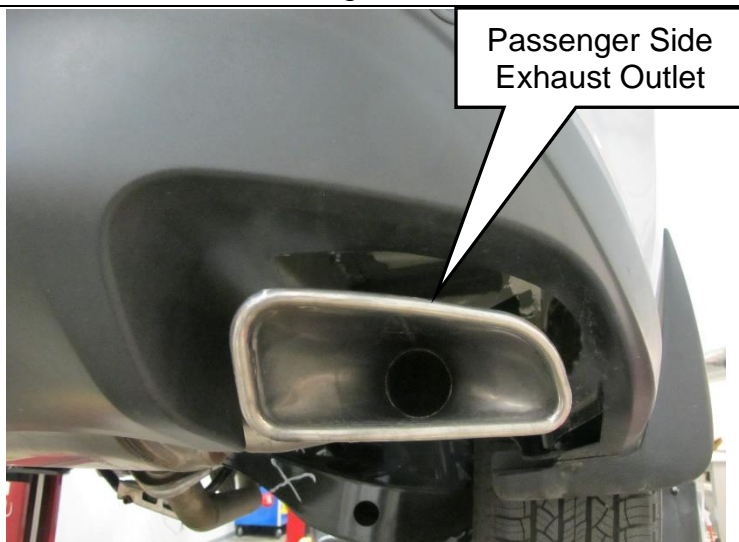
Figure 3

3. Locate the passenger (right) side exhaust outlet (Figure 3).

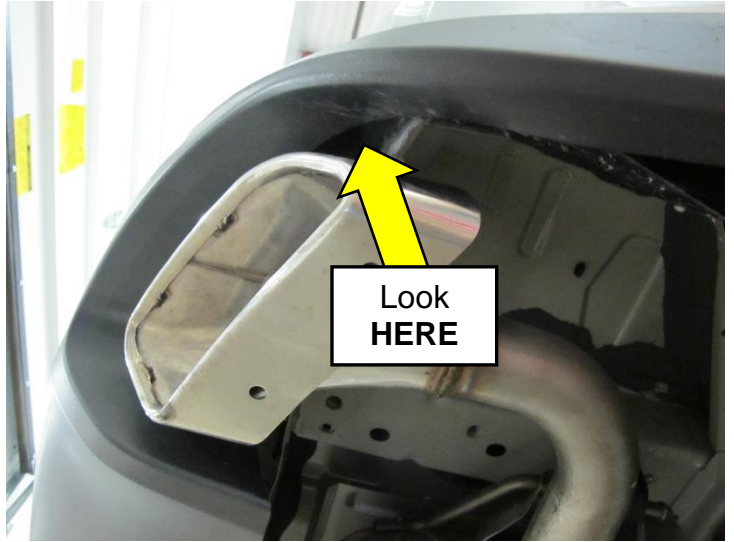
Figure 4

4. Locate the right rear panel seam behind the rear bumper.

- Look up along the right side of the right exhaust outlet (Figure 4)
- Use a light source to assist with locating the seam (Figure 5)

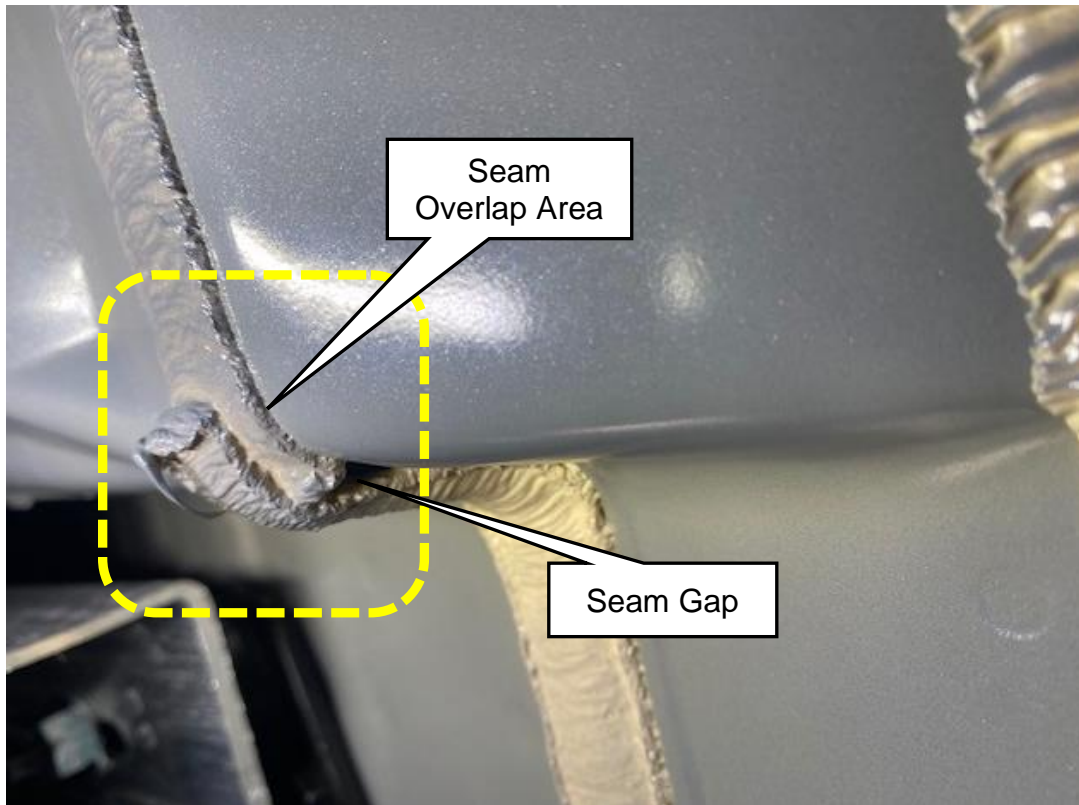
5. Locate the right rear panel seam overlap area and the seam gap.

NOTE: Figure 6 has the exhaust and rear bumper removed for picture clarity. Do NOT remove them for this repair.

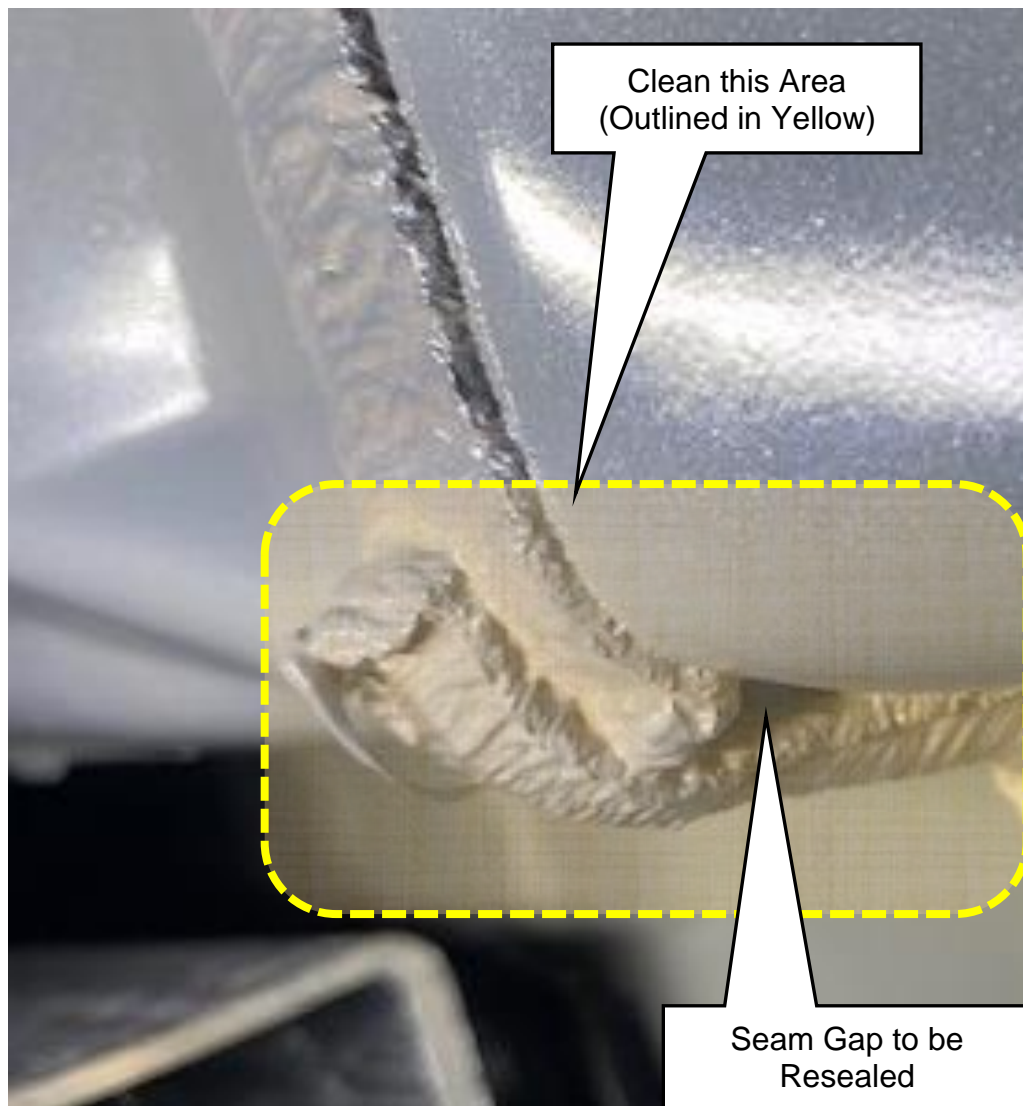
Figure 7

- Using a clean lint free cloth and warm soapy water, clean the area to be resealed (Figure 7)
- Use compressed air to dry the area after cleaning

6. Prepare the right rear panel seam area for application of the seam sealer.

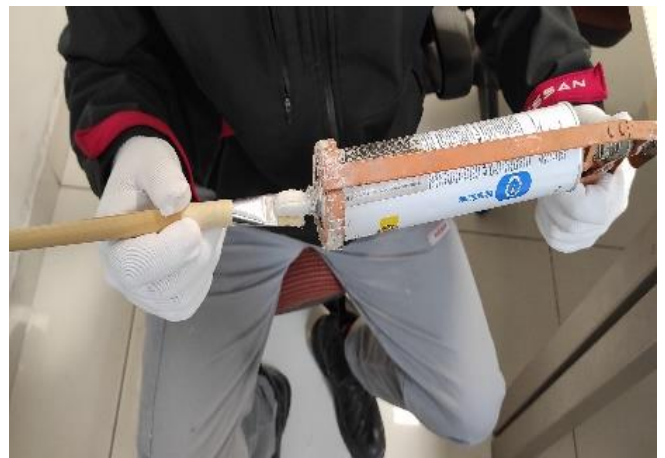
Figure 8

8. Apply 1 inch of the seam sealer on the flat brush (Figure 8).

- Repeat this process until the seam gap shown in Figure 11 on Page 7 is completely sealed

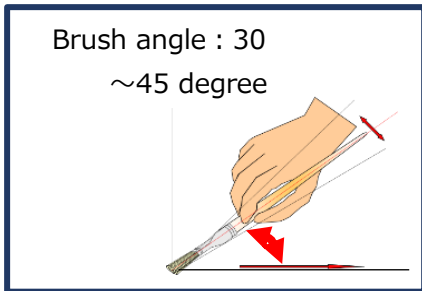
Figure 9

- Use brush angle of 30-45 degrees to smooth the sealer (Figure 9)

9. Using the brush with the seam sealer on it, apply the seam sealer to the right rear panel seam gap identified in Figure 11.

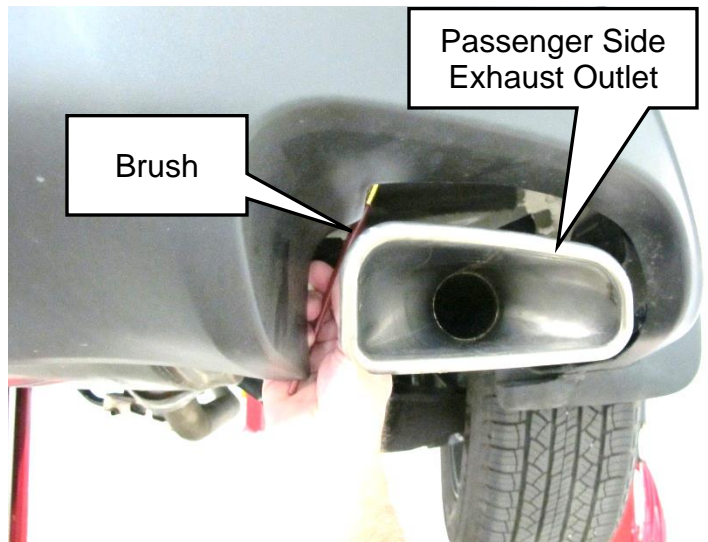
Figure 12

- To gain access to the seam gap with the brush, position the brush on the left side of the right exhaust outlet as shown in Figure 12.

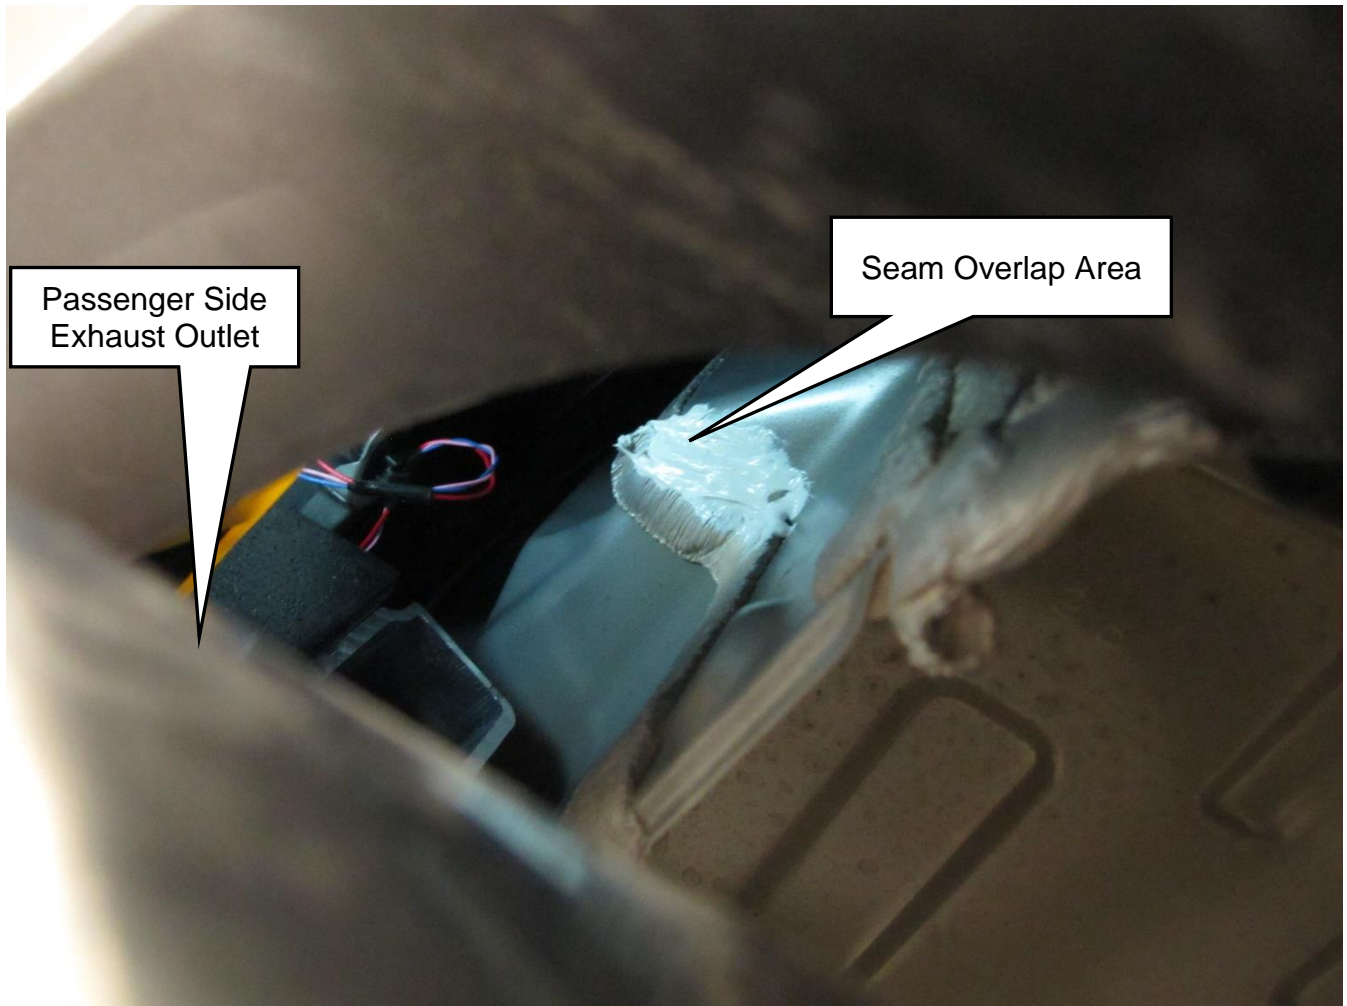
10. Figure 13 shows the right rear panel after the seam gap has been resealed with the brushed on seam sealer.

11. Once the seam sealer application is completed, allow the sealer to dry for 30 minutes.
