Brinkley RV Customer Satisfaction Campaign CSC-2401

RE: Model G Customer Satisfaction Campaign: CSC-2401
Ice Maker Water Line Leak

CUSTOMER SATISFACTION CAMPAIGN MODEL G 5th WHEEL

CSC NUMBER:	ICE MAKER WATER LINE LEAK - CSC - 2401		
PRODUCT:	BRINKLEY MODEL G FIFTH WHEELS		
DATE:	02/01/2024	LABOR RATE:	1.5

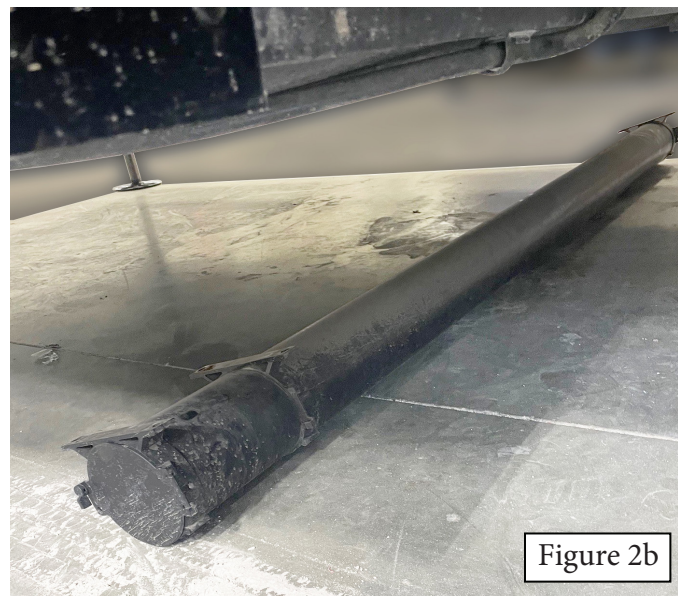
3. Locate and remove sewer hose storage tube (Figure 2a and Figure 2b).

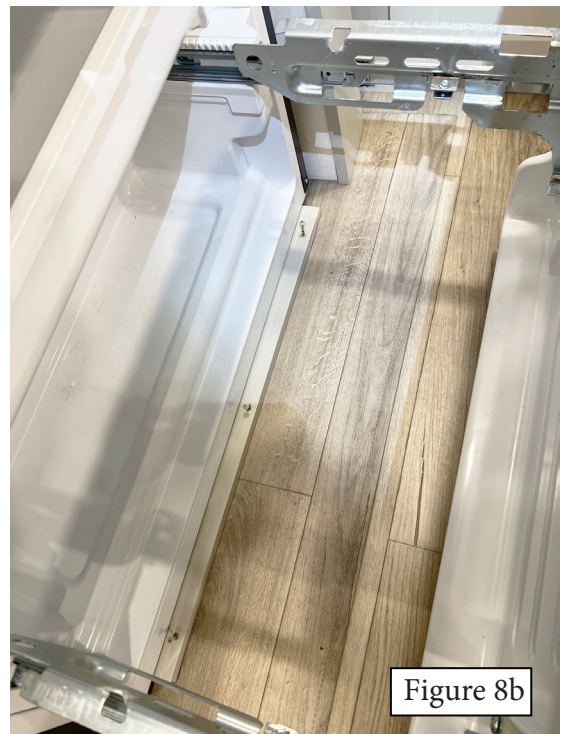
9. Open the freezer drawer in the refrigerator and remove the freezer tray (Figures 8a and 8b).

18. Place the freezer tray back into the freezer drawer (Page 5, Figure 8a).
19. Use black silicone (part #101006) to seal the water line at the openings in the frame rail and slide out floor (Page 4, Figure 4b and Page 5, Figure 7).
20. Locate heating element wires in the blue sheathing of the newly installed ice maker water line. Using two (2) Wago 3-position connectors, wire the water line heating element to the closest fresh water tank heat pad wiring (Figure 17). Wrap the Wago connectors in electrical tape to hold the levers in place.
21. Test tank heat pad and ice maker water line heating element for proper operation by using a clamp-on meter to ensure they are receiving power, or by turning the heat pads on for 30 minutes to make sure they are heating.

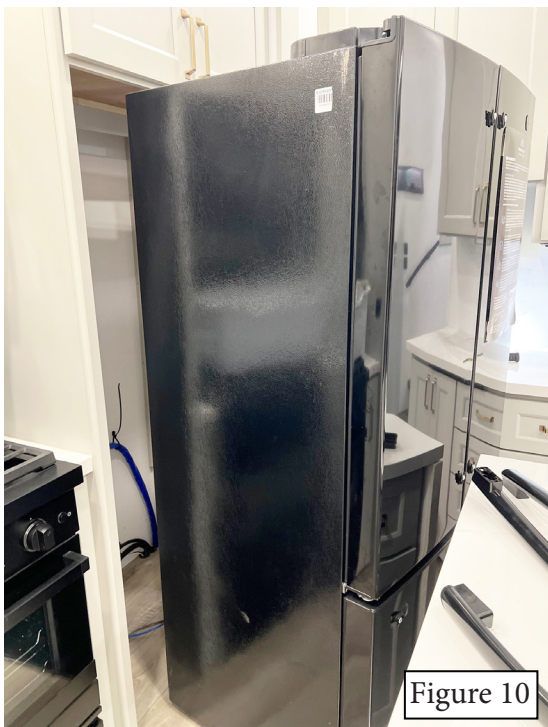
11. Remove the handles for the doors and freezer drawer by pulling them straight up and toward you (Figure 10). Set handles aside.

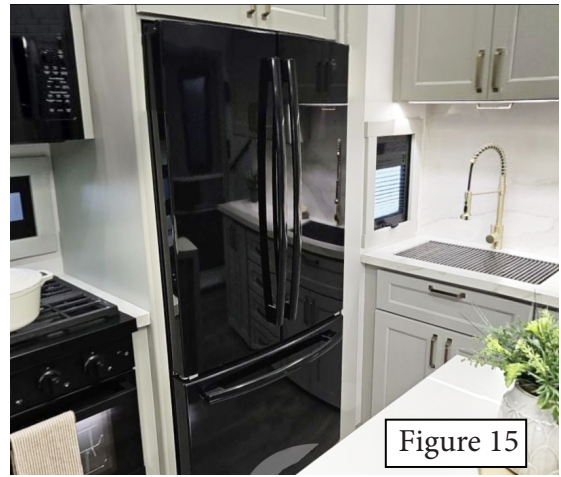
16. Once pressure testing is complete, push the refrigerator back into its opening and install the handles (Figure 15).

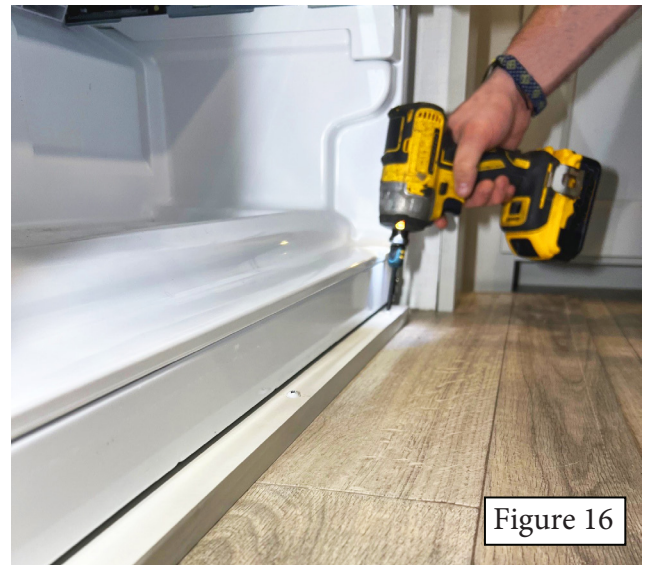
17. Install the stile holding the refrigerator in place using the original fasteners (Figure 16).

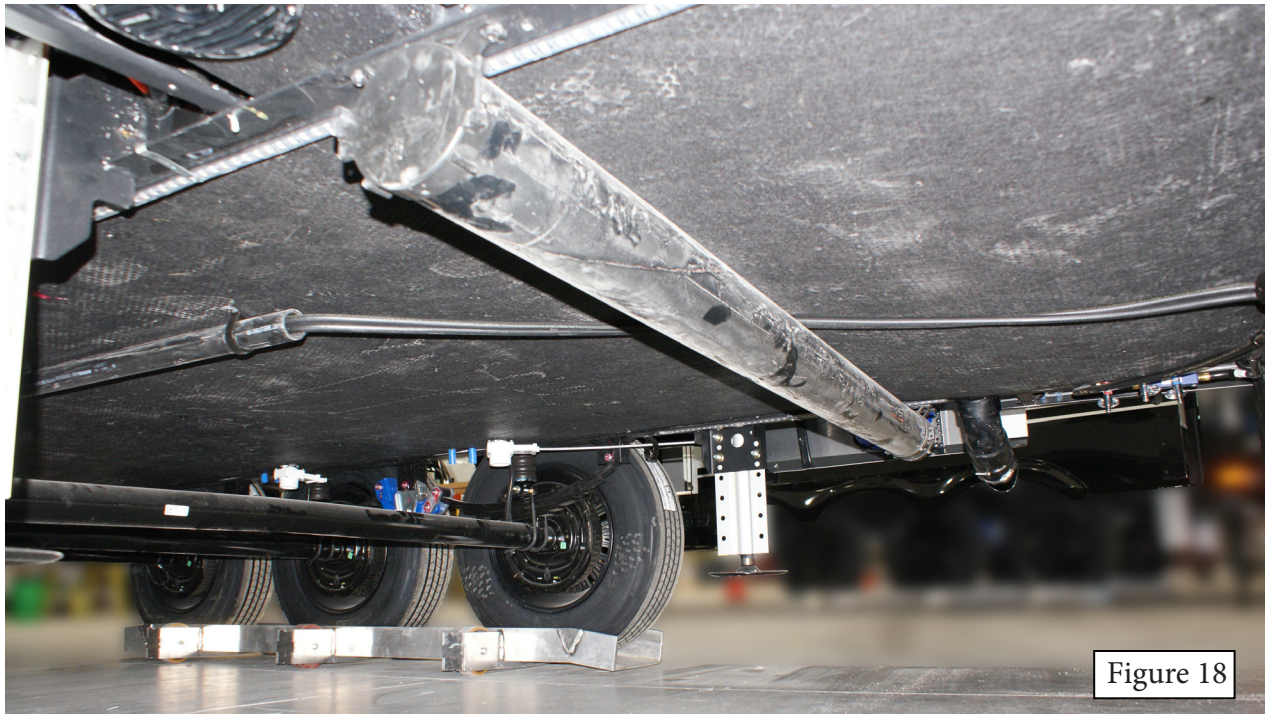
Figure 18

22. After confirming proper operation of the heating pads and ice maker water line heating element, install underbelly, fresh water tank drain valves, and sewer hose storage tube (Figure 18).
