# Service Bulletin

Bulletin No.: 15-NA-019

**Subject:** Fuel Odor During Fuel Filling or During Idle, Possible P0442 or P0455 DTCs Set

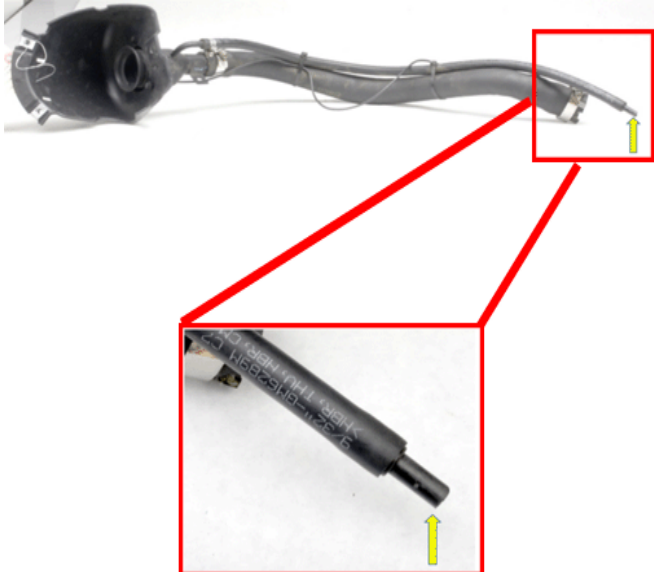
4283370

This may be caused by the fracture or breaking of the gasoline filler neck recirculation line connector.

1. Raise the vehicle and visually inspect the fuel tank filler vent hose connector for damage. Refer to Lifting and Jacking the Vehicle in SI.
  - If connector is damaged, replace the fuel tank filler vent hose. Refer to Fuel Tank Filler Vent Hose Replacement in SI.
  - If there is no damage to the connector, continue diagnosis referring to SI.
