Service Bulletin

Subject: Underbody Component Corrosion

Models: 2024 and Prior GM Passenger Cars and Trucks (Excluding Medium Duty Low Cab Forward)

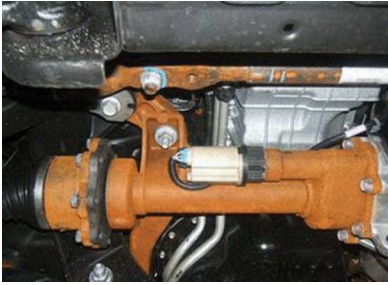
Front axle housing

No repair or consideration should be given for this condition. Surface corrosion on unprotected components will vary with age and exposure. Corrosion on these components has no detrimental impacts, either in short or long-term durability.

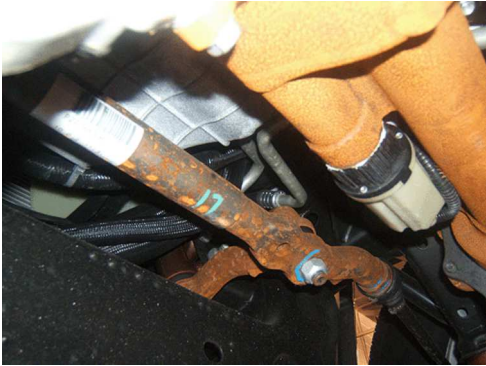
Steering linkage

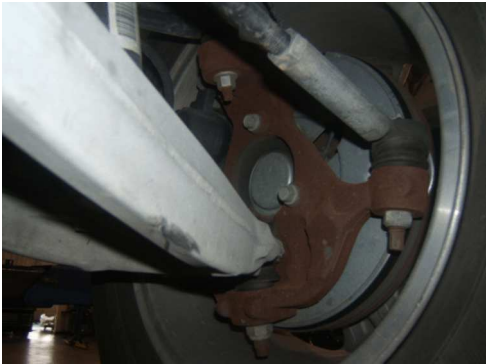
Steering knuckle

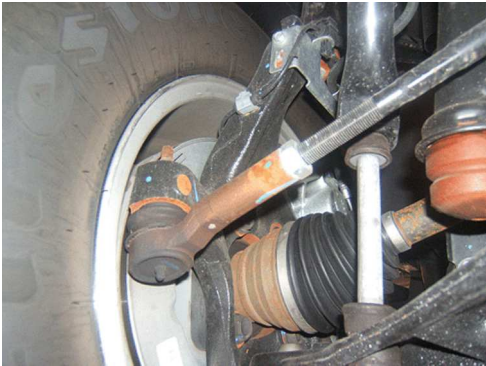
Tie rod end

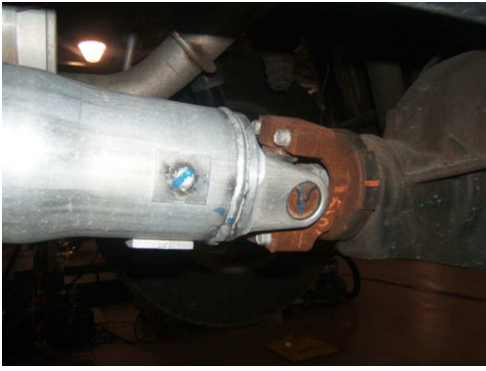
Propshaft yoke

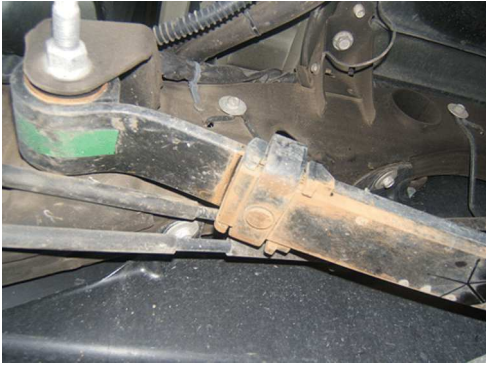
Leaf spring

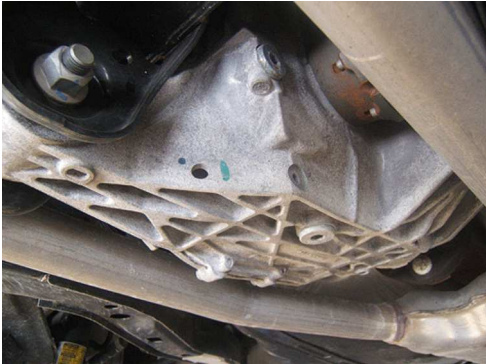
Rear differential housing

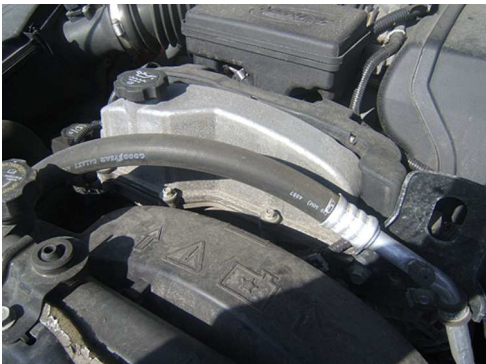
Under hood components

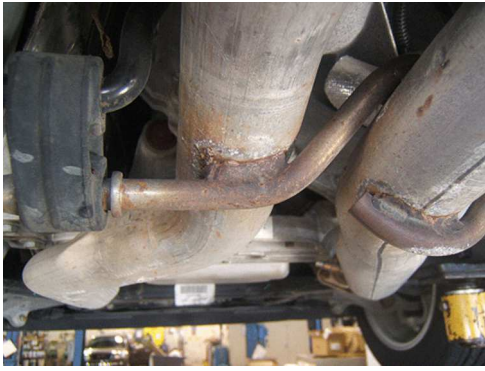
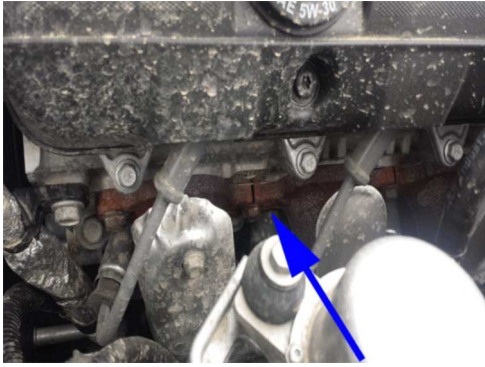
Exhaust system components

Note: During transit between the plant and the dealer, some of the exhaust system components may corrode as a result of salt exposure. These exhaust parts are made of a bare mild-grade stainless steel that will oxidize or appear rusty. Over time, these components will have a uniform rust-like discoloration, which should be considered a normal condition.
