## EXHAUST SYSTEM UPDATE

### AFFECTED MODELS:

**2020 1290 SUPER DUKE R**  
**2021 1290 SUPER DUKE R**  
**2022 1290 SUPER DUKE R EVO**  
**2023 1290 SUPER DUKE R EVO**

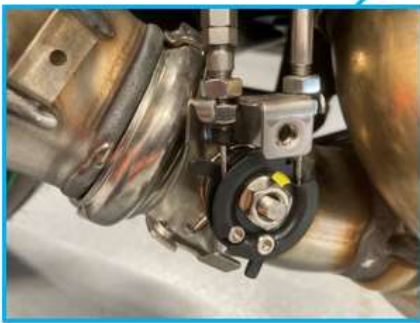
Fig. 2 – Exhaust flap control  
(Heat shield removed)

- Install a new V-clamp D=70.1 (#61705058200) on the exhaust (see Fig.1). An additional anti-twist device on the improved clamp prevents possible damage to the radiator.
- Install a new header gasket 54 mm (#61705005105) on the exhaust (see Fig.1).
- Install the new repair kit (#A62405031044) for the exhaust flap control (see Fig. 2).
- Install the latest software file.
- Use action code 00 for this update.

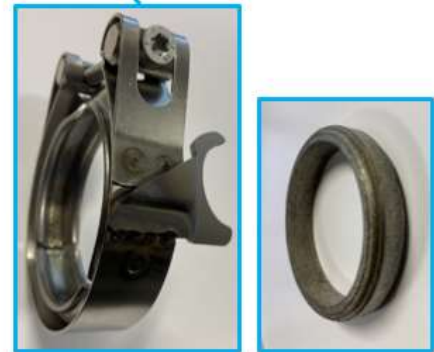
Fig. 1 – V-clamp D=70.1  
with header gasket

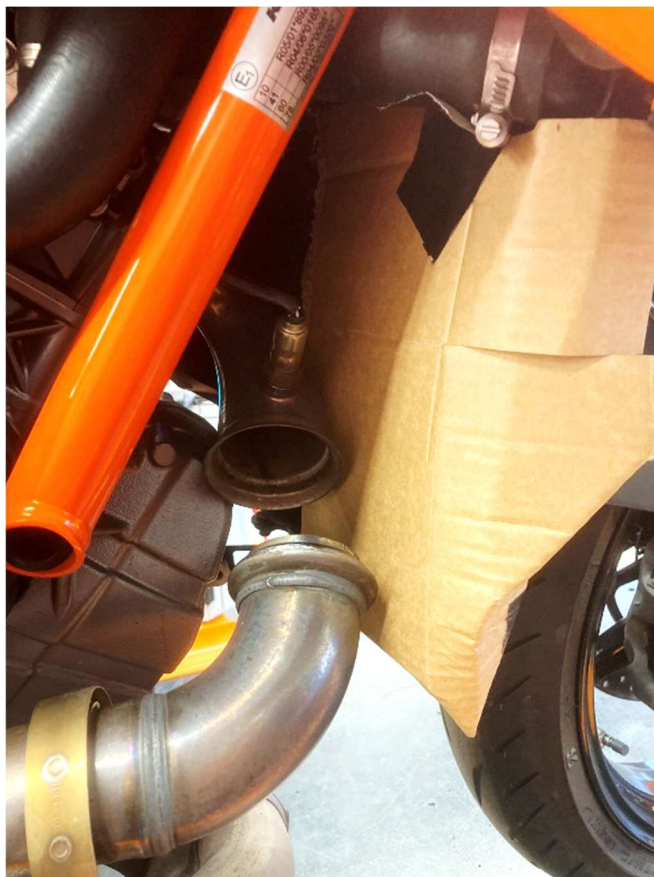
Fig. 3 – Protecting the radiator

1. Dismantle the rear silencer according to the repair instructions.
2. Protect the cooler against damage with cardboard, see Fig. 3.

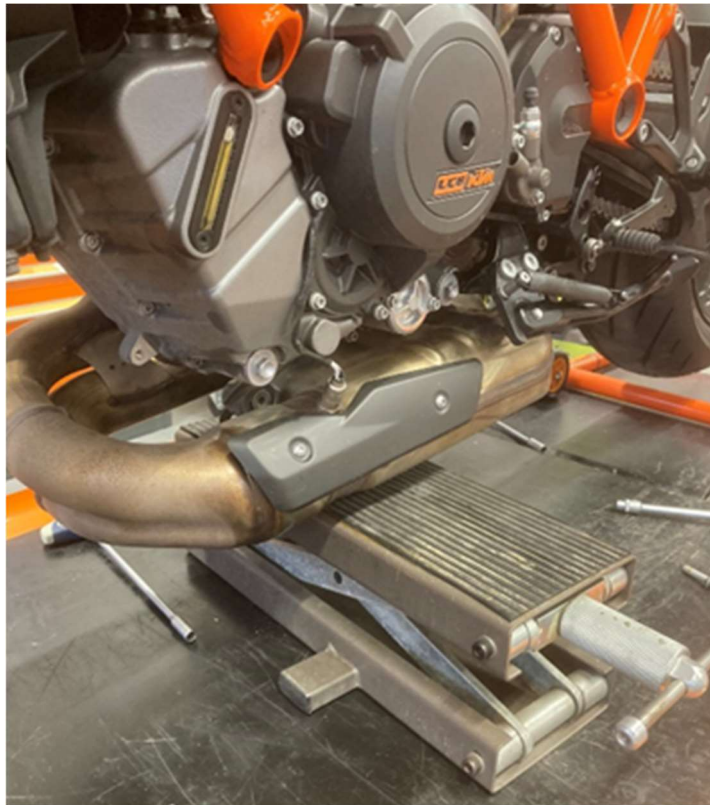
Fig. 4 – Support for front silencer

**Note:** The lambda sensors do not have to be removed, it is sufficient to loosen the pre-silencer, lower it slightly and support it with a suitable tool (e.g., scissor jack), see Fig. 4.

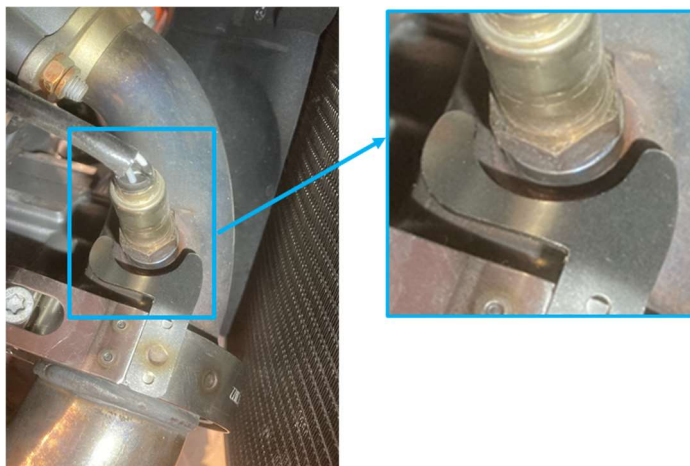
Fig. 5 – Position of V-clamp D=70.1

4. Fit the header gasket (#61705005105).
5. Fit the V-clamp D=70.1 (#61705058200) so that the anti-rotation device does not touch the flange of the lambda sensor, see Fig. 5.

6. Tighten the V-clamp D=70.1 (#61705058200) to the specified torque (see Table 1).
7. Install the front silencer and rear silencer according to the repair instructions.

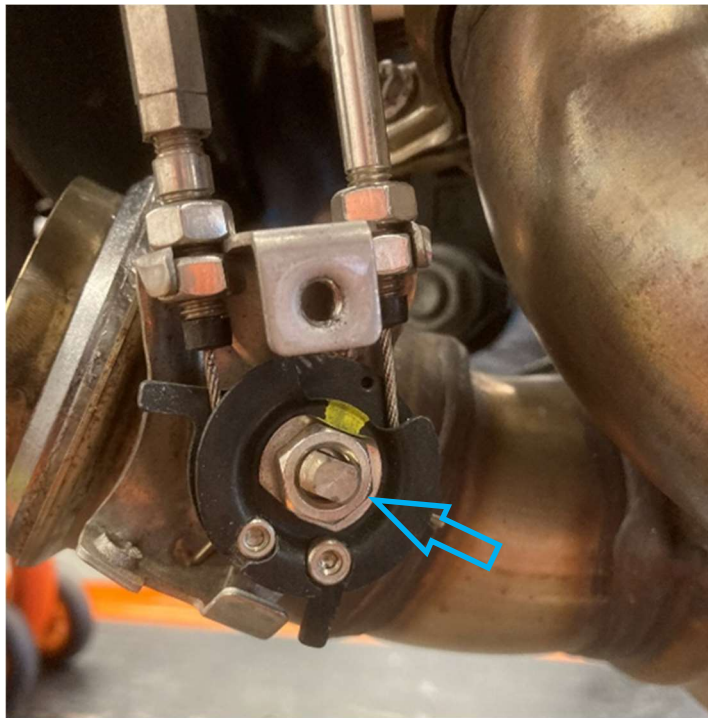
Fig.6 – Locking plate and nut

1. Remove the exhaust flap locking plate and nut, see Fig. 6 and Fig. 7.

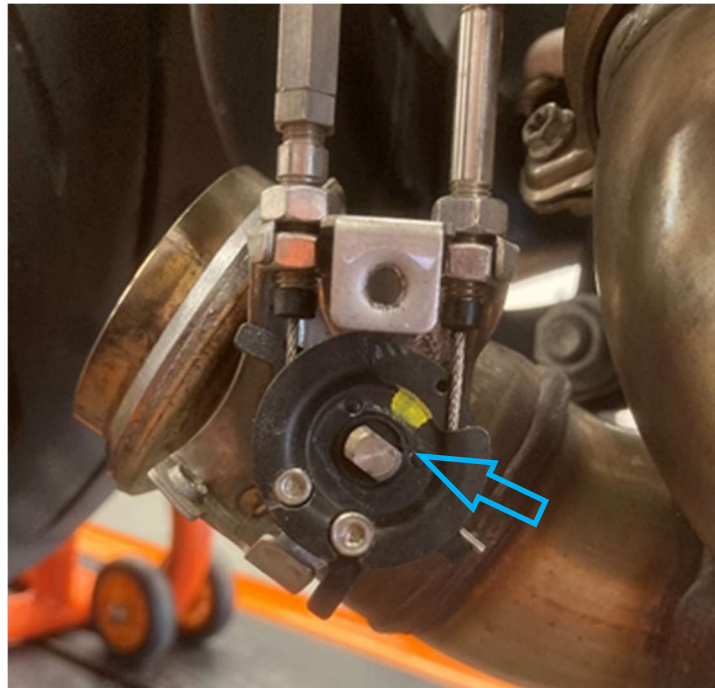
Fig.7 – Locking plate and nut removed

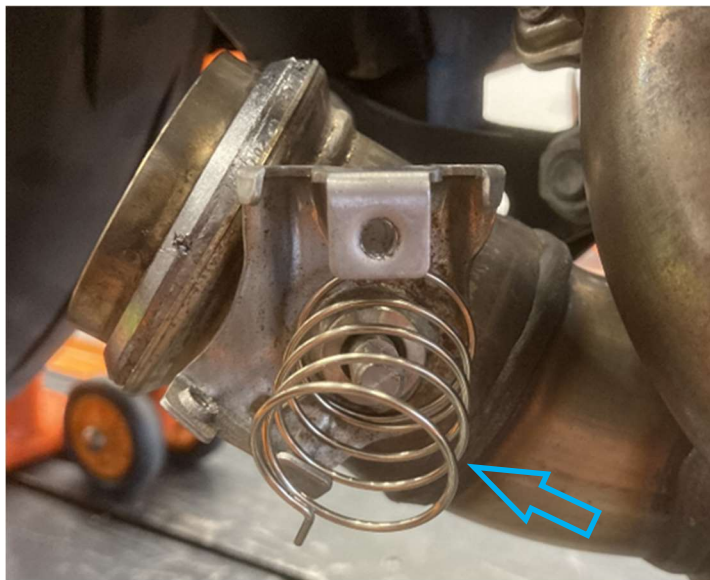
Fig.8 – Replacing the torsion spring.

2. Replace the installed torsion spring of the exhaust flap control with the new torsion spring included in repair kit #A62405031044, see Fig. 8.

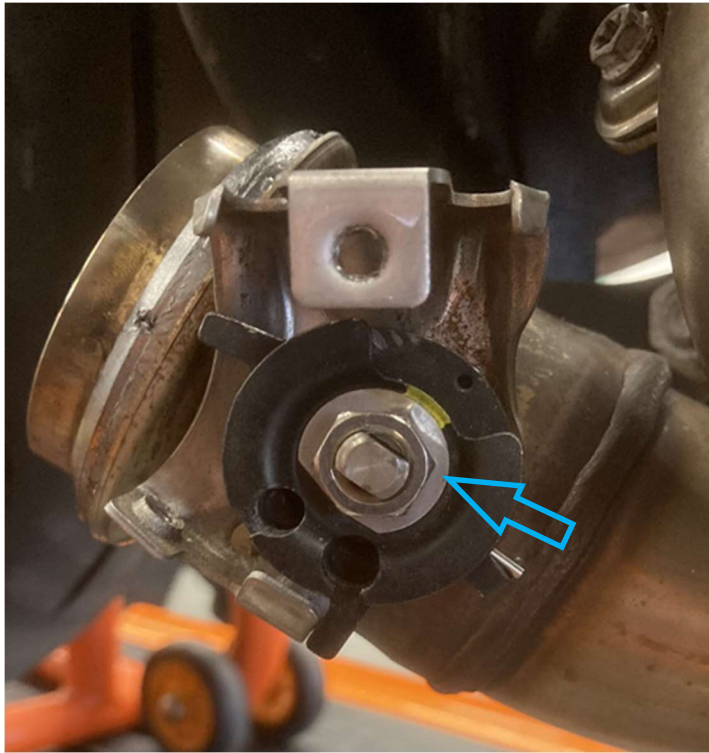
Fig.9 – Locking plate and nut refitted

- Fit the new lock washer and tighten the nut to the specified torque (Table 2), see Fig. 9.

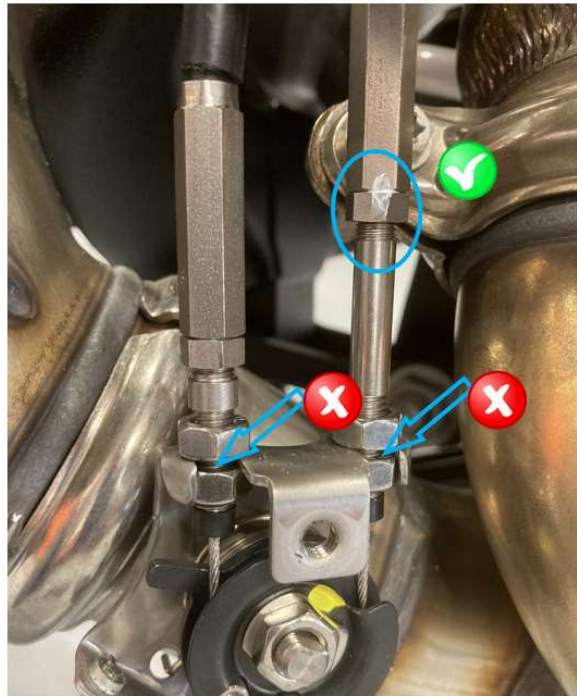
Fig.10 – Adjusting screw with wrench size 8 mm for cable tension

To adjust the cable tension, use only the adjusting screw with a width across flats of 8 mm as shown in Fig. 10.
