**Complaint - Oil Leaks on Double Clutch Transmission (Porsche Doppelkupplung (PDK)):
Observe Specified Procedure (163/20)**

Model Line: **Panamera (971)**

Concerns: **Double clutch transmission (PDK)**

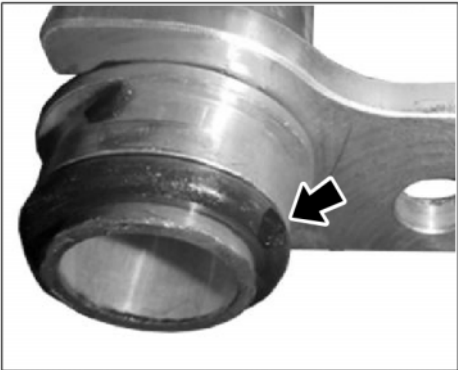
<p>ATF cooler sealing ring</p>	<p>Replace sealing ring on ATF cooling line, see ⇒ Technical Information 'Replacing sealing ring on ATF cooling line'.</p>

Work Procedure: 1 Replace sealing ring on ATF cooling line, see

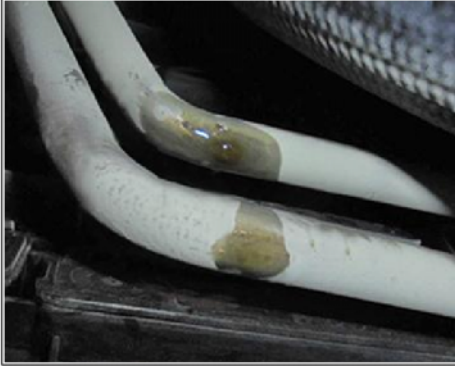
<p><i>ATF cooling line - corroded</i></p>

<p><i>ATF cooling line - crimping damaged</i></p>	<p>Replace ATF cooling line, see ⇒ <i>Technical Information 'Replacing ATF cooling line'</i>.</p>
⇒ <i>Left side of transmission -2-</i>	Screw plug	Screw loose	Check that it is installed securely.
		Sealing ring damaged	Replace double clutch transmission, see ⇒ <i>Technical Information 'Replacing double clutch transmission'</i> .
⇒ <i>Left side of transmission -3-</i>	Parking lock	Sealing ring damaged	Replace sealing ring for parking lock, see ⇒ <i>Technical Information 'Replacing sealing ring for parking lock'</i> .

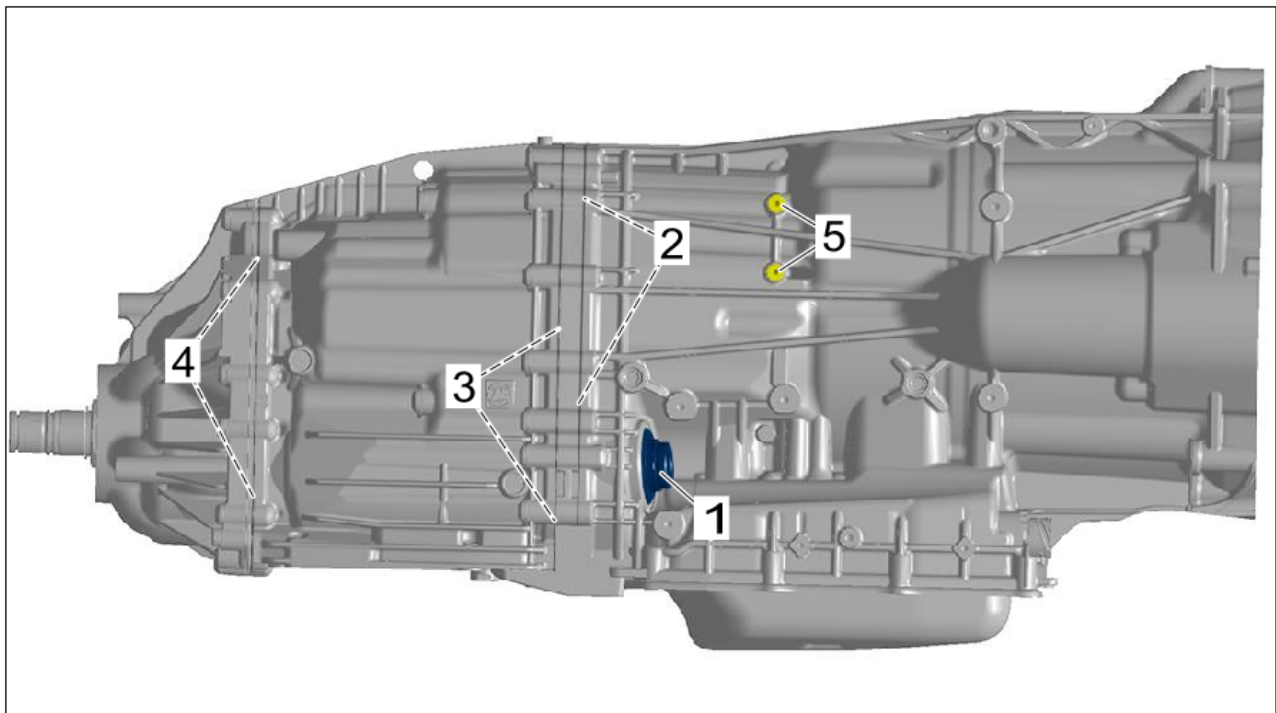
Right side of transmission

Position	Oil leak	Possible cause(s)	Repair measure
<p>⇒ <i>Right side of transmission-1-</i></p>	<p>Front output shaft</p>	<p>Sealing ring damaged:</p>

⇒ <i>Right side of transmission-2-</i>	Transmission housing	Screw loose	Check that it is installed securely.
		Seal damaged	Replace double clutch transmission, see ⇒ <i>Technical Information 'Replacing double clutch transmission'</i> .
⇒ <i>Right side of transmission-3-</i>	Transmission housing	Screw loose	Check that it is installed securely.
		Seal damaged	Replace double clutch transmission, see ⇒ <i>Technical Information 'Replacing double clutch transmission'</i> .
⇒ <i>Right side of transmission-4-</i>	Transmission housing	Screw loose	Check that it is installed securely.
		Seal damaged	Replace double clutch transmission, see ⇒ <i>Technical Information 'Replacing double clutch transmission'</i> .
⇒ <i>Right side of transmission-5-</i>	Screw plug	Screw loose	Check that it is installed securely. Replace screw plug if necessary, see ⇒ <i>Technical Information 'Replacing screw plug'</i> .
		Sealing ring damaged

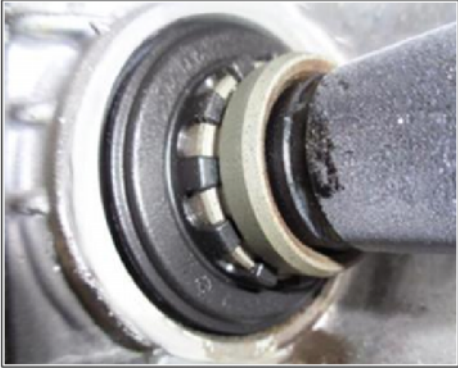
<p><i>Output shaft sealing ring</i></p>	<p>Replace sealing ring for front output shaft, see ⇒ <i>Technical Information 'Replacing sealing ring for front output shaft'</i>.</p>
		<p>O-rings damaged:</p>

Work Procedure: 1 Replace sealing ring for front output shaft, see ⇒ *Workshop Manual '387055 Replacing sealing ring for front output shaft'*.

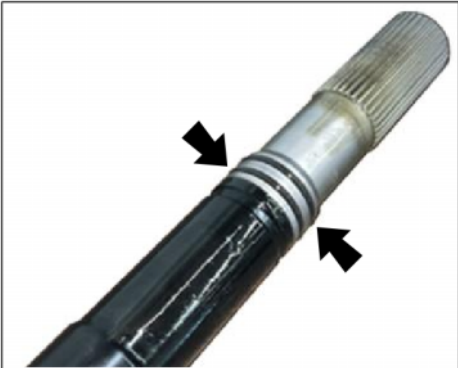
<p><i>Output shaft O-rings</i></p>	
		<p>Connecting shaft damaged</p>	<p>Check connecting shaft and replace it if necessary, see ⇒ <i>Technical Information 'Replacing connecting shaft'</i>.</p>
		<p>Cap damaged (2WD)</p>	<p>Replace cap at transmission output, see ⇒ <i>Technical Information 'Replacing cap at transmission output'</i>.</p>

- Work Procedure: 1 Replace connecting shaft, see ⇒ *Workshop Manual '387055 Replacing sealing ring for front output shaft'*.
- 2 Check and top up ATF; see ⇒ *Workshop Manual '370235 Checking and topping up ATF'*.

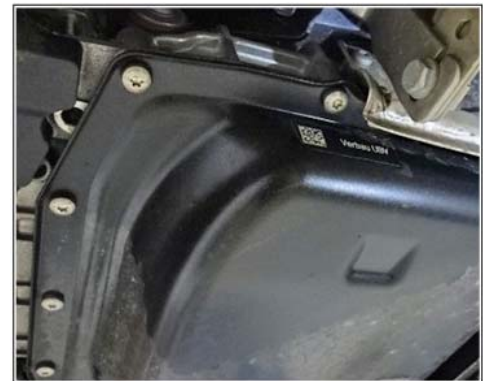
ATF oil pan

If the oil leak has spread so that the oil pan is also oily, as shown, proceed as follows in the event of a complaint:

- Ensure that the accessible oil pan screws are tighten to the specified torque.
- Before carrying out any further work, the entire transmission must be thoroughly cleaned in the areas of oil leaks/ oil contamination and sprayed with a suitable leak tracer/ spray (commercially available).
- Clean the transmission oil pan area extremely thoroughly. An oil pan seal leak can lead to incorrect interpretations. Then perform a test drive.
- **After the test drive, check the transmission for oil leaks below.**
