## **SERVICE BULLETIN**

### **22-23 MY L-SERIES COOLANT DEGAS BOTTLE SUPERSESSION**

**GROUP: 0-GENERAL  
SB NO : 24-002  
DATE: 2/29/2024  
REF : HMM-240219-F1**

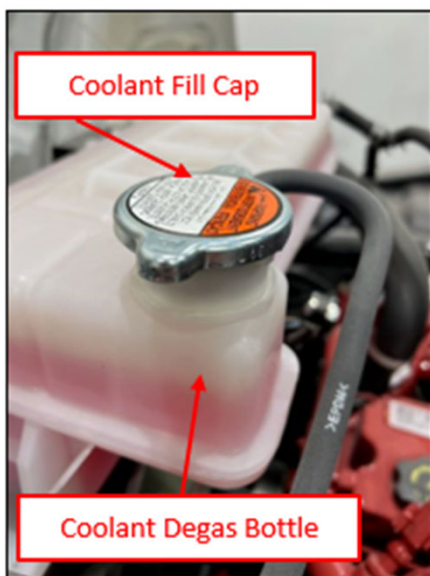
1. Allow the engine and cooling system to cool down to ambient temperature. Remove the engine coolant fill cap from the coolant degas bottle. Open the radiator drain valve and drain the coolant into a suitable container until the coolant degas bottle is empty. Close the radiator drain valve when the coolant degas bottle is empty.

**WARNING:** Do not loosen or remove the coolant fill cap or attempt to drain the cooling system until the coolant and engine have cooled to ambient temperature. Loosening or removing the coolant fill cap or draining the cooling system prior to the cooling system cooling down could cause severe personal injury due to scalding.

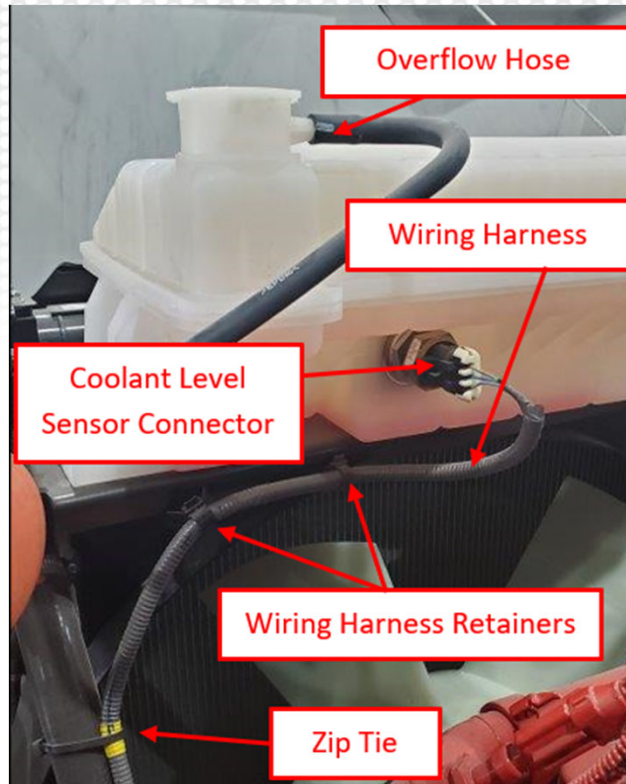
2. Disconnect the overflow hose at the coolant degas bottle and then the coolant level sensor connector. Remove and discard the 2 wiring harness retainers, and single zip tie.

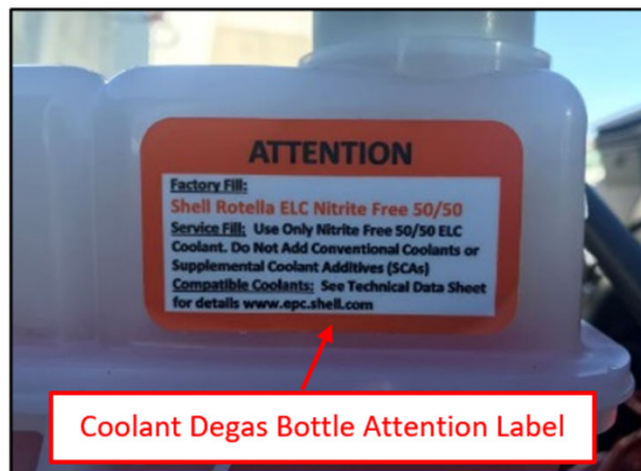
5. Inspect the coolant degas bottle that was just removed. If the old degas bottle contains a coolant attention label, ensure a new attention label is affixed to the new coolant degas bottle before installing the coolant degas bottle to the vehicle.

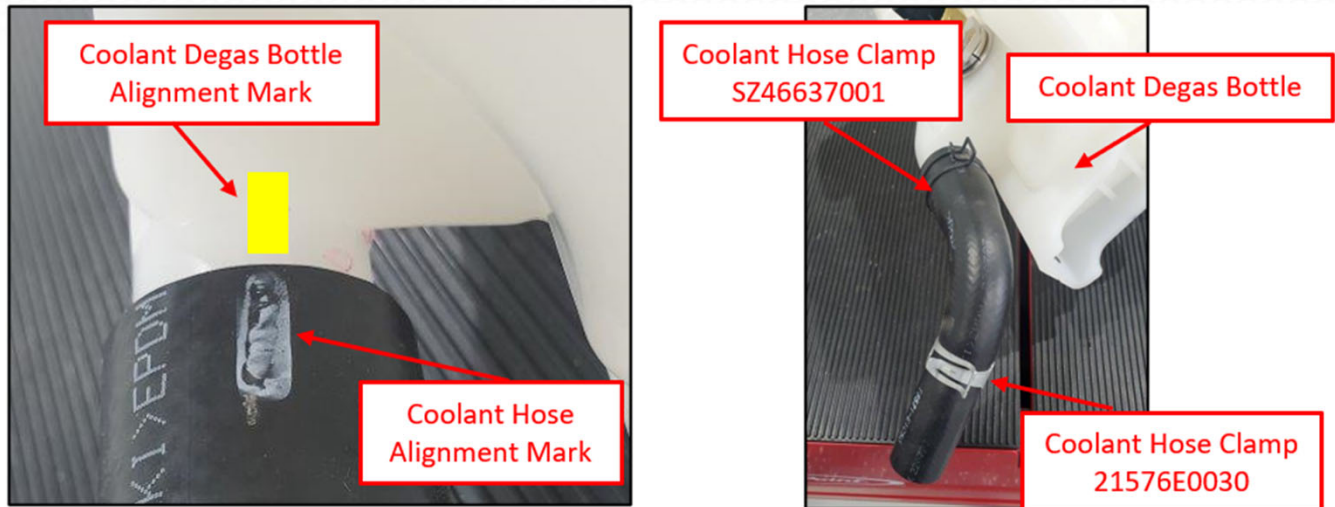
6. Using the new coolant degas bottle, install the new coolant hose onto the coolant degas bottle. Position the white alignment mark on the coolant hose with the raised alignment mark on the coolant degas bottle. Position the 2 coolant hose clamps as shown in the photograph below.

**NOTICE:** In the photograph below, the raised alignment mark on the coolant degas bottle has been highlighted yellow for your reference.
