Subject Head/Valve Cover Gasket Oil Leaks		Market USA
Service Category Engine/Hybrid System	Section Lubrication	
Applicability 2020-2022 NAP A25A-FKS/FXS Models

Head/Valve Cover Gasket Oil Leaks

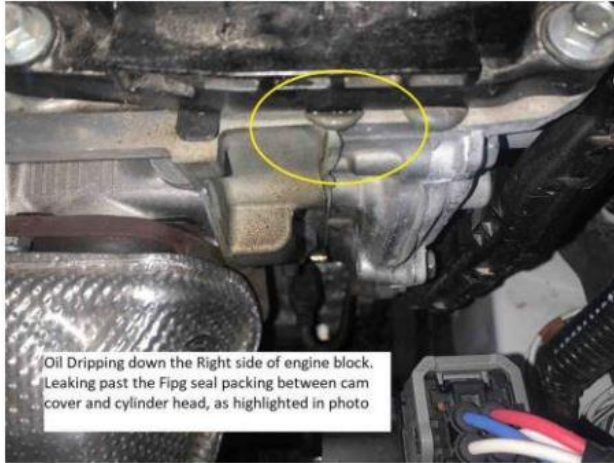
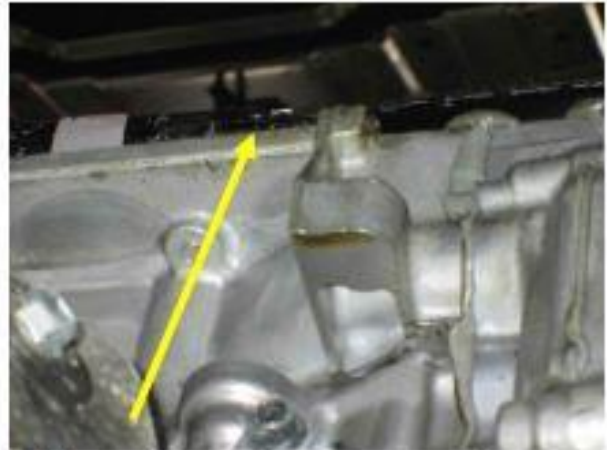
Some 2020-2022 vehicles equipped with North American Produced (NAP) A25A-FKS/FXS engines may experience an oil leak from the head/valve cover gasket. This issue is currently under investigation.

Figure 2. Images of head/valve cover gasket leaks.

1. Take clear pictures of the origin of the leak.
2. Please create a TAS case and contact TAS for instruction prior to diagnosing or repairing of the vehicle. If it is a weekend or holiday, continue with diagnosis and repair. Please save all parts and/or details and contact TAS on the next available workday.
