Diagnostic Sheet

FROM: Maserati TSO

Cambiocorsa "F1" Gearbox Diagnosis

MODELS: Quattroporte (M139) and GranTurismo (M145) with Cambiocorsa (also known as F1 gearbox) transmission

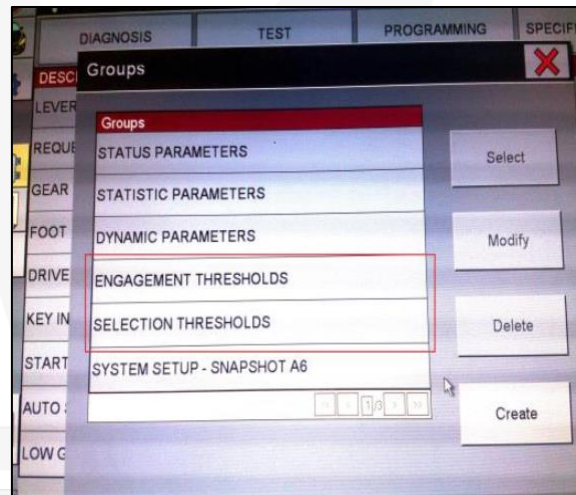
Figure 1: threshold values (minimum/maximum) for engagement and selection (left) and Parameter Groups in the NCR ECU (right).

1. Download the **Excel file F1_Grid.xlsm**.
2. The values required for the filling of the tables "Threshold min./max. Engagement" and "Threshold min./max. Selection" (Figure 1, on the left) can be found in Vehicle in the NCR Parameters Groups Engagement Thresholds and Selection Thresholds (Figure 2, on the right). These values must be pasted in the Excel file for each gear. into NCR ECU and just copy & paste the values for every gear.

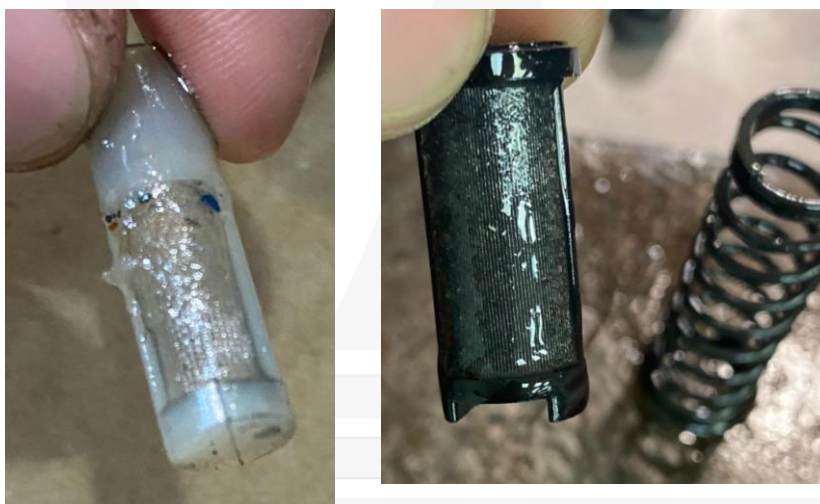
Please verify the presence of metal shavings or contamination on their surface, as shown in Figure 8.

Figure 8: filters of the F1 hydraulic actuation circuit. In this case, they were found to be dirtied by metal shavings.

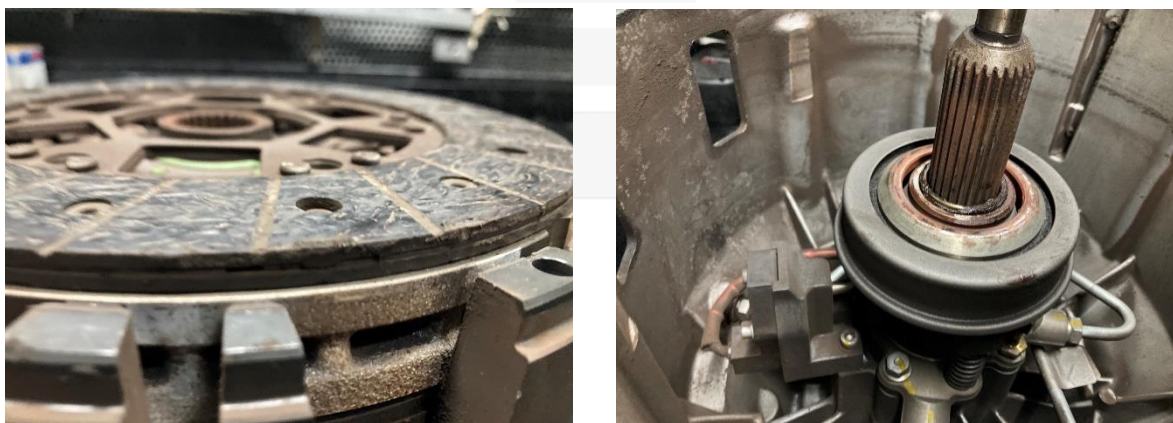
2. Verify the status of actual wear of the friction material on the Clutch Plate itself, as well as the absence of free play or abnormalities on the Clutch Thrust Bearing, as shown in Figure 9.

Figure 9: checks of the wear of the friction material of the clutch plate (left) and of the status of the clutch thrust bearing (right).
