Technical product information

Topic	Rotating display/screen noise - Diagnosis for complaints relating to noise during operation and/or during a drive cycle
Market area	Australia E04 Bentley rest Asia and Australia (6E04),China 723 Volkswagen (Anhui) Automotive CO (6723),China 796 VW Import Comp. Ltd (Vico), Beijing (6796),Germany E02 Bentley rest Europe (6E02),Japan E03 Bentley Japan (6E03),Korea, (South) E08 Bentley South Korea (6E08),United Arab Emirates E06 Bentley Middle East and Africa (6E06),United Kingdom E01 Bentley UK (6E01),United States E05 Bentley USA and rest America (6E05)
Brand	Bentley
Transaction No.	2065895/5
Level	EH
Status	Approval
Release date

Rotating display/screen noise - Diagnosis for complaints relating to noise during operation and/or during a drive cycle

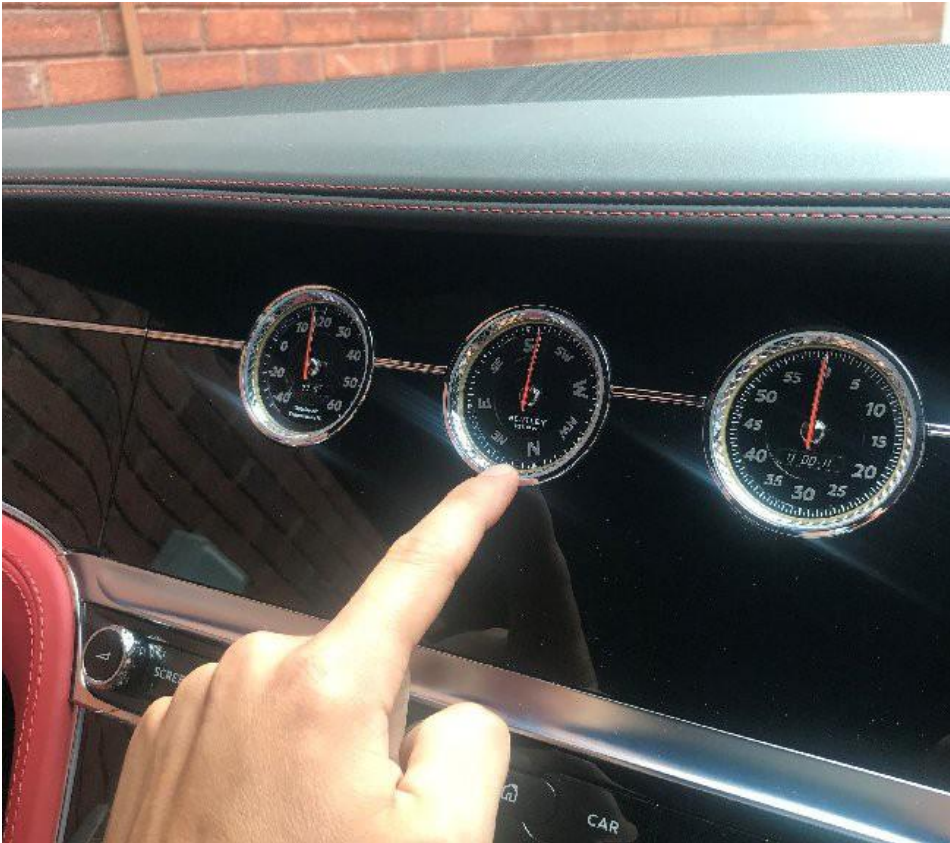
Figure 1

Scenario 1 - Squeak/creak/rattle from the dials during operation or graunching noise from the compass when the vehicle is being driven

When noise is evident from the dials, press on outer bezels (Figure 1) If the noise disappears when the bezels of the dials are pressed - Referring to Gr.91 - Replace the applicable dial(s)

In the event a graunching noise is evident from the compass when the vehicle is being driven - Referring to Gr.91 - Rotating display screen - to remove and fit - Replace the compass

The BRD does require removal when replacing the compass - Refer to Gr.91 - Rotating display screen to remove and fit to replace the compass

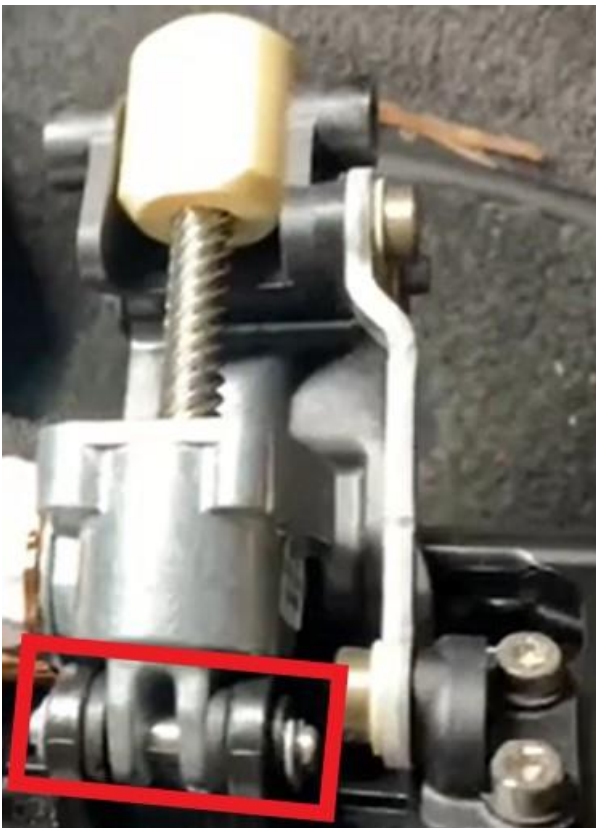
Figure 2

Scenario 2 - Creak/rattle from rotating display whilst driving

TIP: This symptom can in some cases be evident due to excessive movement within the rotating display motor pivot assembly (Figure 2)

- The operative should consider the motor pivot assembly

NOTE: To check the motor pivot assembly for excessive movement the rotating display should be removed - Refer to Rep.Gr 91

- Refer to the Bentley Hub and refer to the video referencing TPI 2065895/-
- Should the movement be as shown in the video, the rotating display unit should be replaced

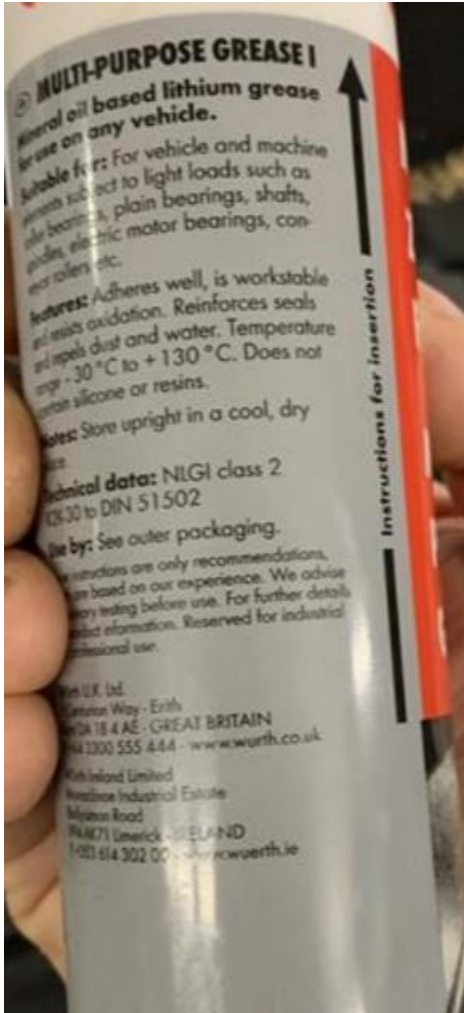
Figure 3

Scenario 3 - Squeaking noise from the rotating display whilst in operation (rotating)

- Refer to the videos located on the Bentley Hub (Video 1 - 2065895 and Video 2 - 2065895)
- Remove the rotating display - Refer to Rep.Gr91
- Apply a thin layer of multi-purpose grease (Figure 3) to the worm drive at the location shown in Figure 4
