# Technical Service Bulletin

**SUBJECT:** WIRING PROTECTION INSTALLATION FOR FRONT BUMPER MAIN WIRING & CONNECTOR (SERVICE CAMPAIGN T36G)

**Description:** Some vehicles may exhibit door unlock malfunctions due to front bumper wiring and fuse disconnections following a collision, stemming from inadequate wiring protection during bumper impacts. This bulletin provides instructions to remove the front bumper and install the enhanced wiring protection measures.

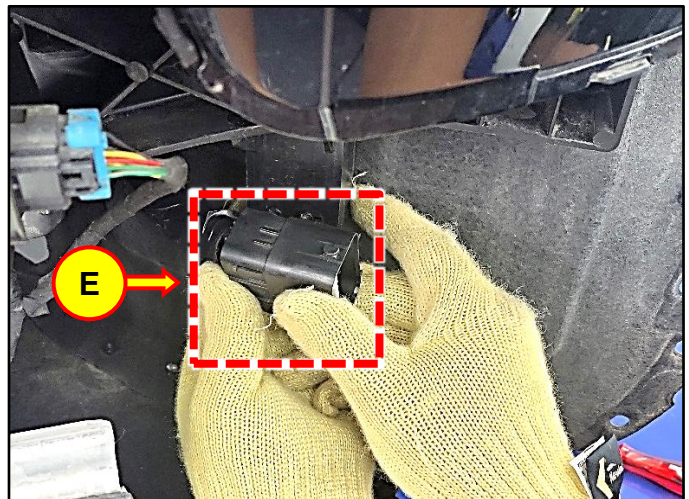
5. Install the connector (E) on the connector mounting area.

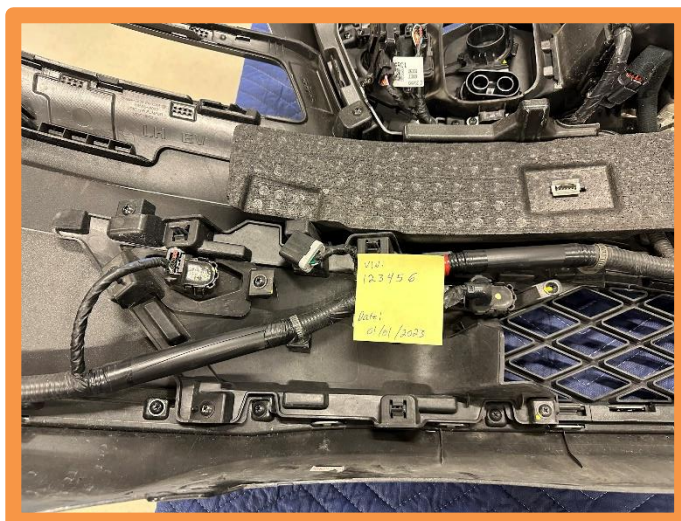
1. **Harness with both PVC tubes attached.**
2. **Vinyl sheet covering the connector wiring.**

**Both photos must have the last 6 digits of the VIN and date of repair on a piece of paper.**
