ARA2 - Checking and if Necessary Replacing Three-Point Belt on Rear Left and Right (Recall Campaign)

Model Line: **911 Coupe (992)**

Model Year: **2023**

Concerns: **Child safety function on the rear three-point belt and the left and right**

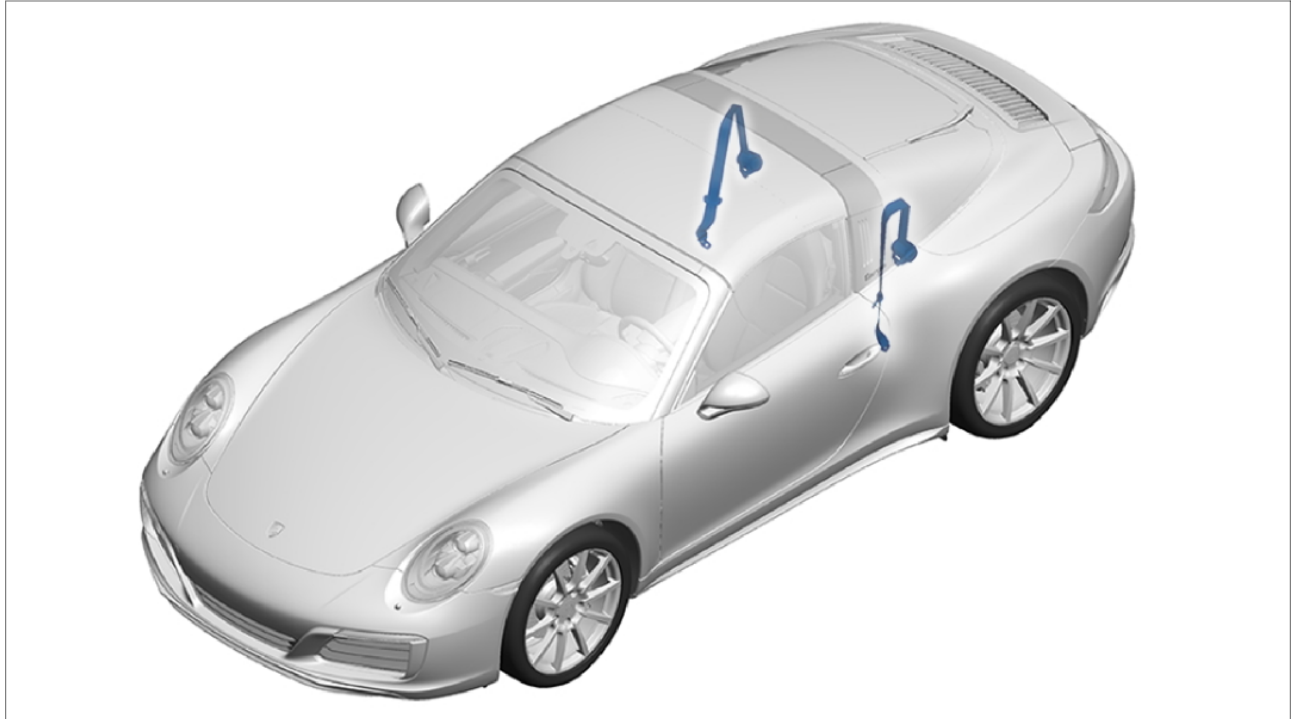
Installation position for rear three-point belts (shown on 911 Targa)

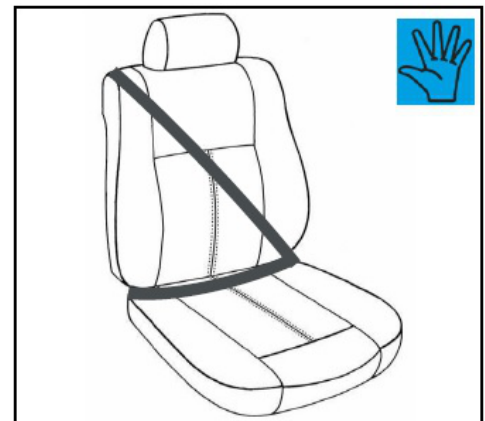
- 1 Insert the three-point belt into the belt buckle and ensure that it locks ⇒ *Closing three-point belt.*

Closing three-point belt

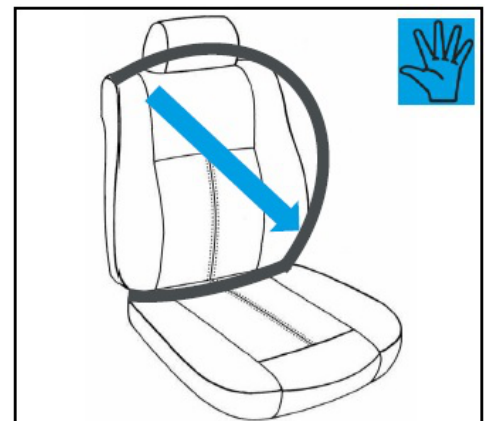
- 2 Pull out the belt strap completely ⇒ *Pulling out belt strap* to activate the child safety function (ALR automatic locking retractor).

Pulling out belt strap

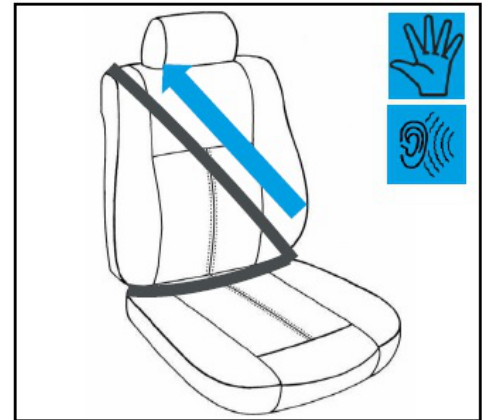
- 3 Slowly allow the belt to roll up, making sure that a click can be heard during retraction ⇒ *Rolling up belt strap*.
The belt strap must be held in place by hand.

Rolling up belt strap

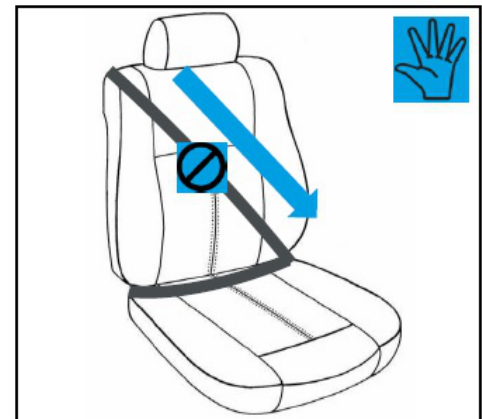
- 4 As soon as the belt strap is retracted, check whether it can be pulled out again or is locked ⇒ *Pulling out belt strap and checking belt lock*.

If the belt strap is locked and a click can be heard when the three-point belt is retracted:

Pulling out belt strap and checking belt lock

If it is found during the inspection of a three-point belt that the **belt does not lock**, the affected three-point belt must be replaced. To do this, continue with:

- Replacing rear three-point belt at the left **and / or**
- replacing rear three-point belt at the right
